October 14, 2024

Subject: **Arborist Report**  
434 Crescent Ave., Sunnyvale CA

GKW Architects is proposing to redevelop the 434 Crescent Ave. site, in Sunnyvale California. Woodreeve Consulting was asked to prepare an **Arborist Report** for the project to meet the City of Sunnyvale requirements. This letter responds to that request.

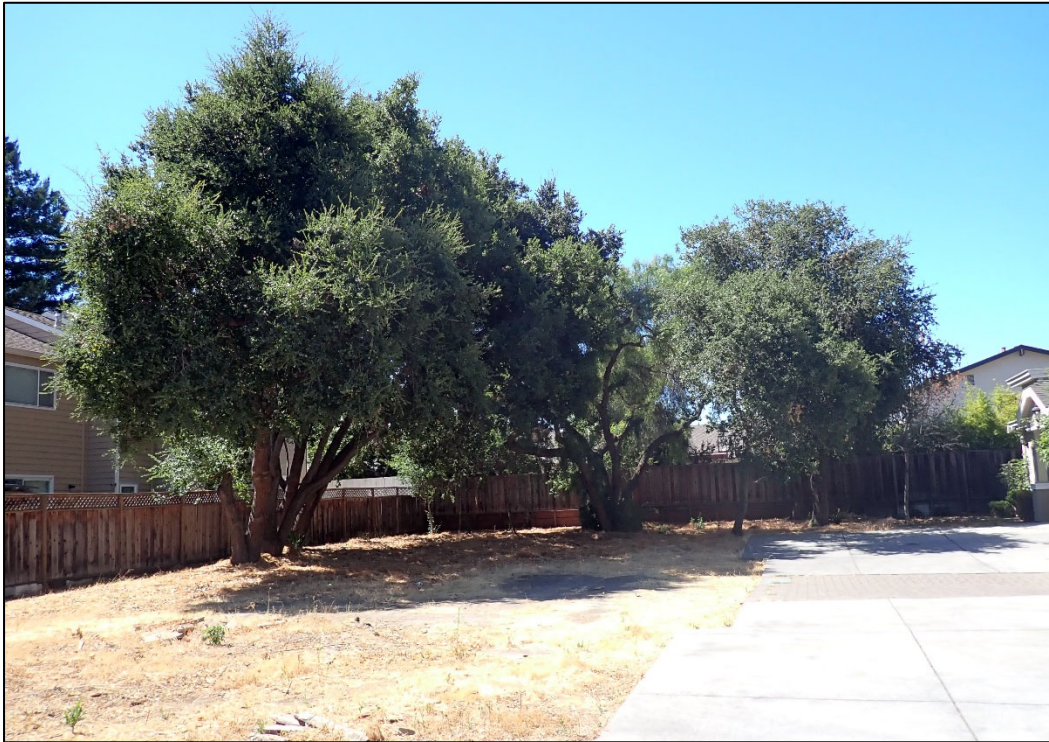
**Photo 1** (above): Looking south at the group of trees growing in the rear yard of the 434 Crescent Ave. property. Seven of the trees were coast live oaks, including 5 semi-mature trees and 2 young trees. Condition was good for 3 of the coast live oaks, fair for 4 and #496 was in poor condition. Calif. pepper #493 was centrally located and in fair condition.

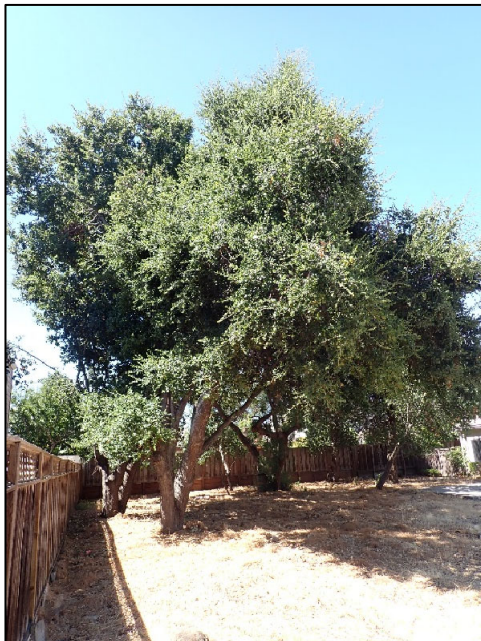
**Photo 2** (above L): Looking southwest at coast live oaks #489-491, growing along the eastern fence line. Several stems had been removed from the west side of the trees and they were sprouting below the cuts. **Photo 3** (above R): Looking west at coast live oak #492, growing along the southern fence line. It was suppressed and had a strong lean to the south.

| TREE No. | SPECIES | TRUNK DIAMETER<br>(in inches) | SIGNIFICANT SIZE | CONDITION<br>1=POOR<br>5=EXCELLENT | SUITABILITY FOR RETENTION | COMMENTS | Dripline (ft.) | | | |
|---|---|---|---|---|---|---|---|---|---|---|
| 489 | Coast live oak | 16,13 | Yes | 3 | Moderate | Codominant trunks at 2'; 13" stem topped at 8'; 16" stem very one sided NW. | 22 | 5 | 8 | 22 |
| 490 | Coast live oak | 14,12 | Yes | 4 | Moderate | Codominant trunks at 2'; 14" stem upright; 12" stem leans W.; weak stem attachment/included bark. | 10 | 15 | 8 | 25 |
| 491 | Coast live oak | 18,15,10 | Yes | 4 | Moderate | Multiple attachments at 1'; 10" stem topped at 7'; 15" stem upright; 18" stem leans SW; entire crown one sided SW. ; 3" branch flopped onto adj. building E. | 8 | 25 | 15 | 30 |

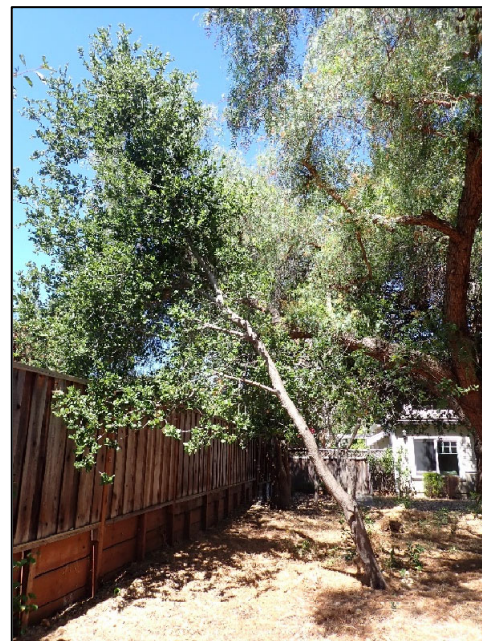
| TREE No. | SPECIES | TRUNK DIAMETER<br>(in inches) | SIGNIFICANT SIZE | CONDITION<br>1=POOR<br>5=EXCELLENT | SUITABILITY FOR RETENTION | COMMENTS | Dripline (ft.) | | | |
|---|---|---|---|---|---|---|---|---|---|---|
| 492 | Coast live oak | 6 | No | 3 | Low | Suppressed beneath tree #493; leaning and one sided S. | 5 | 18 | 8 | 8 |

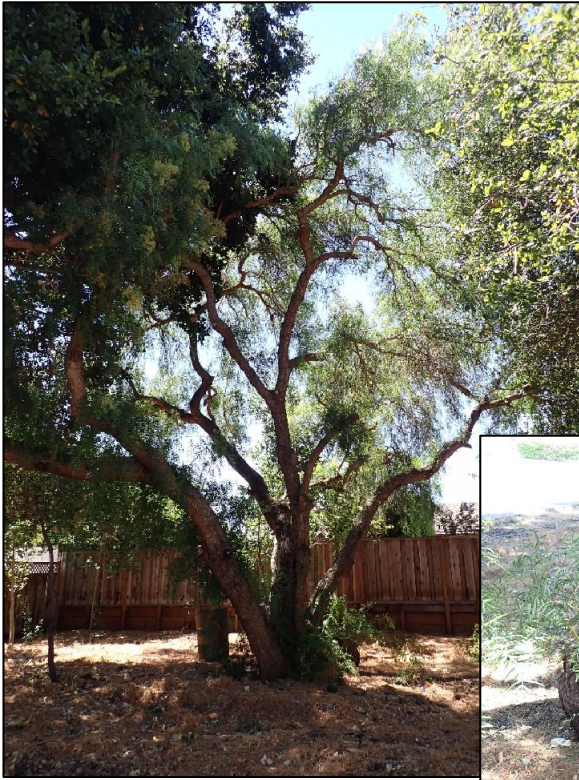
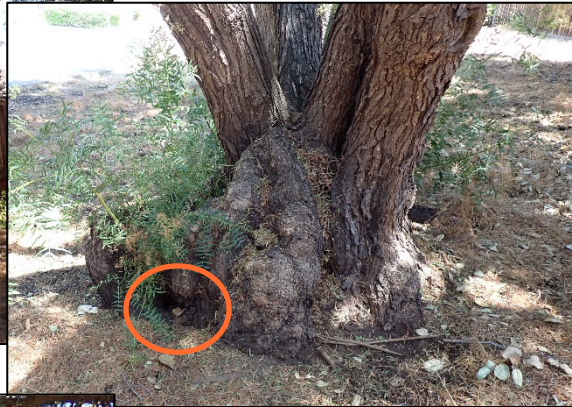
**Photo 4 (L):** Calif. pepper #493 was multi-stemmed and in fair condition. Several stems had been removed. The canopy was sparse and there was an active beehive in a cavity at the base of the tree on the south side.

Inset below shows the location of the cavity and beehive (circle).

| TREE No. | SPECIES | TRUNK DIAMETER<br>(in inches) | SIGNIFICANT SIZE | CONDITION<br>1=POOR<br>5=EXCELLENT | SUITABILITY FOR RETENTION | COMMENTS | Dripline (ft.) | | | |
|---|---|---|---|---|---|---|---|---|---|---|
| 493 | Calif. pepper | 15,14,12,10 | Yes | 3 | Low | Multiple attachments at 1'; one stem upright, others lean away; sparse crown; several stems removed; active bee hive at base S. | 20 | 25 | 18 | 18 |

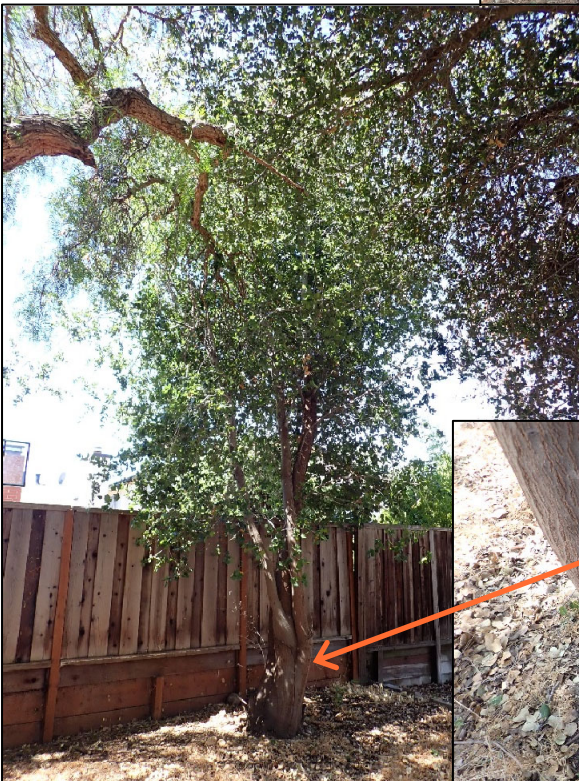
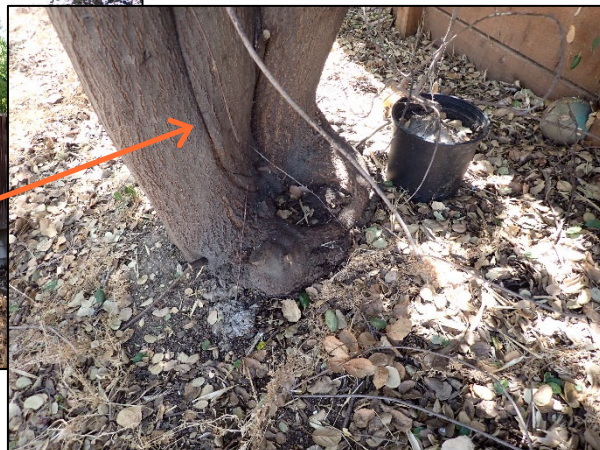
**Photo 5 (L):** Looking southeast at coast live oak #494. The tree was a stump sprout with poor form and structure. It had several stems measuring from 4" to 7" in diameter that had fused at the base (inset below). It was in fair condition due to its vigor but had Low suitability for retention due to its poor form and structure.

| TREE No. | SPECIES | TRUNK DIAMETER<br>(in inches) | SIGNIFICANT SIZE | CONDITION<br>1=POOR<br>5=EXCELLENT | SUITABILITY FOR RETENTION | COMMENTS | Dripline (ft.) | | | |
|---|---|---|---|---|---|---|---|---|---|---|
| 494 | Coast live oak | 7,7,5,4 | No | 3 | Low | Multiple attachments at base; stump sprout; poor form and structure; leaning & one sided S. | 8 | 15 | 12 | 15 |

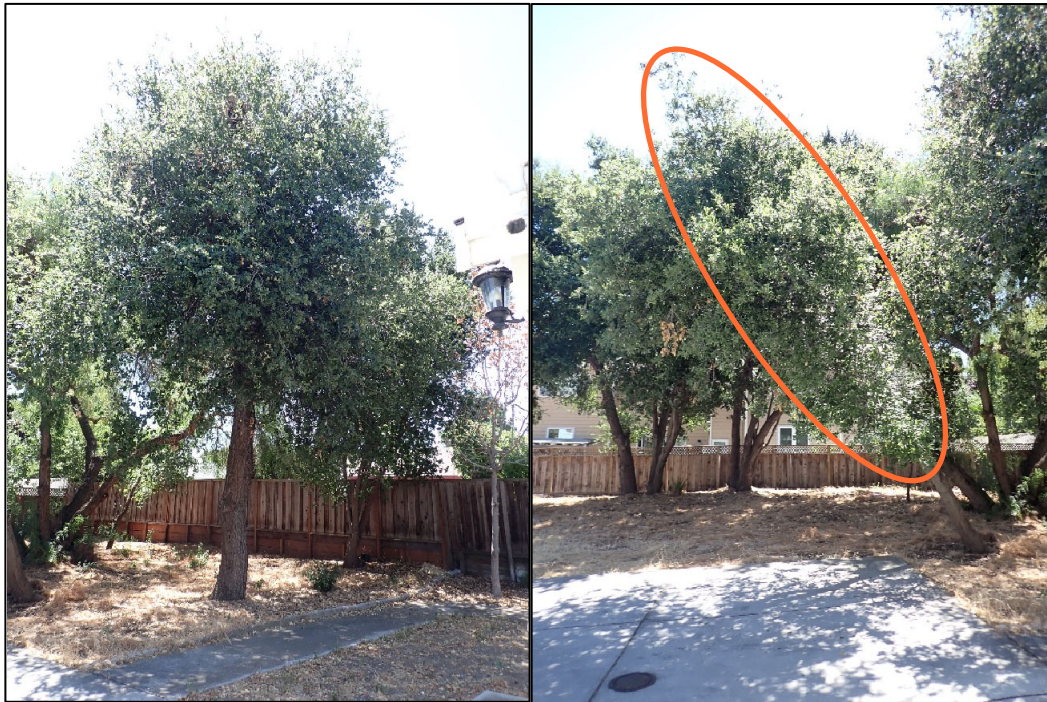
**Photo 6** (above L): Looking southeast at coast live oak #495, growing along the southwestern corner of the property. The tree measured 18" in diameter and was in good condition but had a relatively small crown for the size of the trunk. There were old topping points in the upper crown.

**Photo 7** (above R): Looking east at coast live oak #496 (circle). This young tree had partially failed at the base. It had a strong lean to the north over the adjacent driveway, and roots were visibly uplifted. It was in poor condition.

| TREE No. | SPECIES | TRUNK DIAMETER<br>(in inches) | SIGNIFICANT SIZE | CONDITION<br>1=POOR<br>5=EXCELLENT | SUITABILITY FOR RETENTION | COMMENTS | Dripline (ft.) | | | |
|---|---|---|---|---|---|---|---|---|---|---|
| 495 | Coast live oak | 18 | Yes | 4 | Moderate | Multiple attachments in upper crown; fair form and structure; old topping points. | 18 | 15 | 18 | 15 |
| 496 | Coast live oak | 9 | No | 2 | Low | Partial failure at base; strong lean NW. over adj. driveway; roots lifted out of ground. | 20 | 0 | 5 | 12 |
