# 494 S Bernardo Ave

## Sunnyvale, CA

### Arborist Report 2025

Subject: Tree protection plan for 494 S Bernardo Ave, Sunnyvale, CA 94086

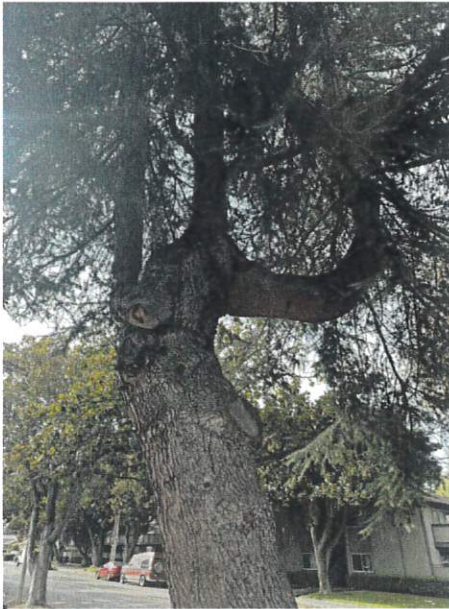
**Tree #1**

| Tree Tag # | Protected Tree | Preserve or Remove | Common Name / Scientific Name | Trunk (in.) | If more than 1 Trunk, Total Diameter | Ten Times the Diameter in (ft.) | Height (ft.) / Canopy Spread (ft.) | Health Rating | Structural Rating | Form Rating | Suitability for Preservation | Overall Condition (0-100%) | Summary | Tree Picture #1 |
|---|---|---|---|---|---|---|---|---|---|---|---|---|---|---|
| 1 | Yes | (R) | DEODAR CEDAR<br><i>Cedrus deodara</i> | 38 | - | 31.7 | 60/40 | Fair | Poor | Poor | Poor | 30% | Topped in the past at 15 feet, decay at root crown, at high risk of failure | |

Tree #1, a Deodar Cedar (*Cedrus deodara*) with a trunk diameter of 38 inches, has been severely compromised by a previous topping at 15 feet. This practice has left the tree with a poor structure that heightens the risk of a large leader failure. Significant decay at the root crown was also observed, increasing the tree's risk of structural failure at the root crown. Given its poor overall condition rating of 30% and the associated risk to people and nearby structures, its removal is warranted under § 19.94.060(a) and (b). Retaining this tree would pose an unacceptable hazard, as its structural integrity cannot be restored.

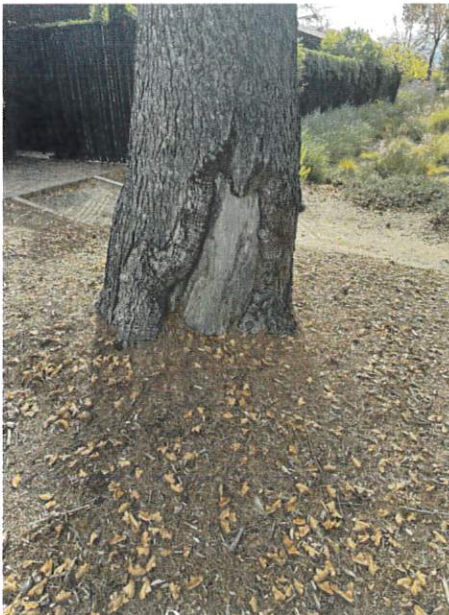
**Showing evidence of root crown decay**

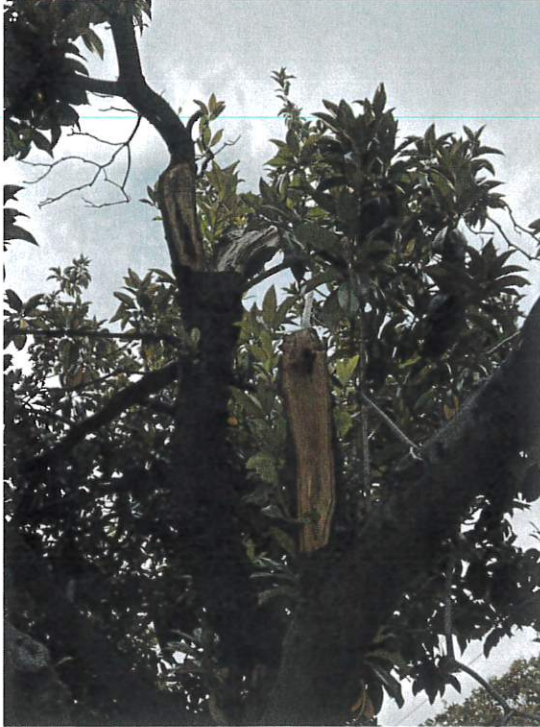
| Tree Tag # | Protected Tree | Preserve or Remove | Common Name / Scientific Name | Trunk (in.) | If more than 1 Trunk, Total Diameter | Ten Times the Diameter in (ft.) | Height (ft.) / Canopy Spread (ft.) | Health Rating | Structural Rating | Form Rating | Suitability for Preservation | Overall Condition (0-100%) | Summary | Tree Picture #1 |
|---|---|---|---|---|---|---|---|---|---|---|---|---|---|---|
| 4 | Yes | (R) | SOUTHERN MAGNOLIA<br><i>Magnolia grandiflora</i> | 15.1 | - | 12.6 | 25/25 | Fair | Poor | Poor | Poor | 30% | History of large limb loss, three large 6" diameter limbs have recently failed from the center of the canopy, codominant at 7 feet, in decline. | |

**Showing the 3 limb failures**

Magnolia Tree #4 exhibits significant structural and physiological concerns that warrant its removal. The tree has a history of large limb failures, with three recent 6-inch diameter limbs detaching from the center of the canopy. This pattern of failure indicates progressive structural weakness, raising concerns about continued limb loss and associated safety risks. The tree's codominant structure at seven feet further exacerbates its instability, as codominant stems are prone to failure due to weak attachment points and included bark, which reduces the tree's ability to withstand wind or additional stress. Moreover, the tree is in a state of decline. Declining magnolias typically exhibit reduced vigor, sparse foliage, and diminished capacity to compartmentalize wounds, making them more susceptible to decay and further structural failure. Given the tree's compromised integrity and history of failure, mitigation through pruning would not be a viable long-term solution, as continued decline will likely lead to additional limb failures. Considering these factors, the removal of Magnolia Tree #4 is a justified course of action to eliminate the ongoing risk of branch failure and potential harm to nearby structures, pedestrians, or vehicles. If canopy coverage is a concern, a suitable replacement tree with strong structure and resilience should be considered to maintain the landscape value. Its removal is essential to eliminate the risk of failure and complies with § 19.94.060(a) and (b), as it is both damaged and hazardous.

Tree #4, another Southern Magnolia, is in poorer condition than Tree #3, with a history of significant limb failure and an overall condition rating of only 30%. The impact on this tree is anticipated to be moderate to high due to its weakened state and its codominant structure at seven feet, which makes it more susceptible to stress from construction. Mitigation efforts include hand excavation within the protection zone, retention of roots larger than 1.5 inches in diameter where feasible, and consistent monitoring by the Project Arborist to address any emergent issues. While these steps will help reduce construction-related stress, the long-term viability of this tree is uncertain given its existing health and structural challenges. Its survival will depend on the effectiveness of these measures and the absence of further structural failures during and after construction.

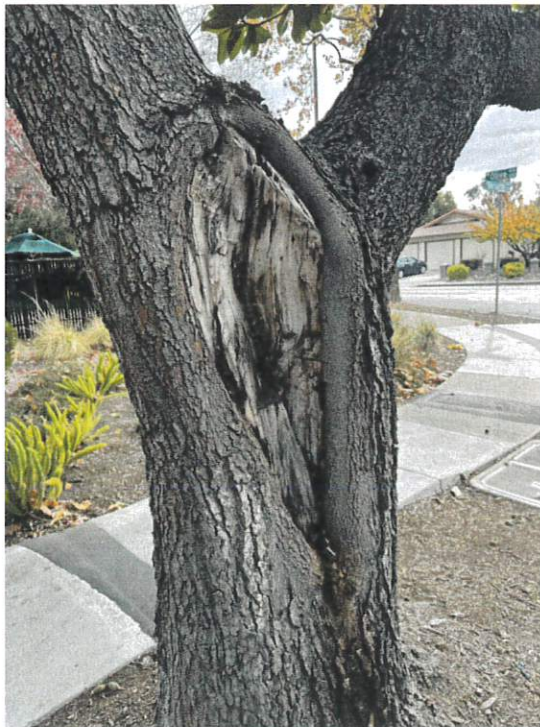
**Tree #6**

| Tree Tag # | Protected Tree | Preserve or Remove | Common Name / Scientific Name | Trunk (in.) | If more than 1 Trunk, Total Diameter | Ten Times the Diameter in (ft.) | Height (ft.) / Canopy Spread (ft.) | Health Rating | Structural Rating | Form Rating | Suitability for Preservation | Overall Condition (0-100%) | Summary | Tree Picture #1 |
|---|---|---|---|---|---|---|---|---|---|---|---|---|---|---|
| 6 | Yes | (R) | SOUTHERN MAGNOLIA<br><i>Magnolia grandiflora</i> | 26 | - | 21.7 | 30/30 | Poor | Poor | Poor | Poor | 30% | Large codominant leader failure on the trunk of the tree due to included bark, Heartwood decay, hazardous tree, recommended to remove | |

Tree #6, a Southern Magnolia (*Magnolia grandiflora*) with a trunk diameter of 26 inches, has experienced a large codominant leader failure due to included bark on the main trunk. The presence of heartwood decay further exacerbates its hazardous condition. With an overall condition rating of 30% and poor structural and health ratings, this tree is unsuitable for retention. Its removal is essential to eliminate the risk of failure and complies with § 19.94.060(a) and (b), as it is both damaged and hazardous.

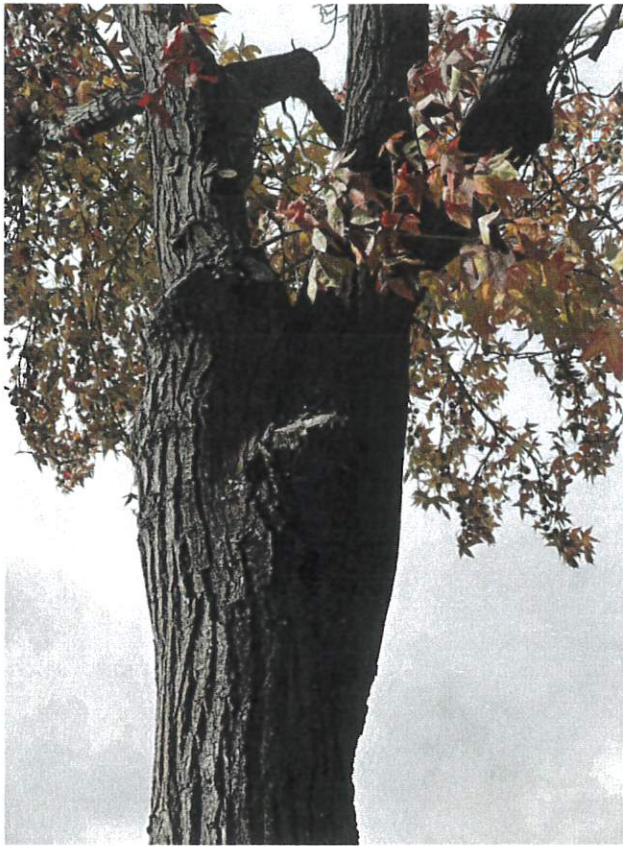
American Sweetgum Tree #7 presents multiple structural concerns that justify its removal. The tree has a codominant structure at 15 feet with included bark, a well-documented structural defect that significantly increases the likelihood of stem failure. Included bark weakens the attachment between codominant stems, making them more prone to splitting, especially under wind load or when additional weight is placed on the canopy. Given the tree's history of limb loss, there is already evidence of structural instability, further increasing the risk of future failure. As a street tree, the risks associated with failure are heightened. Limb or stem failure in this setting poses a direct threat to pedestrians, vehicles, and nearby infrastructure. The history of limb loss suggests that mitigation through pruning has not been sufficient to prevent ongoing structural issues, and due to the presence of included bark, the tree's condition is unlikely to improve with further intervention. Considering these factors, removal of Sweetgum Tree #7 is the most prudent course of action to eliminate safety hazards and liability concerns. If canopy replacement is necessary, a more structurally stable species should be selected to provide long-term benefits without the risks associated with codominant stems and limb failure.

**Showing included bark**

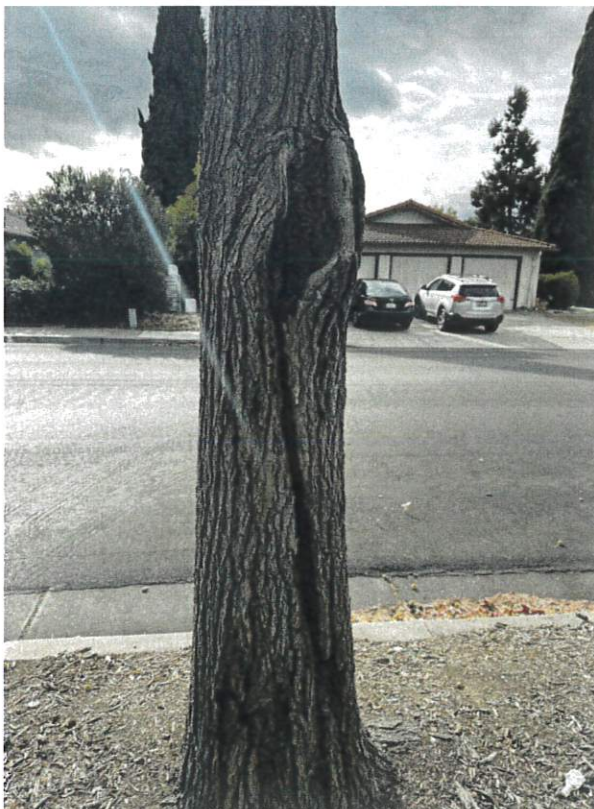
| Tree Tag # | Protected Tree | Preserve or Remove | Common Name / Scientific Name | Trunk (in.) | If more than 1 Trunk, Total Diameter | Ten Times the Diameter in (ft.) | Height (ft.) / Canopy Spread (ft.) | Health Rating | Structural Rating | Form Rating | Suitability for Preservation | Overall Condition (0-100%) | Summary | Tree Picture #1 |
|---|---|---|---|---|---|---|---|---|---|---|---|---|---|---|
| 10 | Yes | (R) | AMERICAN SWEETGUM<br><i>Liquidambar styraciflua</i> | 15.2 | - | 12.7 | 30/20 | Poor | Poor | Poor | Poor | 20% | Codominant at 10 feet, large limb failure at 6 feet in past, heartwood decay, crack along trunk, hazardous tree, recommended to be removed immediately. Poor Vigor | |

Tree #10, an American Sweetgum (*Liquidambar styraciflua*) with a trunk diameter of 15.2 inches, exhibits severe structural deficiencies, including codominance at 10 feet, a crack along the trunk, and heartwood decay. The tree has a history of large limb failure, further indicating its instability. Its poor vigor and overall condition rating of 20% make it a significant liability. Removal of this tree is critical to address its immediate hazard potential, as outlined in § 19.94.060(a) and (b).

**Showing decay in the stem on tree #10**

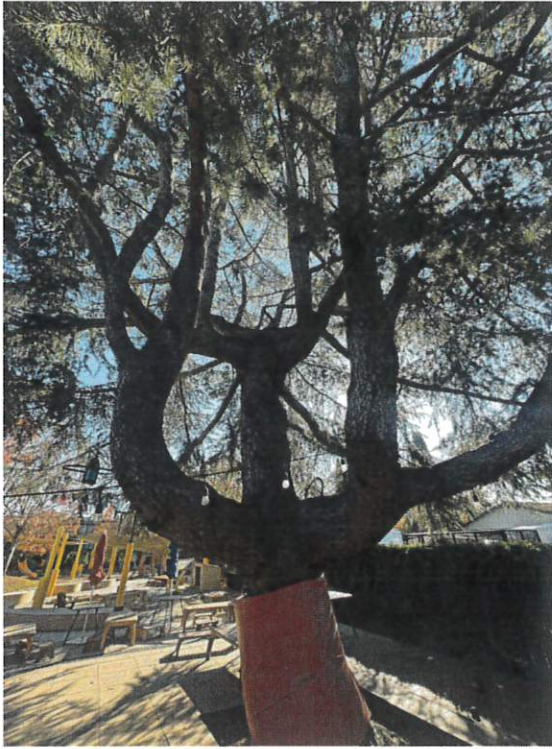
**Tree #13**

Tree #13, a Deodar Cedar (*Cedrus deodara*) with a trunk diameter of 36.5 inches, has been previously topped at 15 feet, resulting in poor structural integrity. Additionally, the tree is surrounded by a deck that restricts its natural growth and compromises its usefulness in the landscape. Despite its fair health rating, the tree's poor structural and form ratings, along with an overall condition of 45%, justify its removal under § 19.94.060(a), (b), and (c)(7). Its removal will allow for improved use of the property and eliminate ongoing management concerns.

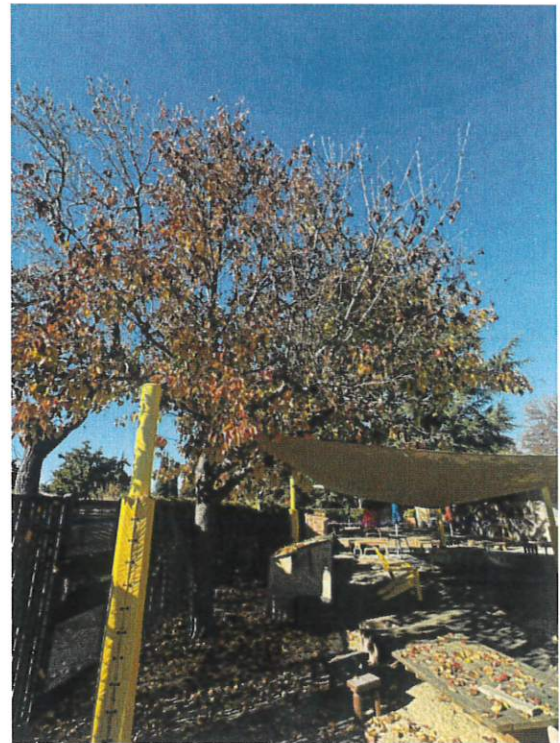
**Tree #27**

Tree #27, a Callery Pear (*Pyrus calleryana*) with a trunk diameter of 12.7 inches, is one-sided and heavily suppressed by a nearby street tree. Additionally, it shows signs of fire blight, a bacterial infection that weakens the tree's structural integrity and health. With a fair condition rating of 65%, its removal is necessary under § 19.94.060(a) to address its declining health and ensure better conditions for surrounding trees.
