Preliminary Tree Report

Butcher's Corner

October 21, 2015

Butcher's Corner
East Fremont Avenue
Sunnyvale CA

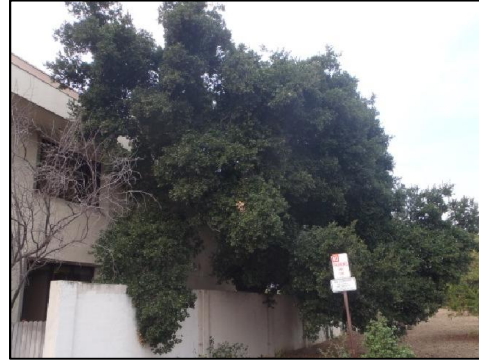
Coast live oak (20 trees) was the most frequently occurring species. Tree maturity ranged from young to mature. Tree trunk diameters were between 6" and 36". About half of the coast live oaks were smaller than 18" in diameter. Several large trees were present. Coast live oak #116 was 36" and in good condition. Tree #118 was also 36" but in fair condition. Both trees #116 and 118 were located off-site, near Wolfe Road, with canopies that extended over the wall separating the two properties (Photo 1).

Photo 1. The canopy of coast live oak #118 extended over the property line and into the project area.

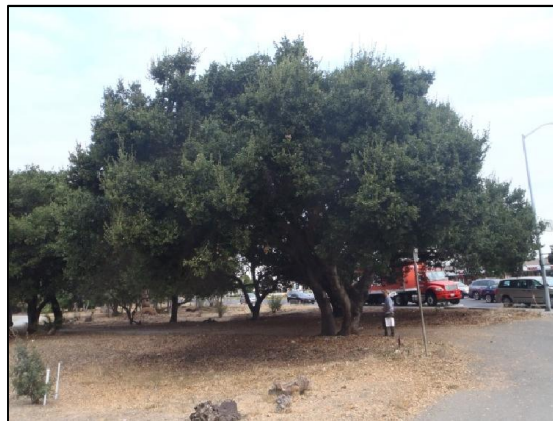
Photo 2. Coast live oak #121.

Several large coast live oaks were present in the east side of the property. Tree #121 had several stems that arose near ground level (Photo 2). It was in good condition. Other large oaks included #119 (31", good condition), 125 (27", poor condition), and #126 (26", good condition). Several smaller oaks were also present in this area.

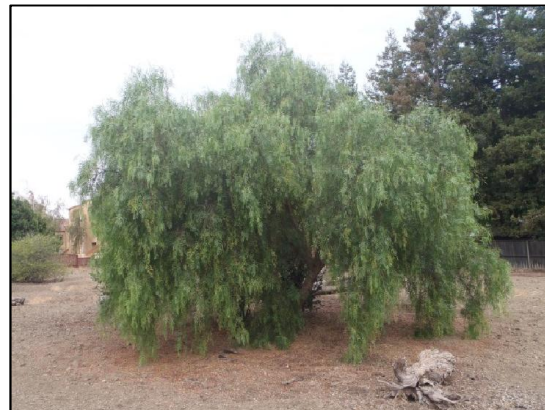
Photo 3. Typical Calif. pepper.

Nine (9) Calif. peppers were present (Photo 3). Several trees were located near the existing residence. Trees ranged from young (#151, 160) to semi-mature (#136, 140, 143) to mature (#128, 141, 169) to overmature (#115). Located near the entrance to the site, Calif. pepper #115 was 47" and in fair condition with several large stems. Tree condition varied by diameter with the small trees in excellent condition while larger trees were in fair and poor (#140, 141) condition.

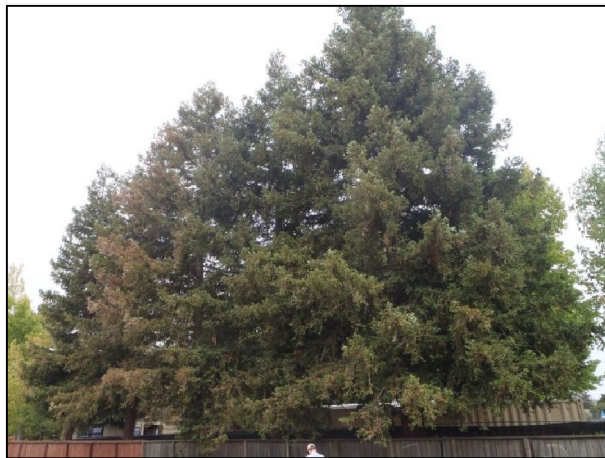
Photo 4. Coast redwoods #152 – 156.

- Coast redwoods #152 – 156 were semi-mature and mature in development with trunk diameters between 15" and 28" (Photo 4). Trees were located off-site, along the north edge of the property. Tree canopies extended into the project area. Tree condition was poor (#154), fair (#152, 153, 155) and good (#156). The primary limitation to tree health was lack of irrigation. Tree canopies were thin with extensive dieback.

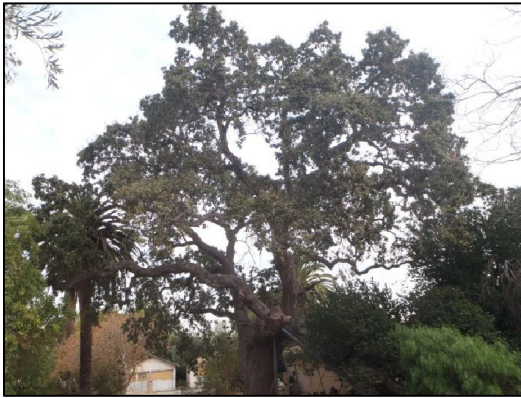
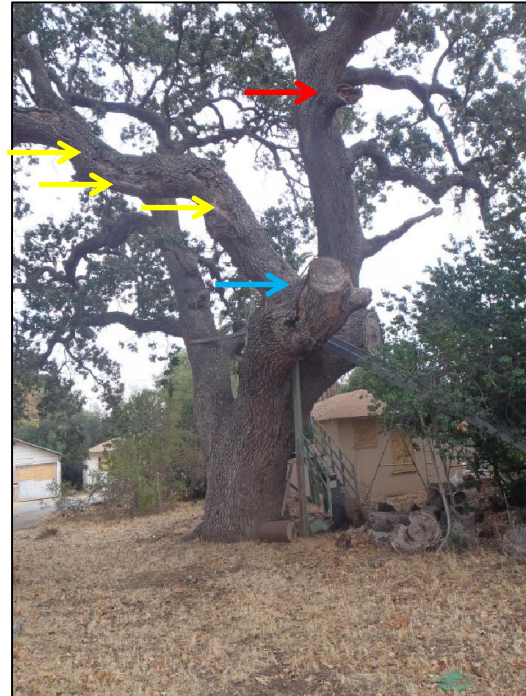
Valley oak #106 was the largest and most dominant tree at Butcher's Corner with a trunk diameter of 64" (Photo 5, following page). Overall tree structure was typical of valley oaks of this age and size. Several large scaffold limbs arose at 12'. Large pruning wounds and branch failures resulted in decay. A cavity was present at the base. The tree's canopy was thin.

Photo 4. Valley oak #106. Above: tree crown. Right: lower trunk and scaffold limbs. Note failed branch (red arrow), areas of dead bark (yellow arrow) and large stub (blue arrow).

Both site plan options depict retention of valley oak #106 (Table 3, following page). This is a large massive tree in fair condition with low suitability for preservation due to its age, health and structure. It can be expected to decline over many years by losing large branches. Decay is present in the scaffold limbs and at the base. Valley oaks of this size and maturity often drop branches without any warning. Because of the risk of branch or whole tree failure, no development activity should take place within the dripline of this tree. No use such as paths, benches or parking should be planned within the dripline.

The site plans depict the tree as having a 60' wide canopy. The actual canopy is 85' to 90' wide. In order to accommodate the tree, some re-design must occur to provide additional space for the tree. No details of construction activity near the tree are provided. But removal of structures and controls to disturbance under this tree as well as corrective work on past poorly cut limbs or failed branches, together with cabling and possibly major limb support should serve to improve conditions, and reduce risks associated with this tree. So long as the proposed **TREE PROTECTION ZONE** accommodates the entire canopy, impacts from construction should be within the tolerance of the tree.

In order to maintain tree health and limit the potential for someone to be injured by a failing branch, I recommend that no improvements and use areas be established beneath the tree. No activity should occur within the dripline subsequent to demolition: The area under the dripline should be mulched with 4" to 6" of wood chips. No grading, construction, landscaping, irrigation, lighting, or utilities should be installed within the dripline with the exception of removal of artificial fills placed under the tree, paving and other impervious surfaces, the existing treehouse built onto the tree, and the nearby garage structure, assuming this work is performed under the supervision of a Certified Arborist with careful controls as described further below under the recommended **Tree Preservation Guidelines**. Grading around the tree should ensure that storm water does not collect around the base of the tree.

1. Establish the horizontal and vertical elevation of valley oak #106 and include on all plans.
2. Design improvements so that no grading or construction occurs within the dripline of valley oak #106. Demolition of the existing garage, tree house, impervious surfaces and artificial fills under the dripline of this tree shall be performed under the supervision of the Consulting Arborist. Equipment operation shall be restricted from the furthest point possible to the tree trunk, so minimize the potential for compaction and root zone disturbance.

3. Valley oak #106 must be irrigated during the construction period. The irrigation schedule to be determined by the Consulting Arborist. Each irrigation shall wet the soil within the **TREE PROTECTION ZONE** to a depth of 30". For planning purposes, expect to irrigate the tree twice per month during months with no or low rainfall.
