Re: **Blue Oak Tree House**

Assignment

It was my assignment to inspect the Blue Oak (*Quercus douglasii* – see image to right), advise on the proposed deck and “tree house” and make recommendations for the care of this tree.

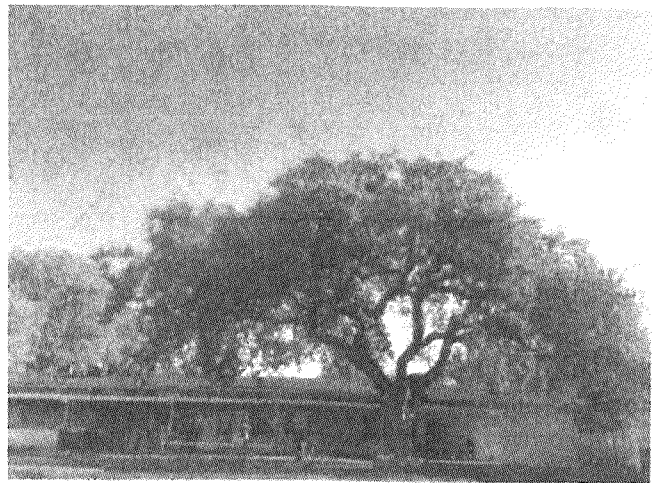
This tree is in good health and has a Fair Structure. With careful preparation, thoughtful placement of the piers, and a smart contractor I believe this structure can be installed and the tree will be able to continue to thrive.

The Blue Oak is located on the side of the building and is currently in Good Health with a Fair Structure. This tree is approximately 60' tall and wide. The tree currently has several old cables in it to help prevent major limb failures. This tree needs end weight reduction pruning all over,

and the installation of 3 cables to help prevent limb failures at this time. With this work the tree will be more stable overall.

Additionally, to help improve the overall health of this tree, I recommend:

1. All of the soil under this tree is aerated.
2. All bare soils are covered with 10" of chipped tree trimmings, keeping the root collar free of debris.
3. The Root Collar is excavated and left open.
4. All bare soils under the tree are irrigated to a soil depth of 24" once/month during the dry season, in perpetuity.
5. The foliage of the tree is treated for insect or fungal pathogens as they arise.
