1212 BORDEAUX DRIVE  
SUNNYVALE, CA

### ARBORIST REPORT

Project #3475-36

Revised and amended  
27 June 2016

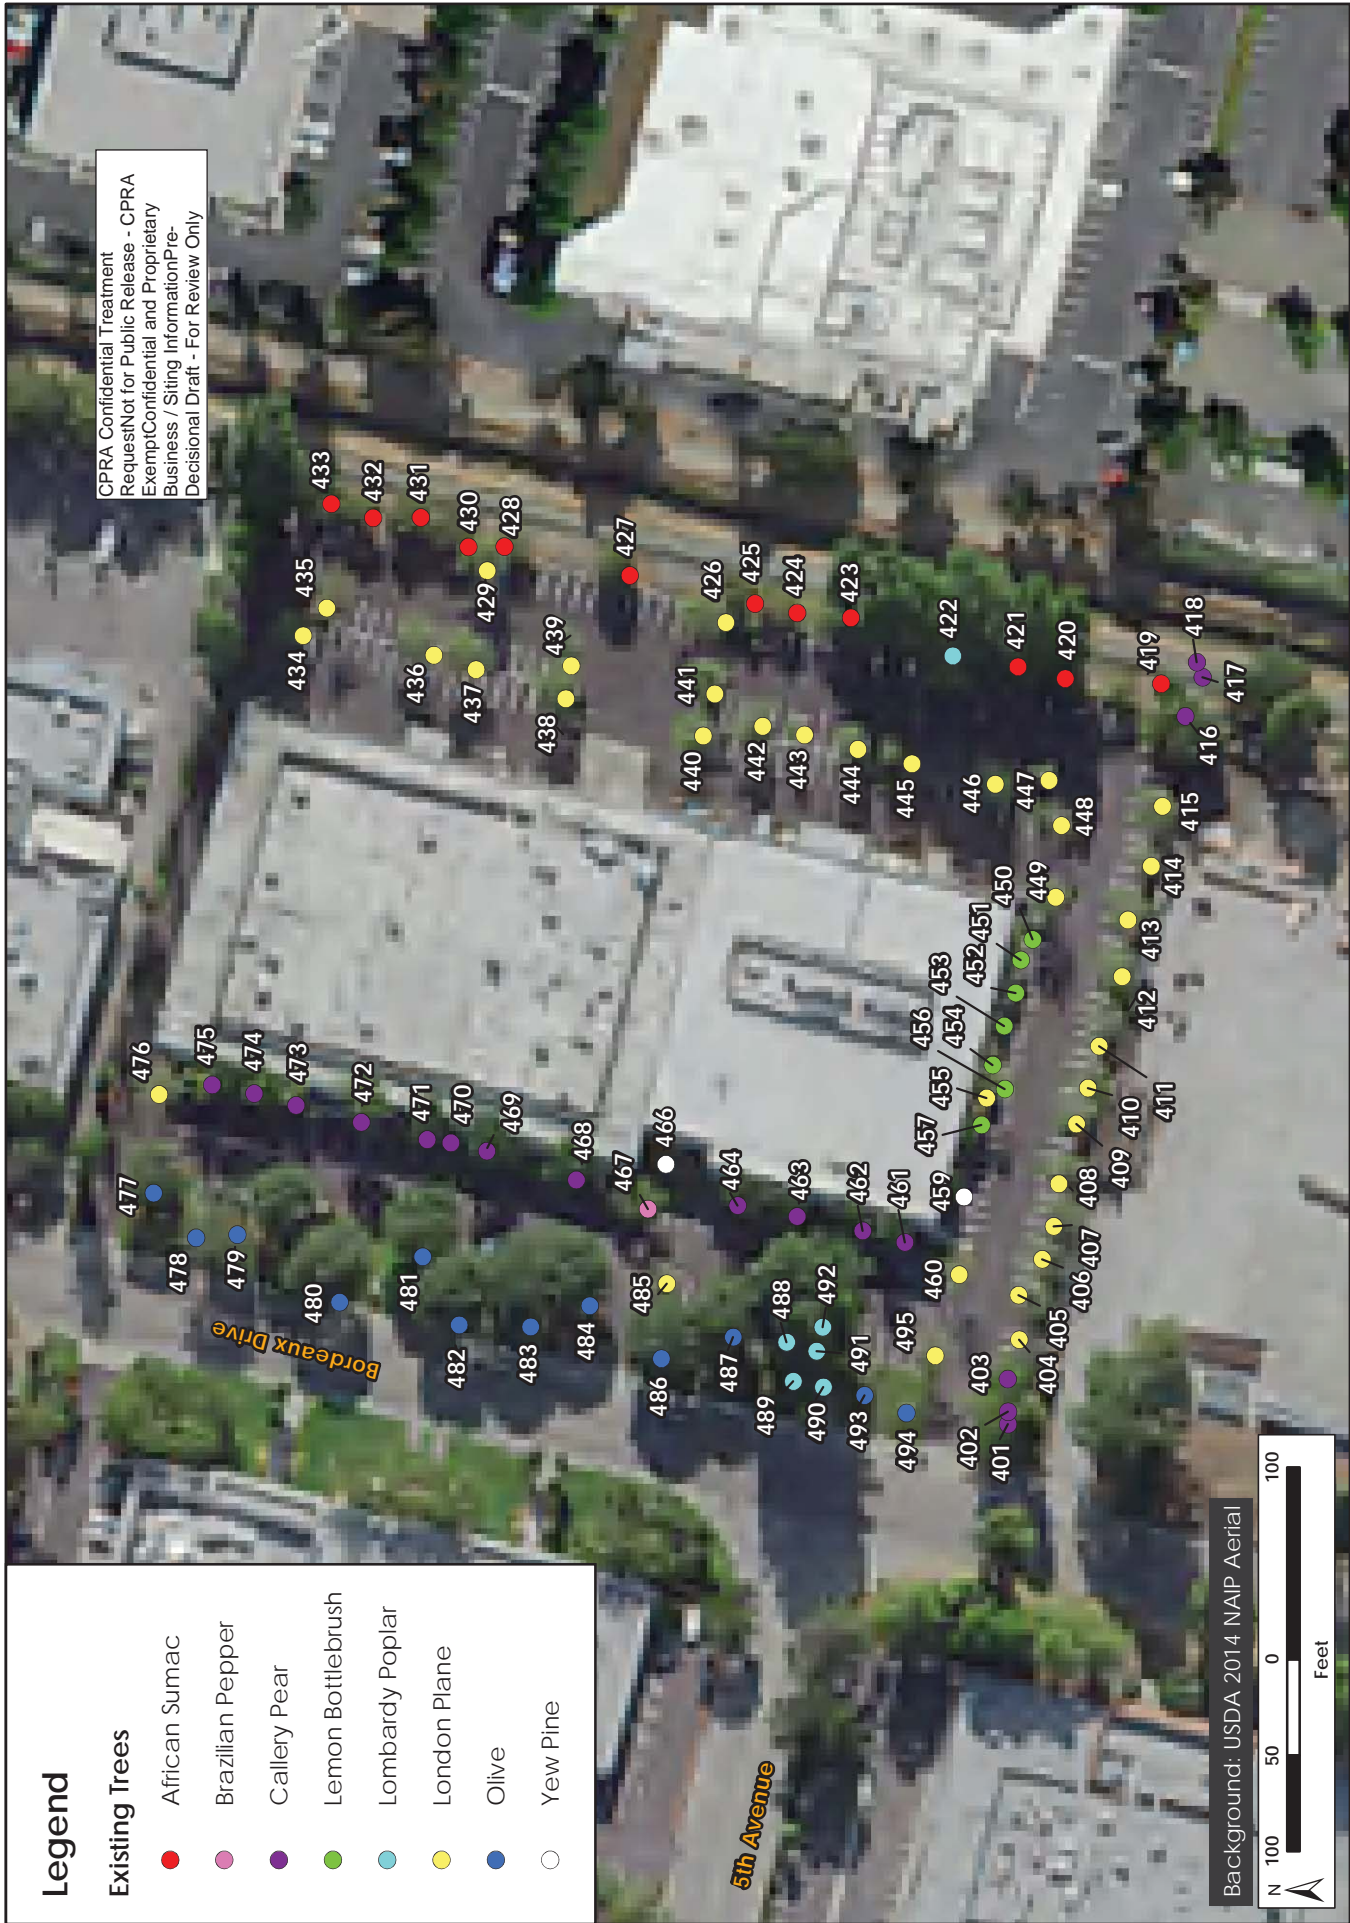
**Appendix B. Locations of Existing Trees**  
1212 Bordeaux Drive, Sunnyvale, CA Arborist Report (3475-36)  
March 2016

The March 2016 tree survey found that trees were located in close proximity to the west and south sides of the building in continuous planting areas. Trees were also located along the site's western perimeter at Bordeaux Drive, most in a raised, grass-covered berm and in an ivy-covered, continuous planting area along the site's eastern perimeter. The balance of trees were located in parking lot cut-outs and along the fence at the site's southern perimeter. The location of each tree is shown on the diagram in Appendix B.
