# Preliminary Tree Report

## Butcher's Corner

**October 21, 2015**

Butcher's Corner  
East Fremont Avenue  
Sunnyvale CA

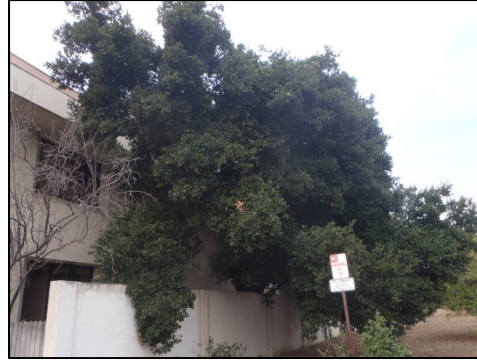
Coast live oak (20 trees) was the most frequently occurring species. Tree maturity ranged from young to mature. Tree trunk diameters were between 6" and 36". About half of the coast live oaks were smaller than 18" in diameter. Several large trees were present. Coast live oak #116 was 36" and in good condition. Tree #118 was also 36" but in fair condition. Both trees #116 and 118 were located off-site, near Wolfe Road, with canopies that extended over the wall separating the two properties (Photo 1).

**Photo 1.** The canopy of coast live oak #118 extended over the property line and into the project area.

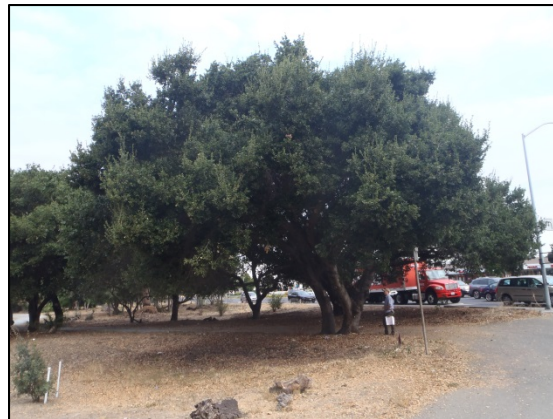
Several large coast live oaks were present in the east side of the property. Tree #121 had several stems that arose near ground level (Photo 2). It was in good condition. Other large oaks included #119 (31", good condition), 125 (27", poor condition), and #126 (26", good condition). Several smaller oaks were also present in this area.

**Photo 2.** Coast live oak #121.

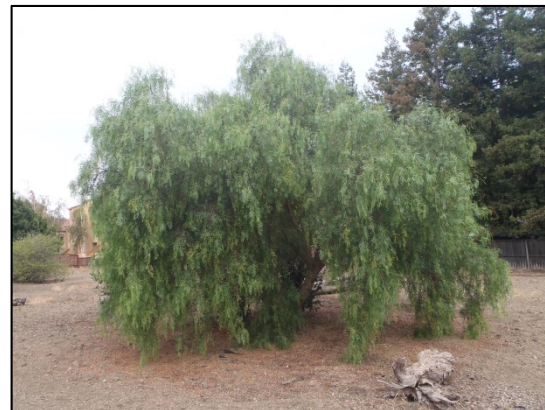
Nine (9) Calif. peppers were present (Photo 3). Several trees were located near the existing residence. Trees ranged from young (#151, 160) to semi-mature (#136, 140, 143) to mature (#128, 141, 169) to overmature (#115). Located near the entrance to the site, Calif. pepper #115 was 47" and in fair condition with several large stems. Tree condition varied by diameter with the small trees in excellent condition while larger trees were in fair and poor (#140, 141) condition.

**Photo 3.** Typical Calif. pepper.

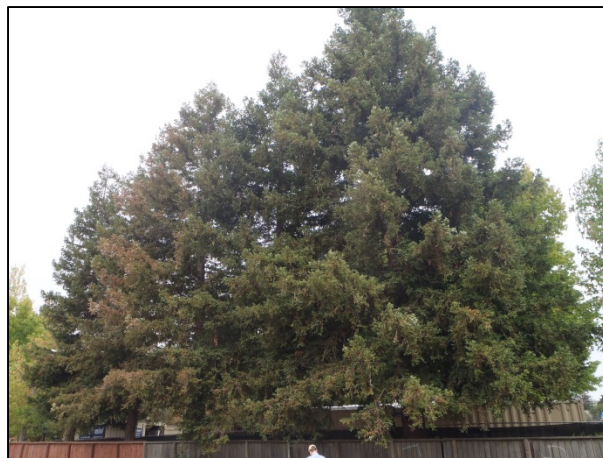
- Coast redwoods #152 – 156 were semi-mature and mature in development with trunk diameters between 15" and 28" (Photo 4). Trees were located off-site, along the north edge of the property. Tree canopies extended into the project area. Tree condition was poor (#154), fair (#152, 153, 155) and good (#156). The primary limitation to tree health was lack of irrigation. Tree canopies were thin with extensive dieback.

**Photo 4.** Coast redwoods #152 – 156.

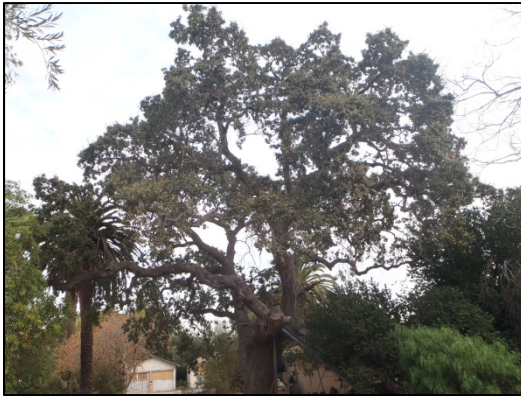
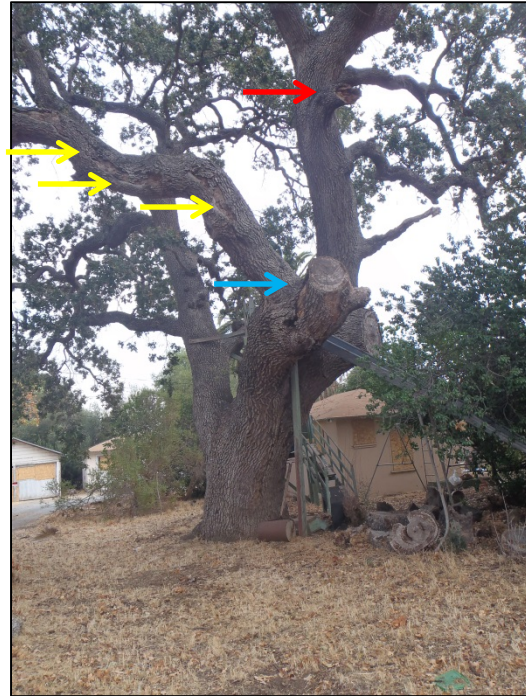
Valley oak #106 was the largest and most dominant tree at Butcher's Corner with a trunk diameter of 64" (Photo 5, following page). Overall tree structure was typical of valley oaks of this age and size. Several large scaffold limbs arose at 12'. Large pruning wounds and branch failures resulted in decay. A cavity was present at the base. The tree's canopy was thin.

**Photo 4.** Valley oak #106. Above: tree crown. Right: lower trunk and scaffold limbs. Note failed branch (red arrow), areas of dead bark (yellow arrow) and large stub (blue arrow).

Both site plan options depict retention of valley oak #106 (Table 3, following page). This is a large massive tree in fair condition with low suitability for preservation due to its age, health and structure. It can be expected to decline over many years by losing large branches. Decay is present in the scaffold limbs and at the base. Valley oaks of this size and maturity often drop branches without any warning. Because of the risk of branch or whole tree failure, no development activity should take place within the dripline of this tree. No use such as paths, benches or parking should be planned within the dripline.

The site plans depict the tree as having a 60' wide canopy. The actual canopy is 85' to 90' wide. In order to accommodate the tree, some re-design must occur to provide additional space for the tree. No details of construction activity near the tree are provided. But removal of structures and controls to disturbance under this tree as well as corrective work on past poorly cut limbs or failed branches, together with cabling and possibly major limb support should serve to improve conditions, and reduce risks associated with this tree. So long as the proposed **TREE PROTECTION ZONE** accommodates the entire canopy, impacts from construction should be within the tolerance of the tree.

In order to maintain tree health and limit the potential for someone to be injured by a failing branch, I recommend that no improvements and use areas be established beneath the tree. No activity should occur within the dripline subsequent to demolition: The area under the dripline should be mulched with 4" to 6" of wood chips. No grading, construction, landscaping, irrigation, lighting, or utilities should be installed within the dripline with the exception of removal of artificial fills placed under the tree, paving and other impervious surfaces, the existing treehouse built onto the tree, and the nearby garage structure, assuming this work is performed under the supervision of a Certified Arborist with careful controls as described further below under the recommended **Tree Preservation Guidelines**. Grading around the tree should ensure that storm water does not collect around the base of the tree.
