PROPERTY CONDITION ASSESSMENT

221 North Mathilda Avenue
Sunnyvale, California 94086

ALLWEST PROJECT 15083.61
May 13, 2015

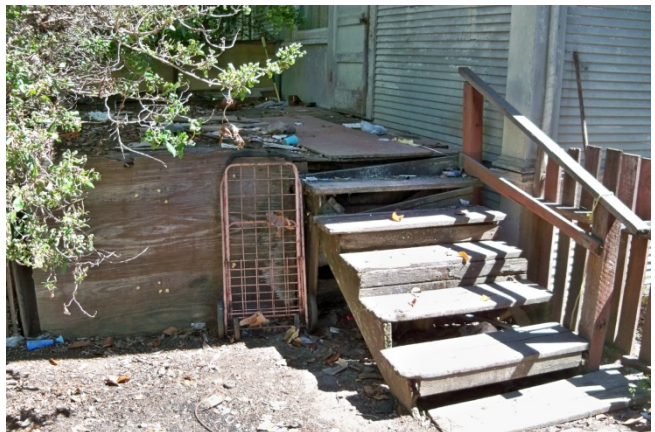
Comment: Exterior building elements exhibit numerous deficiencies and show signs of severe neglect. Rotten and missing wood exterior building elements were observed in numerous locations. Paint finishes are in a highly degraded condition. Stairs and handrails are in an unsafe condition and do not meet current code requirements. Guardrails are absent on rear balcony. Balcony decking at rear of building is rotten and in an unsafe condition.

6. Degraded condition of rear stairs and back porch.

AllWest recommends the exterior building elements deficiencies be addressed.

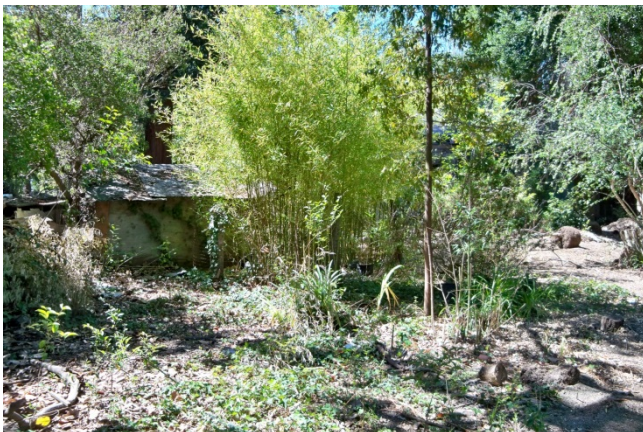
11. Secondary wood framed structure and overgrown vegetation.

Widespread clearing of overgrown vegetation is recommended.

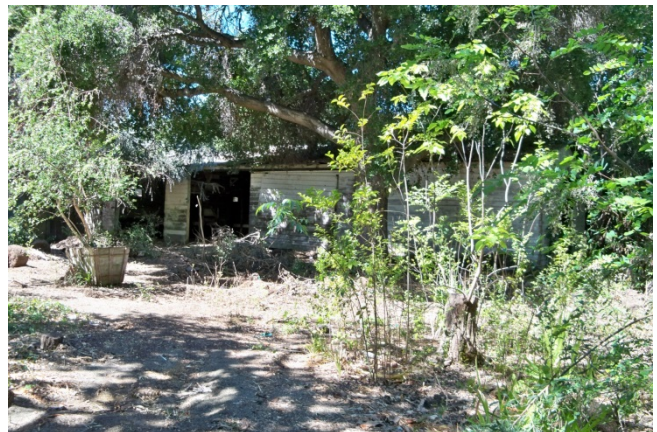
12. Secondary wood framed structure and overgrown vegetation.

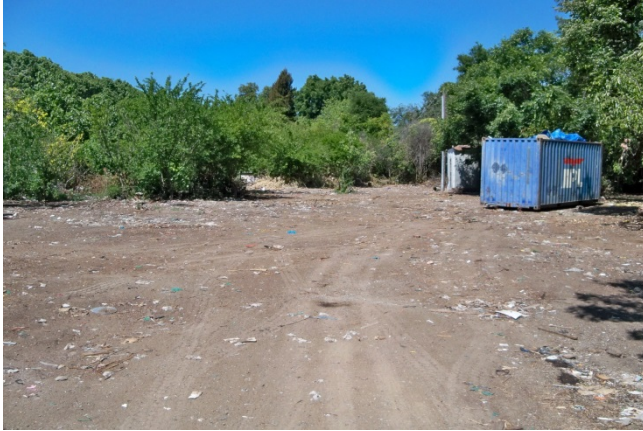
sidewalk, are in a generally rundown condition with numerous instances of deferred maintenance and, indeed, neglect observed. Landscaping is overgrown and untended. Perimeter chain-link fencing is in a degraded condition in places. More recently installed chain link fencing is in "Good" condition.

13. Cleared area to west of main house with overgrown vegetation shown, looking north-northeast.

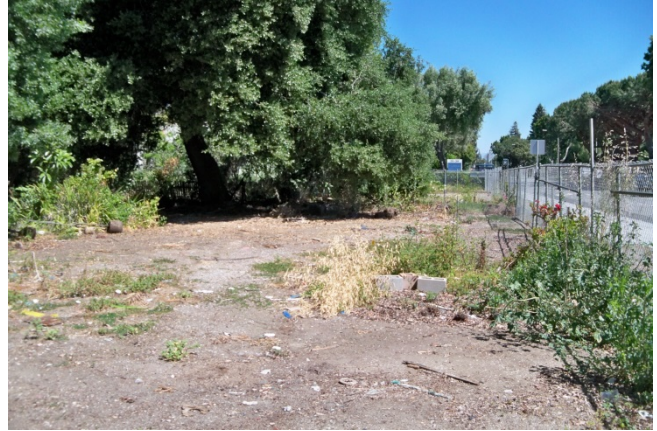
14. Typical condition of landscaping along North Mathilda Avenue, looking north-northeast.

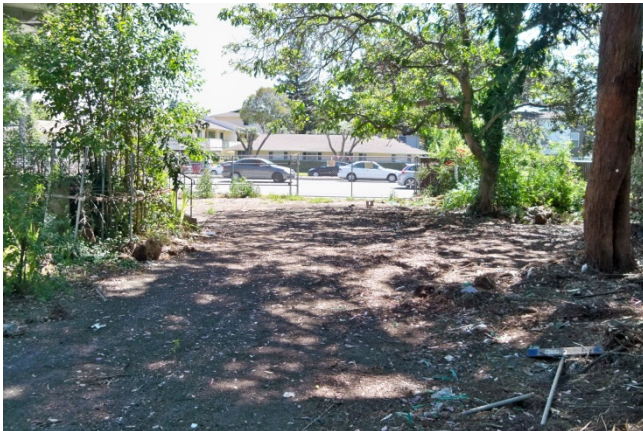
15. Cleared area to west of main house with overgrown vegetation shown, looking south-southwest.

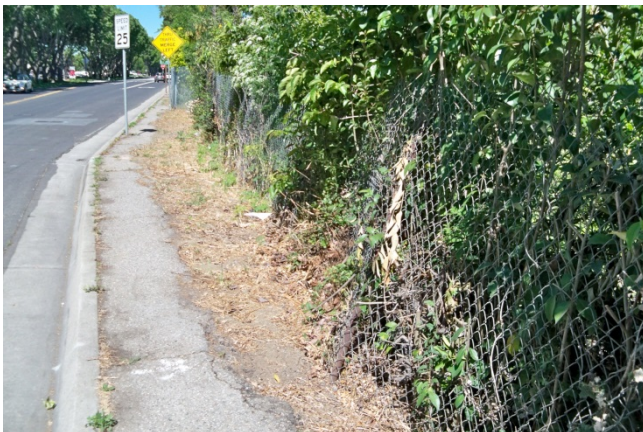
17. Various portions of the fence have out of plumb posts and bulging chain link.

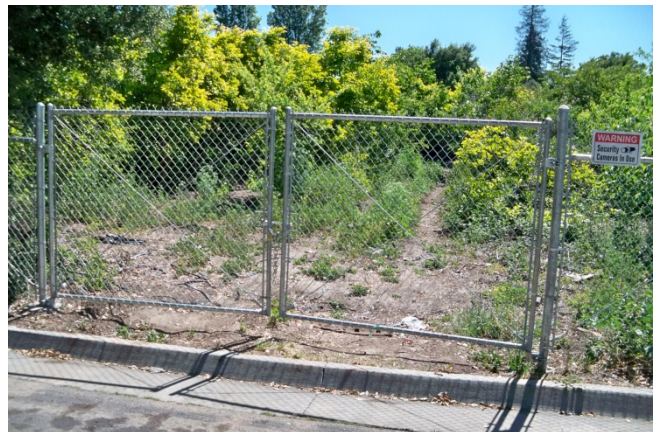
18. In some places the fencing appears to be of more recent installation and is in "Good" condition.

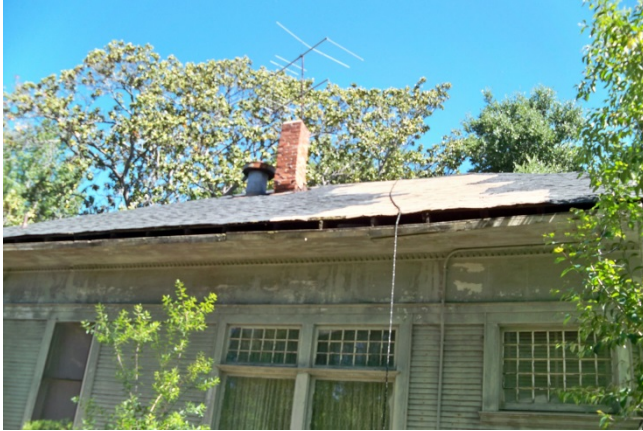
Comment: The roofing system is of unknown age and in a highly degraded condition. Evidence of numerous leaks into the interior was observed. Downspouts and gutters exhibit numerous instances of neglect and are in a degraded condition; gutters were missing in various locations. The painted wood soffits and fascia panels are in a highly degraded condition. There is a likelihood that the roof structure, though not observed except along the eave edge where wood trim was missing, may have suffered water damage and may require repairs.

19. The asphalt composite shingle roof is in a highly degraded condition.

AllWest recommends the deficiencies with roofing elements be addressed.

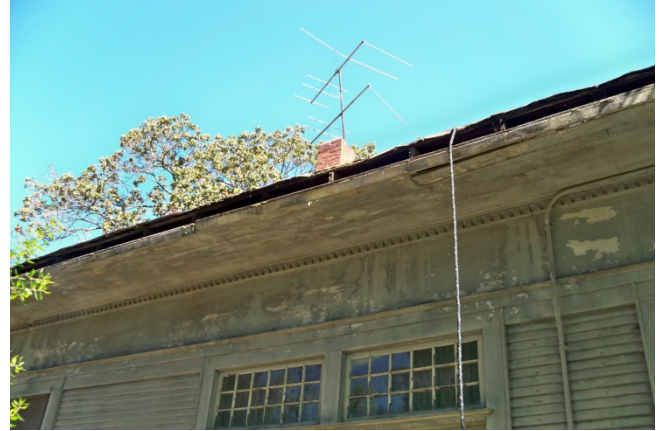
20. Soffits, fascias, gutters, and downspouts are in a highly degraded condition. Gutters are missing altogether in several places.

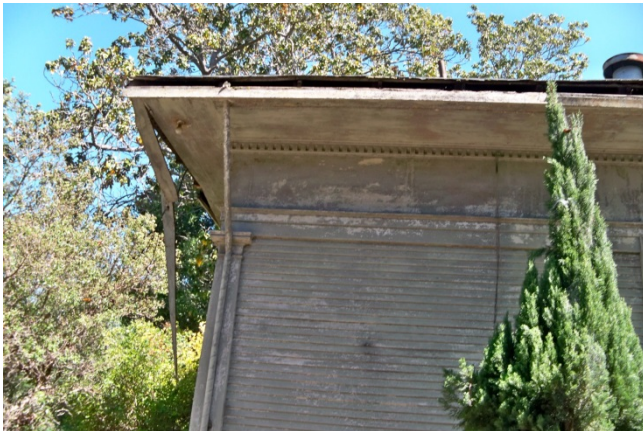
21. Exterior wood trim is in a highly degraded condition and absent in some locations.

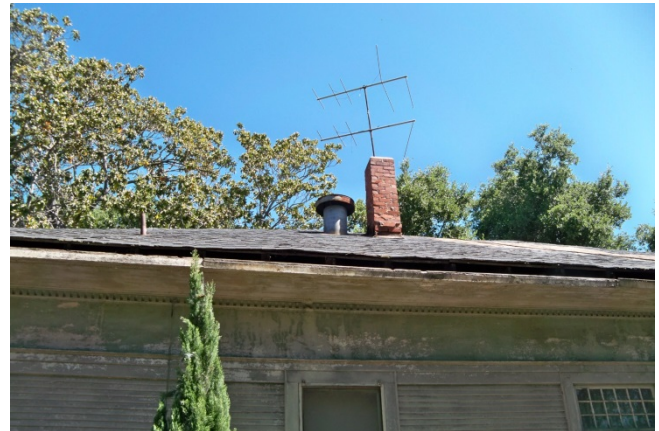
22. All exterior building elements are in a highly degraded condition.

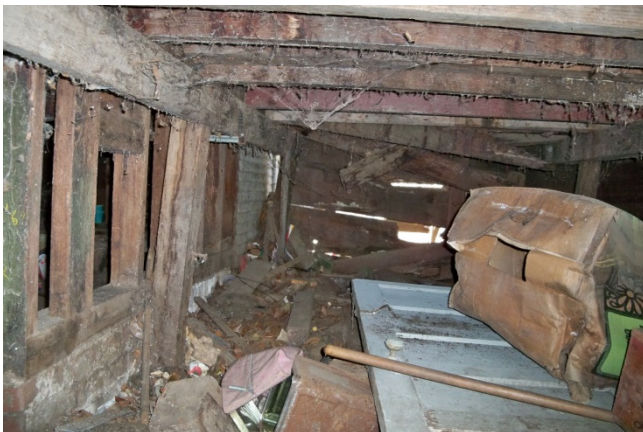
Comment: Wood framed structural elements exhibit numerous deficiencies; these building elements are typically in a highly degraded condition. Rotten wood on back porch/balcony

was observed. Water damaged wood structural members were observed in crawl space. Settlement and damage of brick masonry pony walls was observed. Restoration of the house may likely require extensive replacement of existing, damaged structural members.

23. Wood framing underneath back porch is in a highly degraded condition and is structurally unsound.

AllWest recommends the deficiencies with structural elements be addressed.

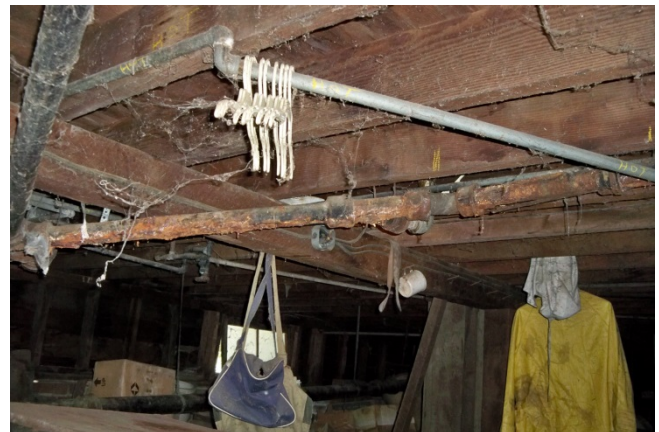
Comment: The plumbing supply and drain piping is presumed to date to original construction. Some drain piping was observed in a heavily rusted condition. A natural gas fired water heater is installed in the crawl space. It lacks seismic strapping and a flexible gas connector. Plumbing fixtures date to original construction and are in a highly degraded condition.

24. Typical condition of wood framing in crawlspace. Cast iron drain piping is heavily rusted in various locations.

Complete replacement of all supply and drain piping and bathroom and kitchen fixtures is recommended to rehabilitate the house.

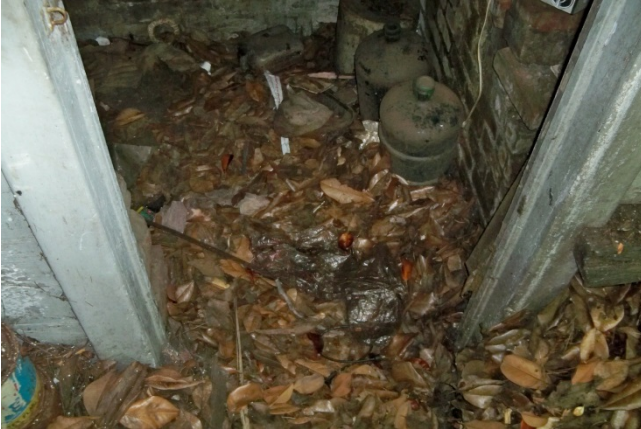
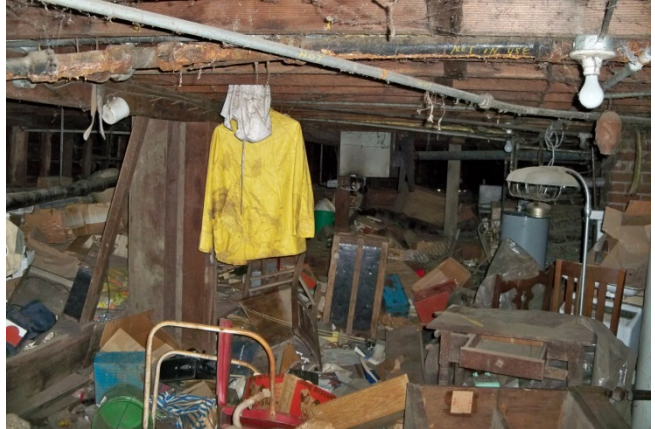
25. Dead vegetation, debris, rubbish and stored items are prevalent in the crawlspace.

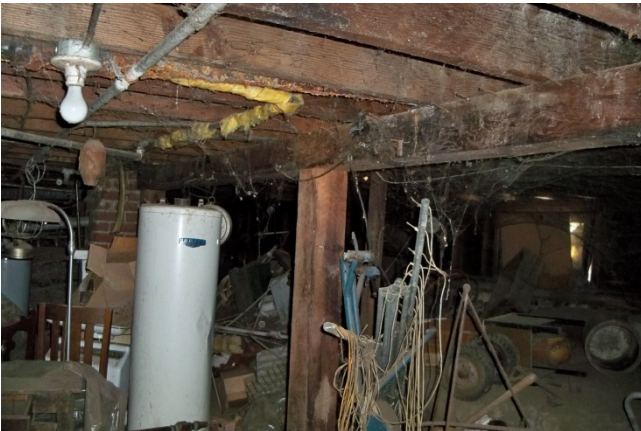
27. Typical condition of wood framing in crawlspace.

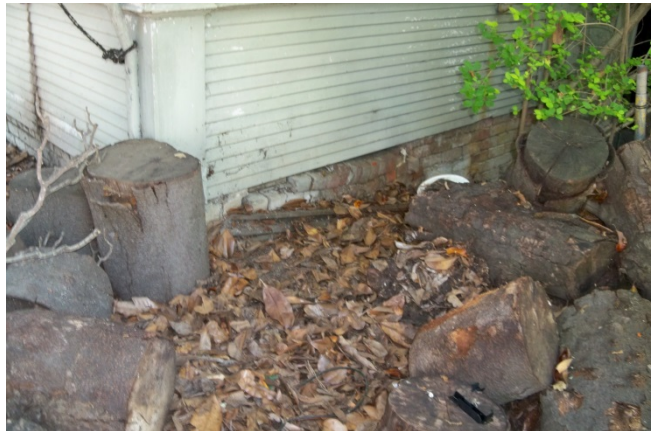
28. Non-reinforced brick masonry pony walls are in a highly degraded condition with evidence of subsidence observed.

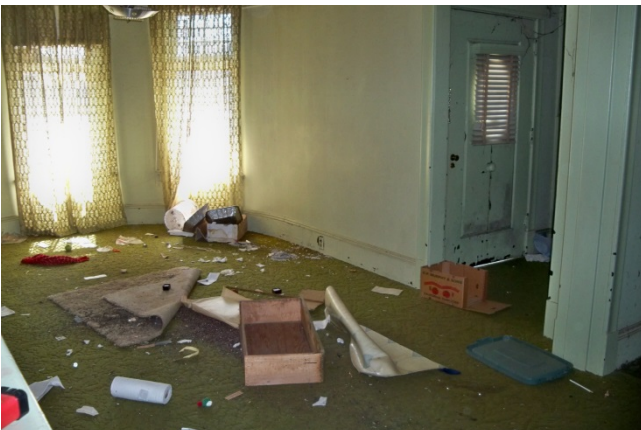
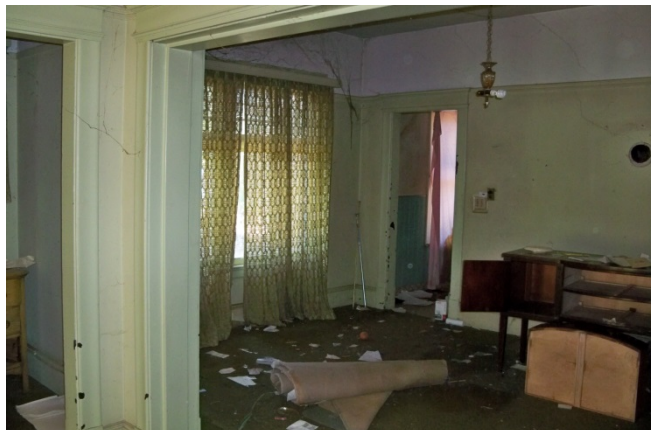
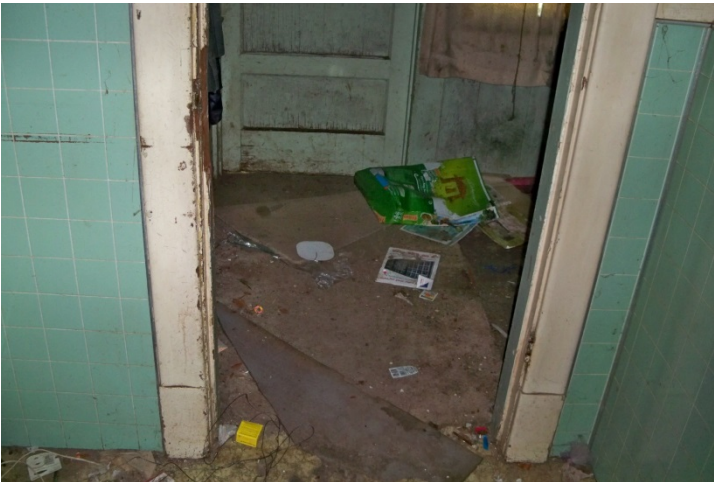
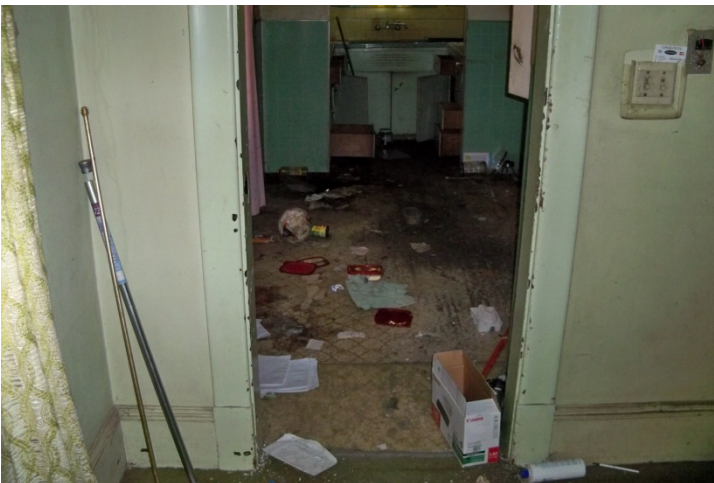
Comment: All interior building elements exhibit numerous deficiencies. Paint finishes on walls and ceilings are in a highly degraded condition, as are floor finishes. All interior elements will require rehabilitation to restore subject property to satisfactory condition.

29. All interior finishes are in a highly degraded condition.

AllWest recommends the deficiencies with interior building elements be addressed.

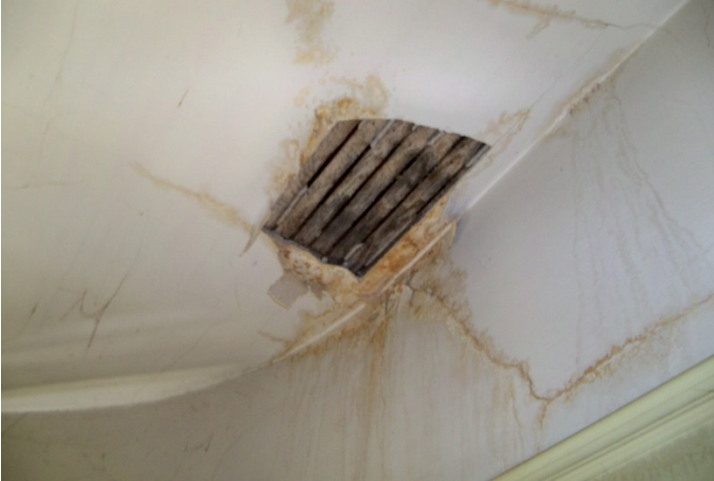
31. Evidence of roof leaks was observed in several locations.

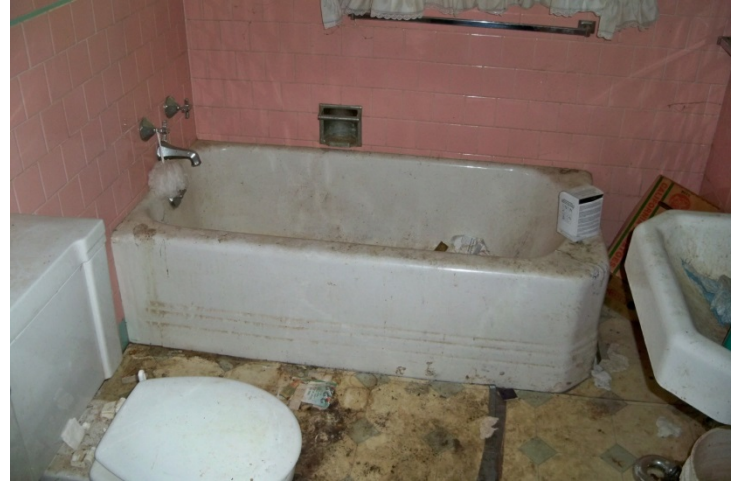
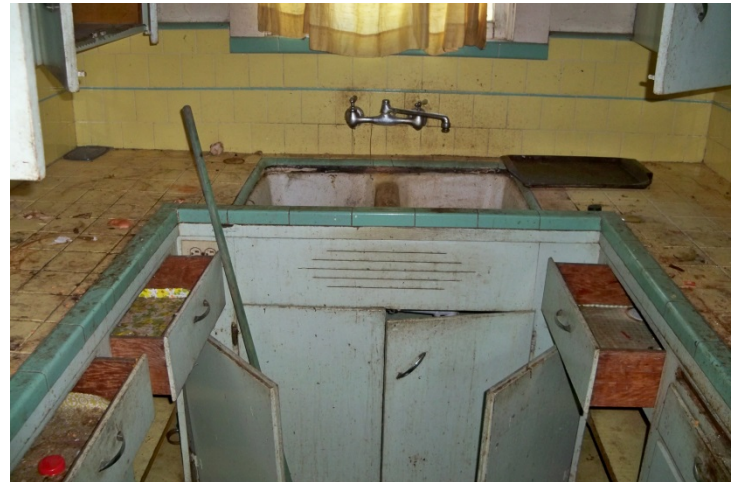
32. All interior finishes and fixtures are in a highly degraded condition.

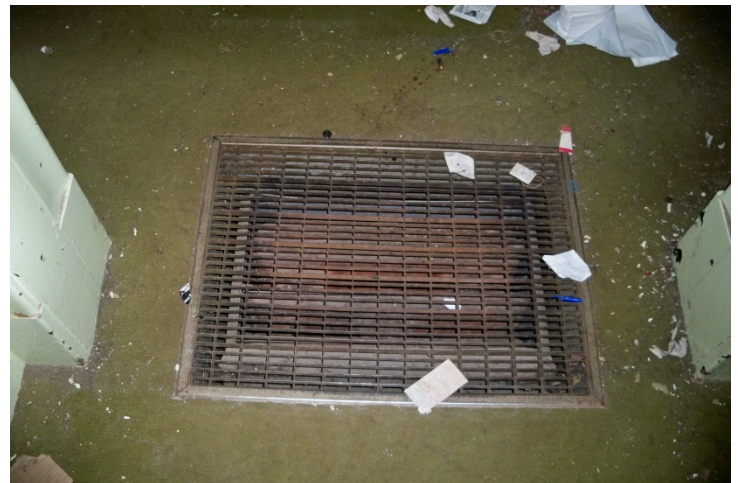
Comment: An air conditioning system was not observed. A single natural gas floor furnace is installed. It is presumed to date to original construction and is in a degraded condition. Replacement of the floor furnace will be required to rehabilitate the house.

36. A natural gas-fired floor furnace, presumed to date to original construction, is installed.

A installing a new floor furnace is recommended.

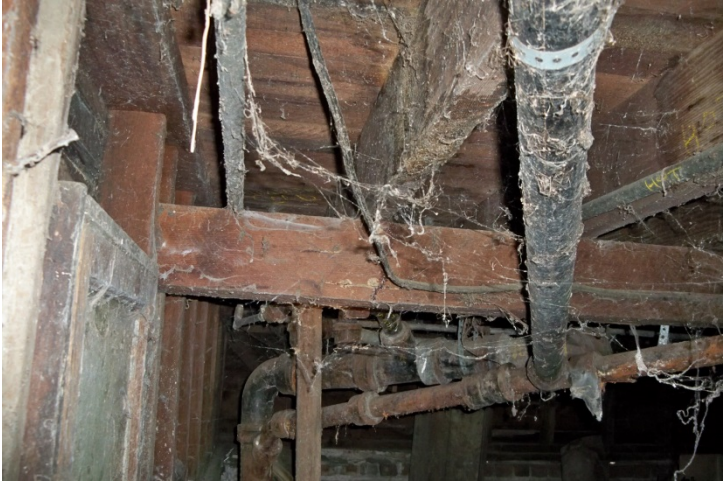
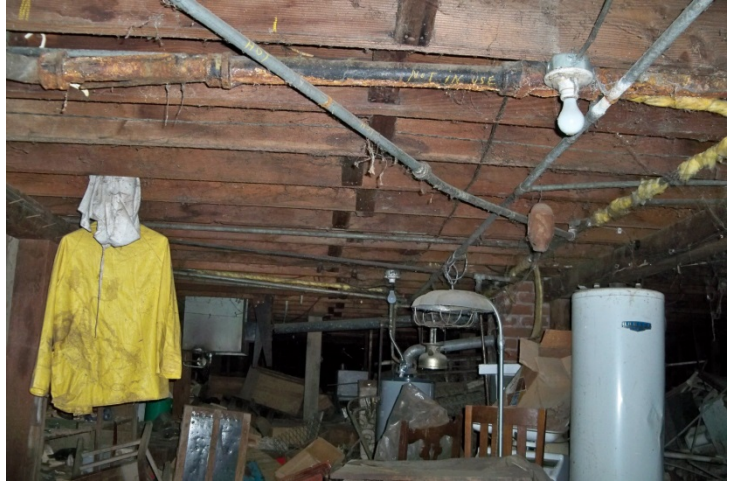
Comment: The electrical system is presumed to date to original construction. Wiring is an older style woven fabric cover type. Complete replacement of all wiring, fixtures, outlets, and distribution panels is recommended to rehabilitate the house.

Comment: The gas system is presumed to date to original construction. Black steel pipe provides gas distribution to the floor furnace and to a water heater located in the crawl space. Complete replacement of all gas piping is recommended to rehabilitate the house. The gas meter was not observed; it is presumed to lack an automatic seismic shut-off valve.

37. Electrical wiring and piping, both for gas and water service, are presumed to date to original construction.

Installing a new electrical system is recommended.

Installing new gas piping is recommended.
