# PRELIMINARY BUILDING ENCLOSURE AND STRUCTURAL ASSESSMENT

221 NORTH MATHILDA  
AVENUE  
SUNNYVALE, CA

13 September 2016

SGH Project 167047

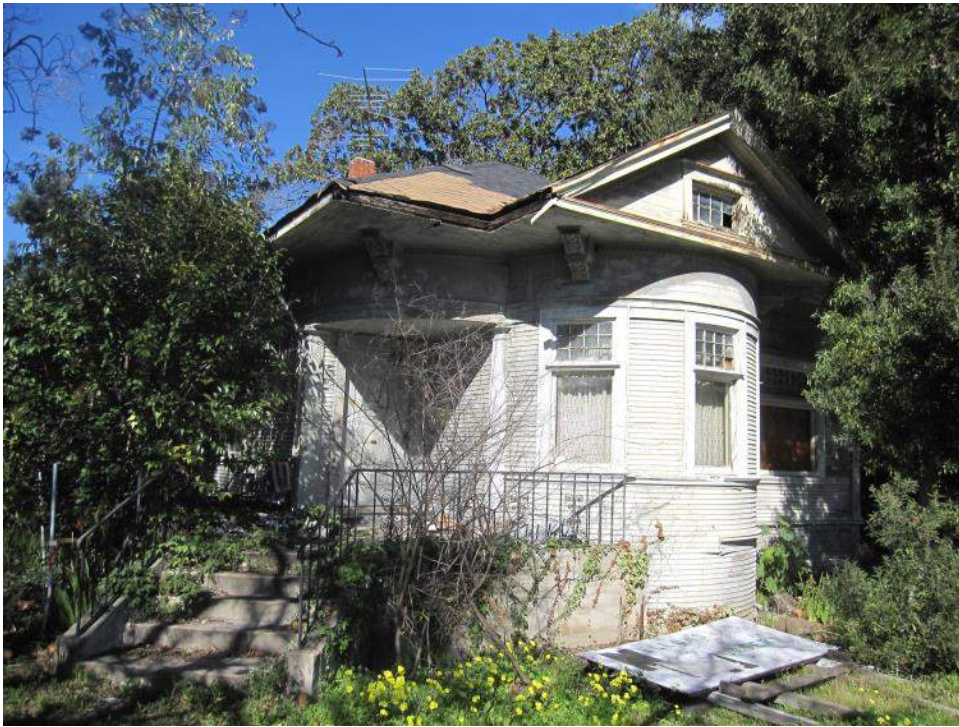
South elevation of the building.

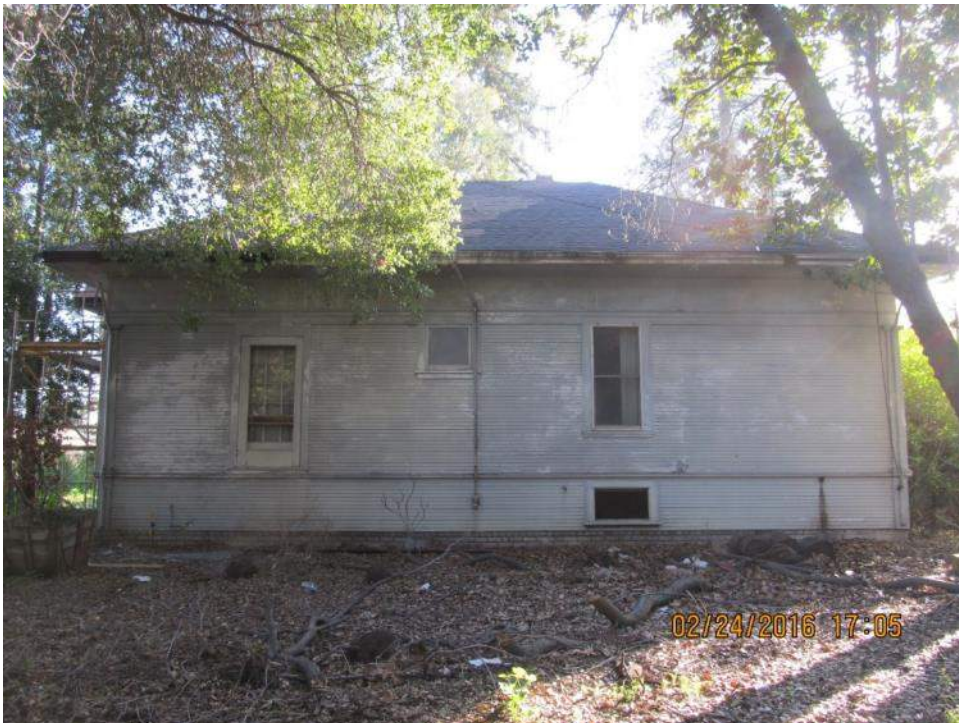
**Photo 2**

East elevation of the building.

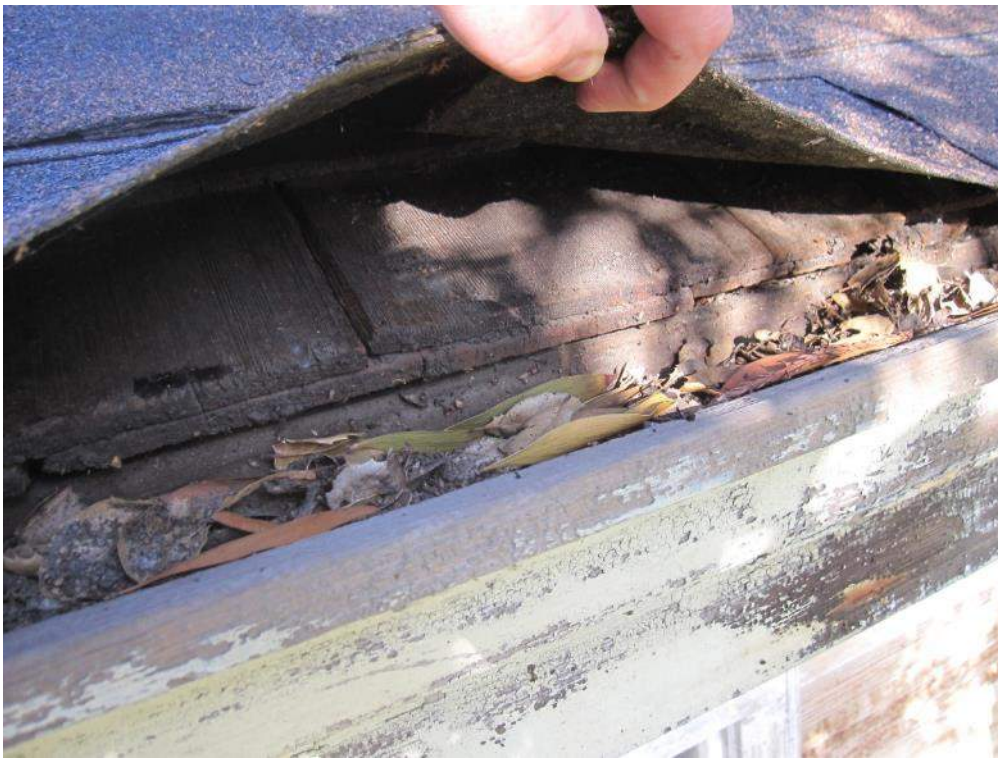
- Deteriorated and missing shingles at various locations throughout the steep-slope roof. We observed three different shingle types, including two varieties of composite asphalt single and wood shake roofing beneath them (Photo 5).

Roofing consists of asphalt singles over wood shake over steep sloped wood framing.

Note wood gutter located at lower right.

- Remove all layers of existing roofing to expose the skip sheathing and make necessary framing repairs.
- Install 1/2 in. plywood sheathing over restored roof framing, as required for application of a waterproofing underlayment.
- Install new roofing system, perimeter flashings and wood gutters in-kind with existing. Assume a fire retardant wood shake roofing system installed over ventilated cribbing per the recommendations of the Wood Shake Manual. An example of the recommended assembly is provided in Appendix C.2. The use of a wood shake roofing system will require review and approval with the local fire code, which is beyond the scope of this assessment.
- Replace sheet metal flashings at brick chimney and repoint all exposed mortar joints above the flashings 100%. Consider sheet metal chimney cap (or spark arrestor) subject to review and approval by City Planning.

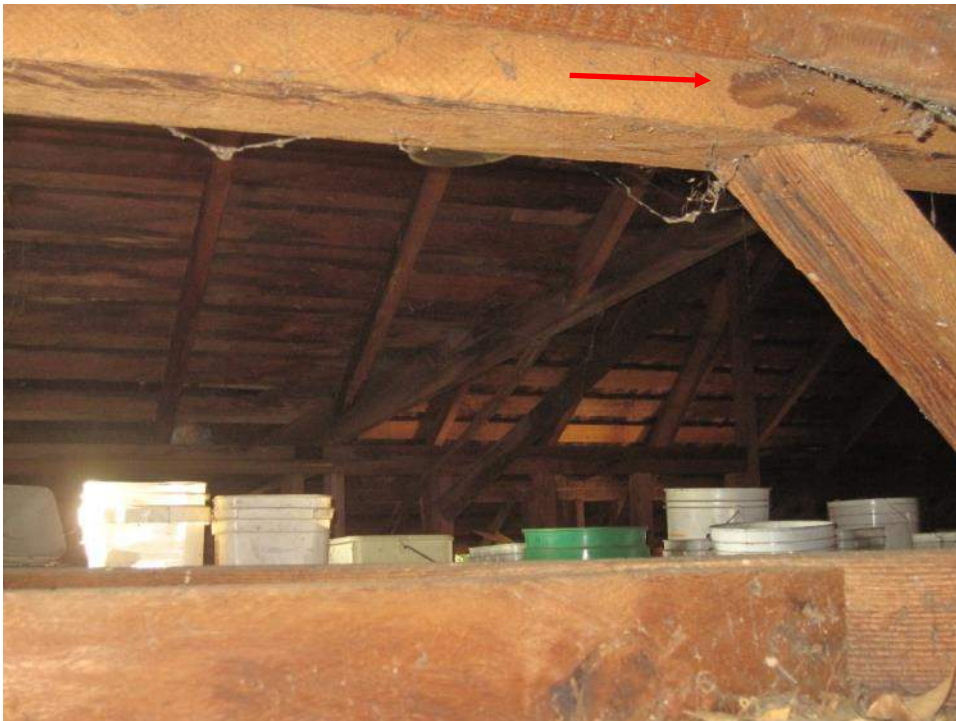
**Photo 6**

- Staining on the wood framing below the roof level. Numerous buckets have been placed within the attic space below the roof to capture water entering through the roof (Photo 6).

There are pervasive signs of staining and localized deterioration below the roof level, particularly at the eaves. There are also a large number of buckets and cans placed within the attic space below the roof, suggesting leakage has been ongoing for some time. The roof should be replaced in order to protect the house from further deterioration. While the original roof type is not known, consideration should be given to replacing with wood shake which is located below the composite shingle overlay. Use of a wood shake roof will require consideration of the local fire code requirements, which may limit the use of combustible materials for roofing or require the use of fire retardants, etc.

Staining on the wood and numerous buckets placed in attic below roofing.

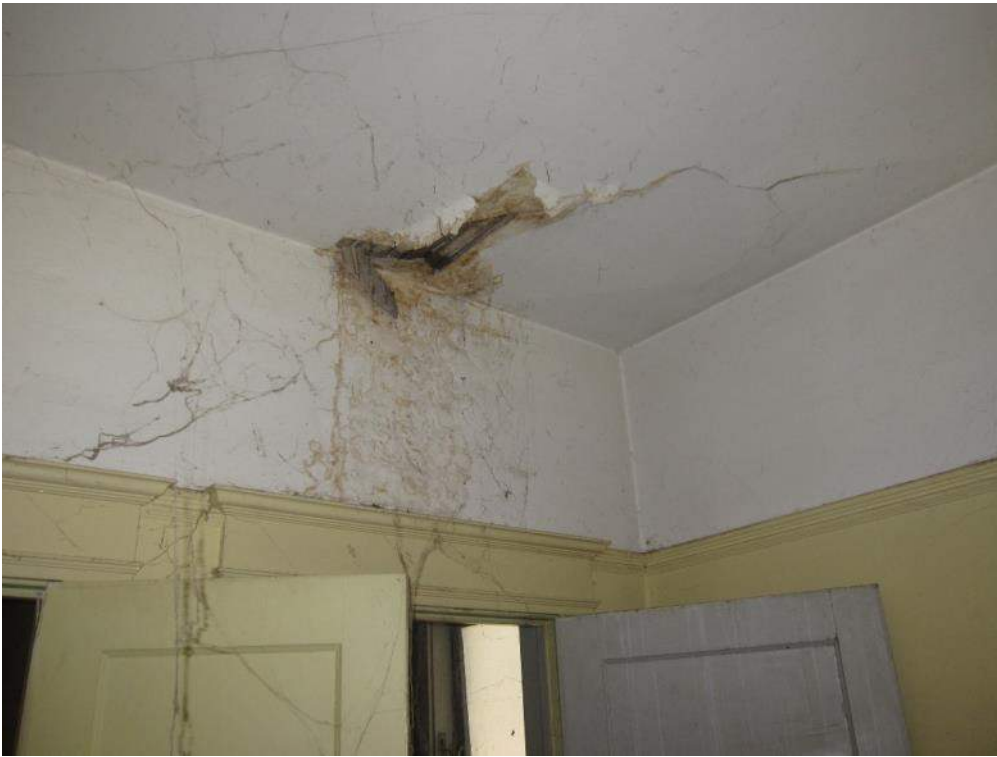
- Damage and staining on the interior ceiling finishes in several locations (Photo 7).
- Severely deteriorated wood gutter that is severely dry-rotted and has fallen off the structure in various locations (Photo 8).

Interior damage due to water intrusion through the roof.

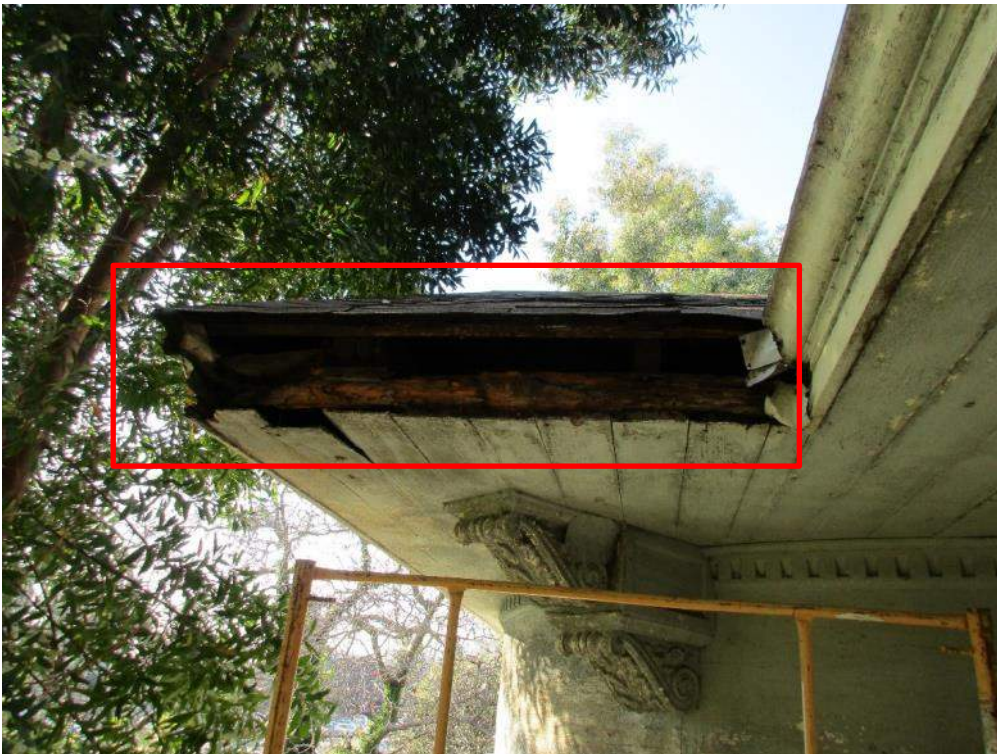
**Photo 8**

The wood gutter should be replaced where missing or severely deteriorated to match the existing ogee profile. We also recommend the gutter be lined with a protective flashing or coating to enhance the durability of the rebuilt materials. We are unsure if the galvanized sheet metal rain water leaders are original, however, based on their condition, we recommend replacing these elements to ensure the rain water system will perform effectively.

A location where the wood gutter and fascia had fallen off the structure.

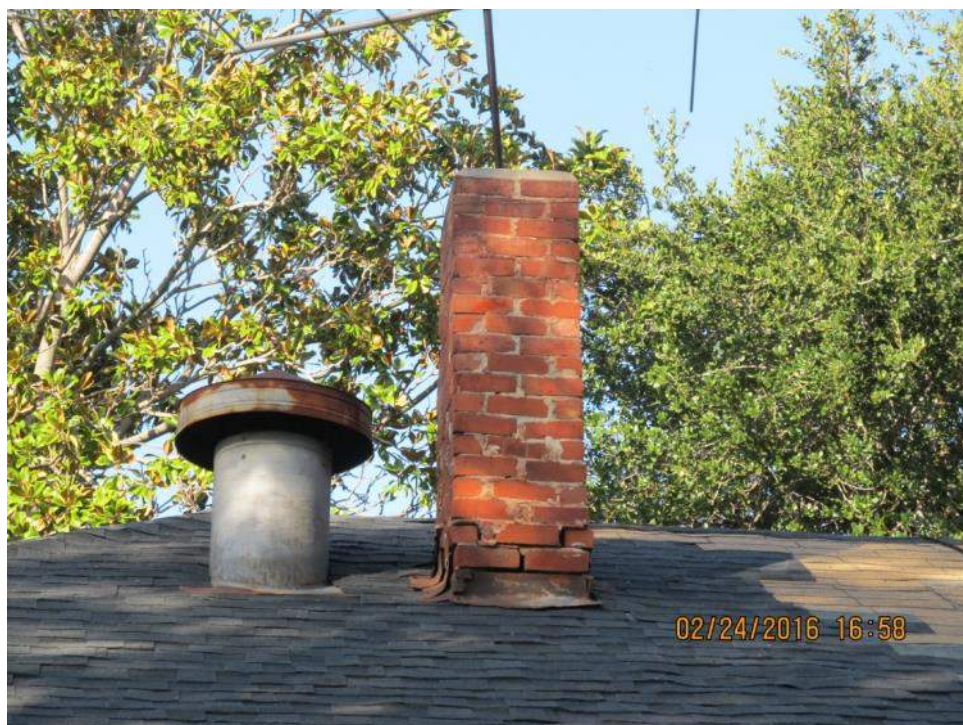
**Photo 9**

- Missing mortar and deteriorated flashings at the brick chimney above the roofline (Photo 9).
- Damaged or missing rain water leaders in some locations. They appear to be painted galvanized sheet metal (Photo 11).

The brick chimney extending through the roof also displays signs of disrepair. Our visual survey did not include access to closely observe the chimney; however, from the ground it is apparent the missing and severely deteriorated mortar between the brick is a direct result from long-term weathering (and lack of maintenance). The chimney is believed to be unreinforced brick masonry and, therefore, will warrant structural strengthening or reconstruction to reduce the risks of damage (or collapse) in an earthquake.

The brick chimney has missing or deteriorated mortar.

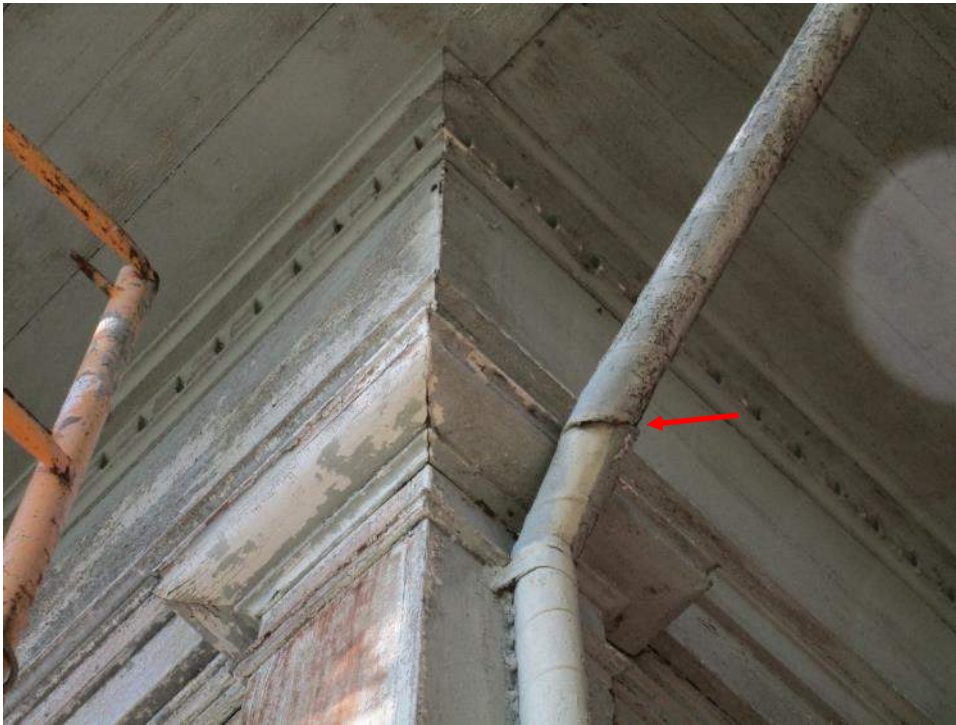
Damaged rainwater leader. Several rainwater leaders are missing.

- The gutter requires complete removal and replacement. The attached rain water leaders should be replaced as well to ensure a reliable rain water collection system.

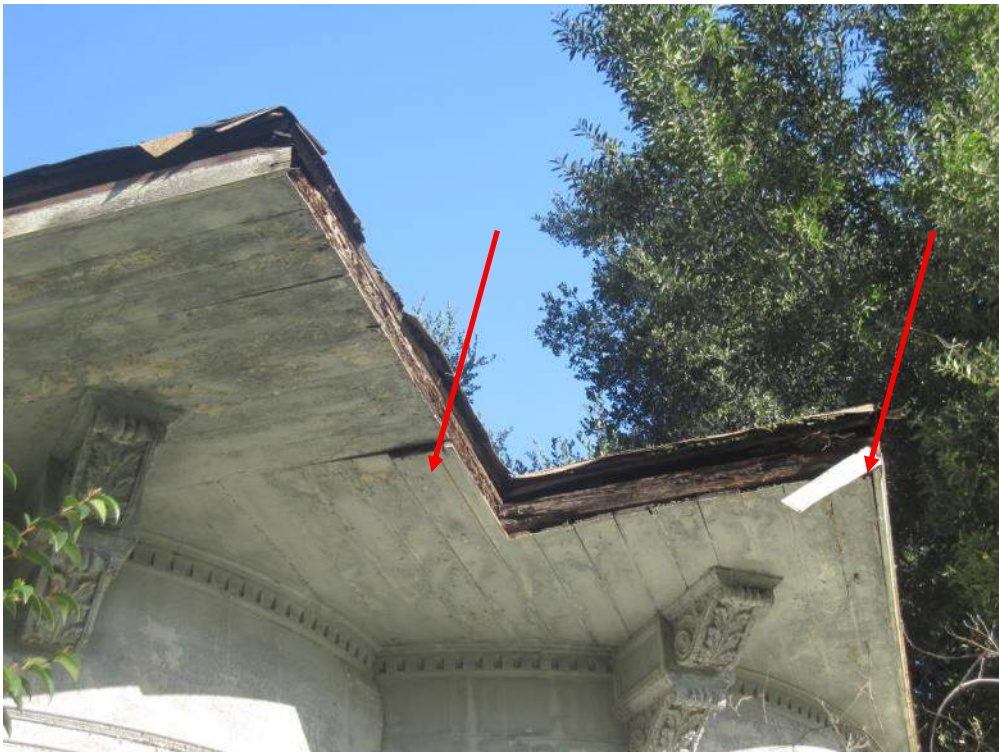
**Photo 11**

The large overhangs provided by the roof eave offers good protection for most of the soffit except for the gutter and wood fascia located near the face of the eave. With less protection, the ends of the panels are in worse condition than sheltered members near the dentil. Some localized replacement of the soffit panels will be required.

Soffit damage requiring repair.

- The soffit will require partial removal and replacement. We project approximately 30% of the soffit will require replacement while the rest will require exterior coating repair to be performed in place.

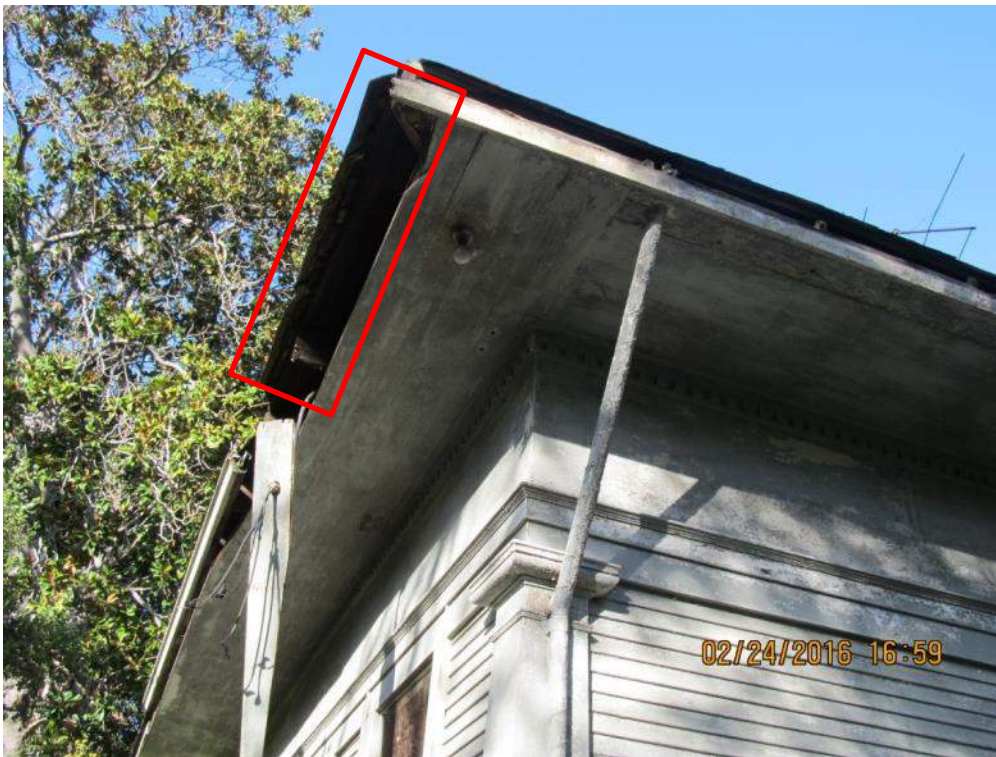
Sections of the gutter, fascia and soffit construction has fallen off in various locations.

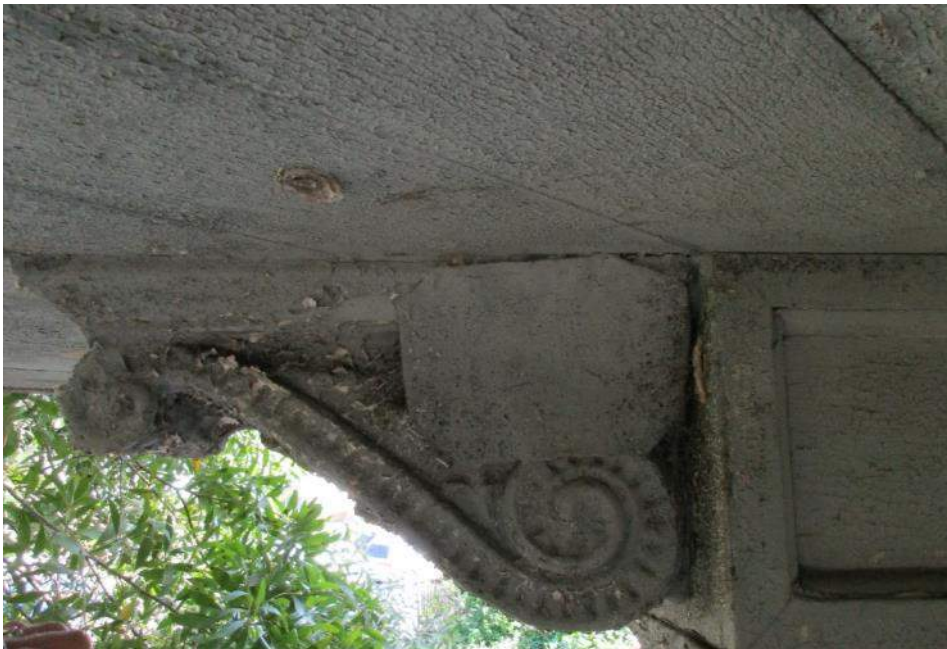
**Photo 13**

The paint is chipping on the decorative brackets.

Note sheet metal patch installed over portion of bracket.

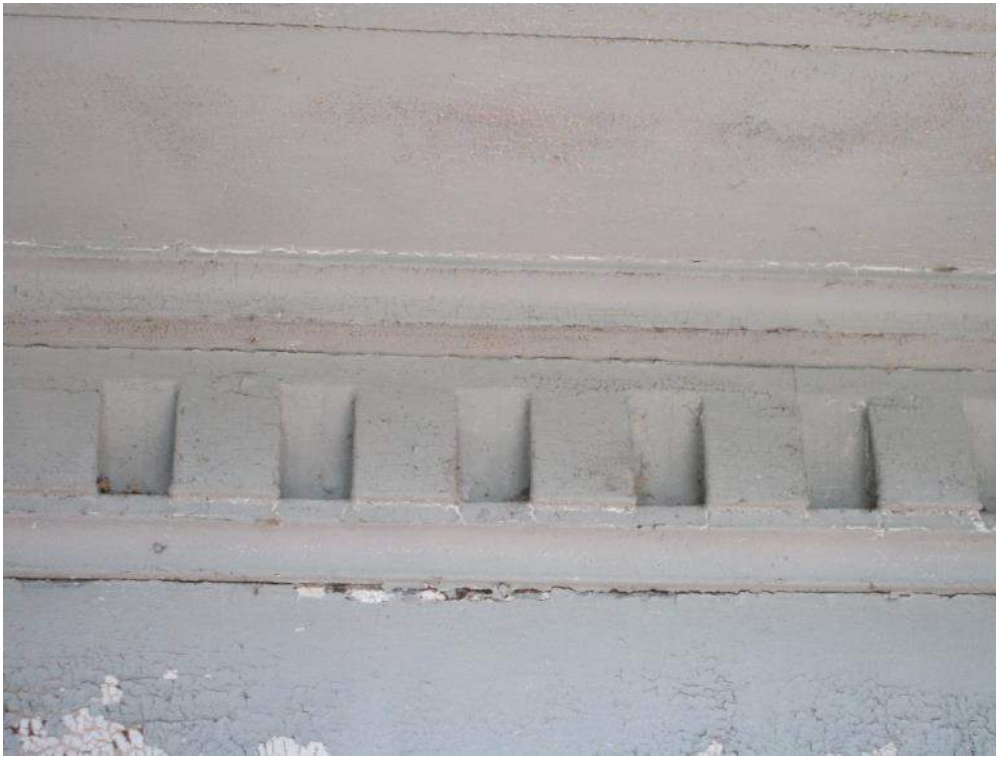
The wood dentil appears to be in good condition, requiring only localized refurbishment and repainting.

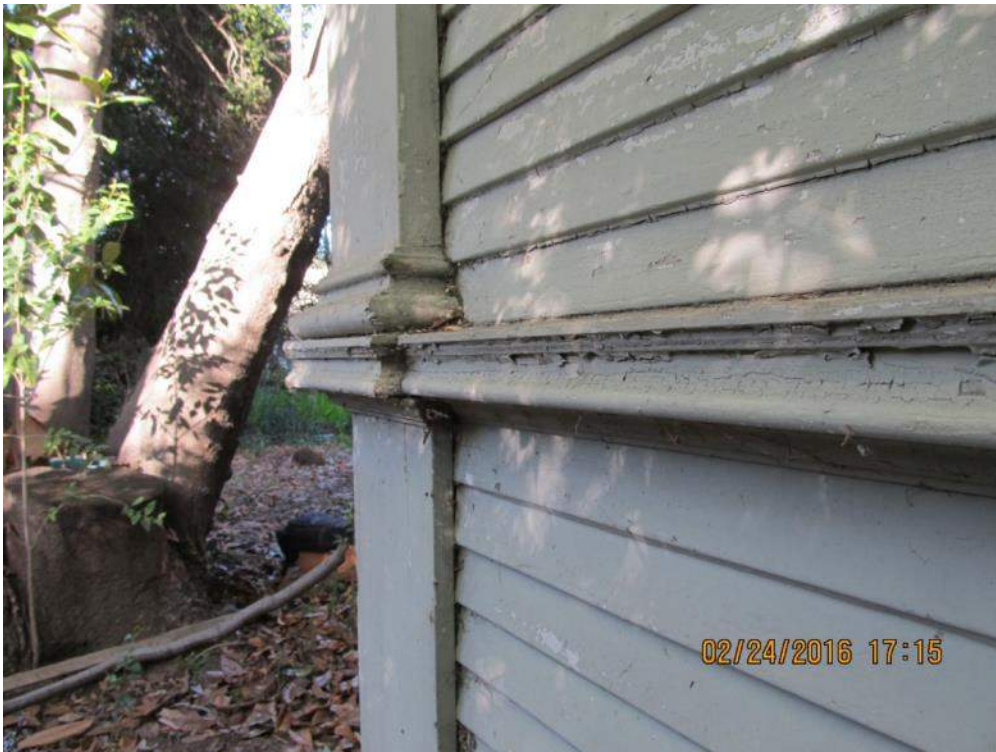
**Photo 15**

- Peeling paint on the wood siding and trim at all elevations (Photos 14 – 16). Generally, we did not observe deterioration or wood rot to the siding, although there are some localized exceptions.

The exterior coating is peeling off the wood siding.

- Remove all layers of existing coatings and sealants as required to expose exterior wood siding and trim for restoration. Test for potentially hazardous materials and perform abatement as specified (by others).

- Restore areas of dry-rot and other damage with an appropriate exterior-grade wood patching compound suitable for painting. Remove and replace in-kind isolated areas of wood siding and trim that are beyond repair.

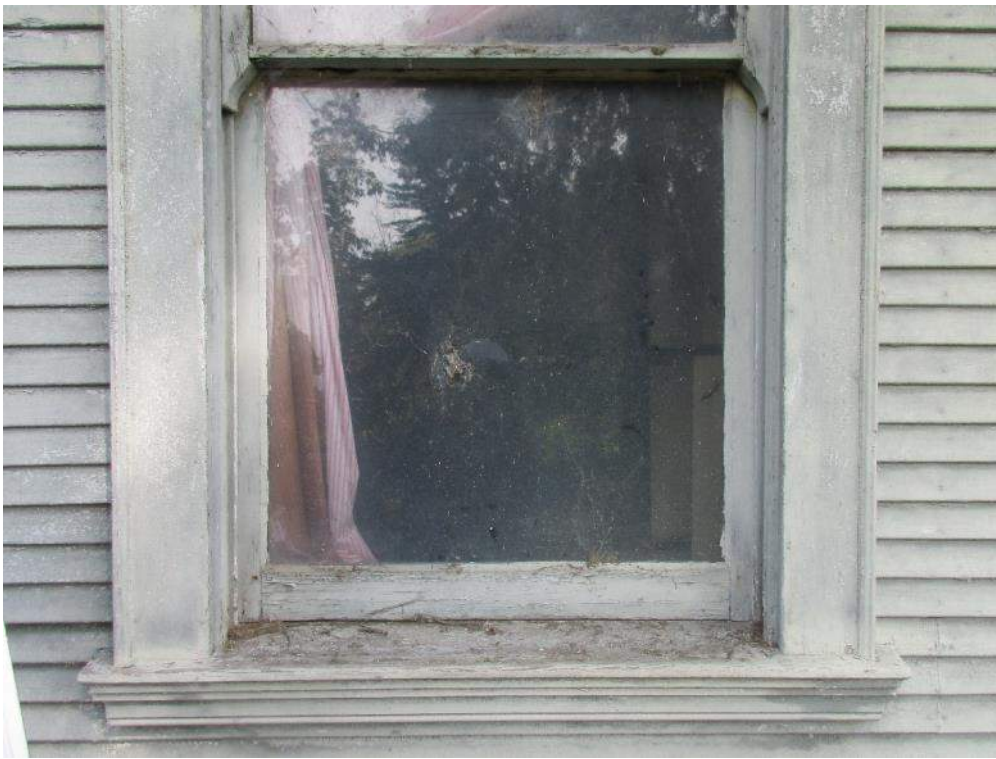
The window framing is in good condition.

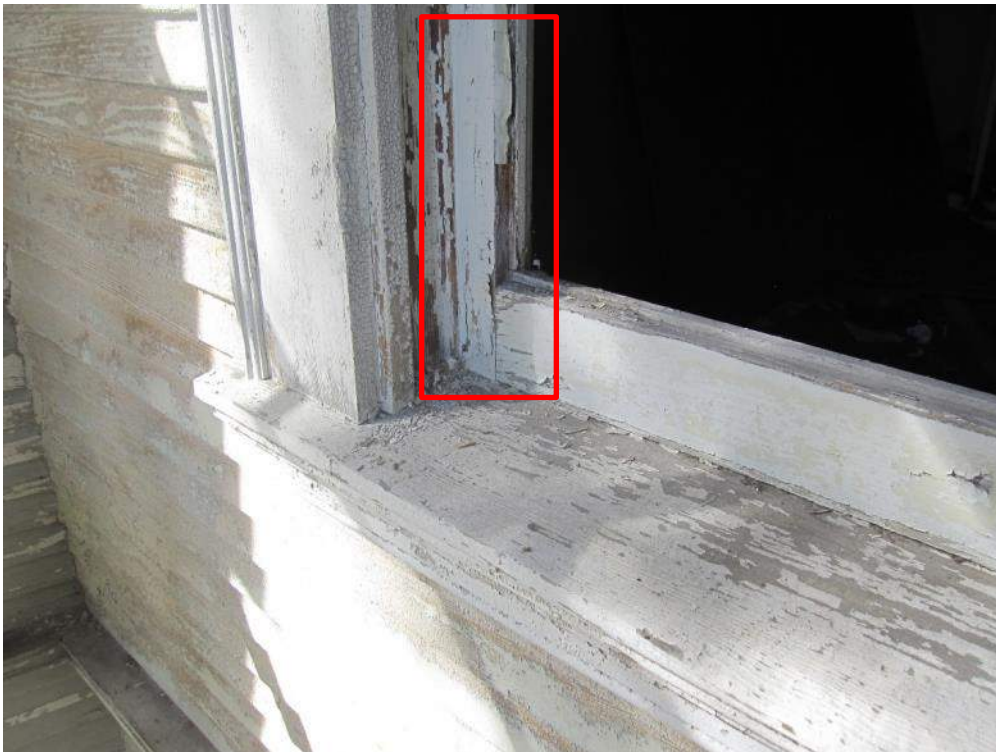
**Photo 17**

Similarly, the window frames generally appear to be in relatively sound condition and suitable for restoration. However, the window sashes and associated glazing is in generally much poorer condition, with split joinery and failed glazing putties occurring throughout. Based on our observations, it may be feasible to restore the existing window frames in-place; however, this assumption requires further assessment and confirmation by a window restoration subcontractor. The sashes will most likely require removal for comprehensive restoration, or replacement if repairs to the existing materials are determined to be impractical.

Joinery in operable window sash is separating.

- Repair and repaint existing window frames. Remove sashes as required for comprehensive refurbishment of wood framing, glazing putties, and damaged or missing lites. We recommend retaining a window restoration specialist to assist the project team in determining the feasibility of restoring the existing sashes or if replacement in-kind will be required where original. Consider either restoring or infilling the non-matching window and door located on the east elevation.

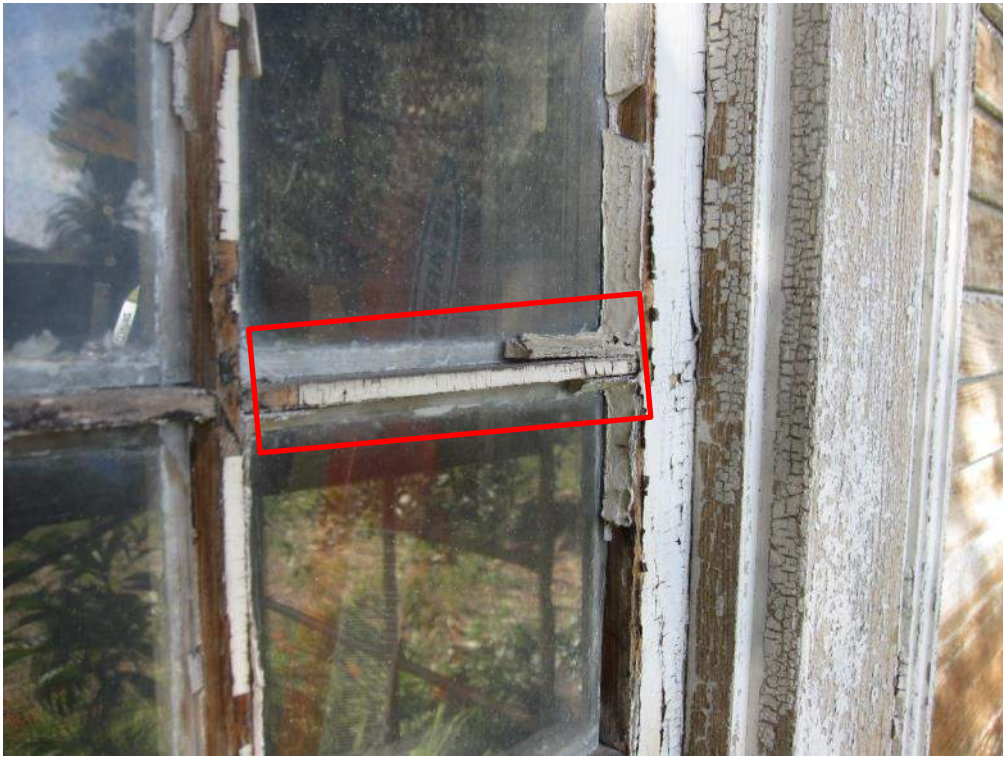
Missing and deteriorated glazing putty.

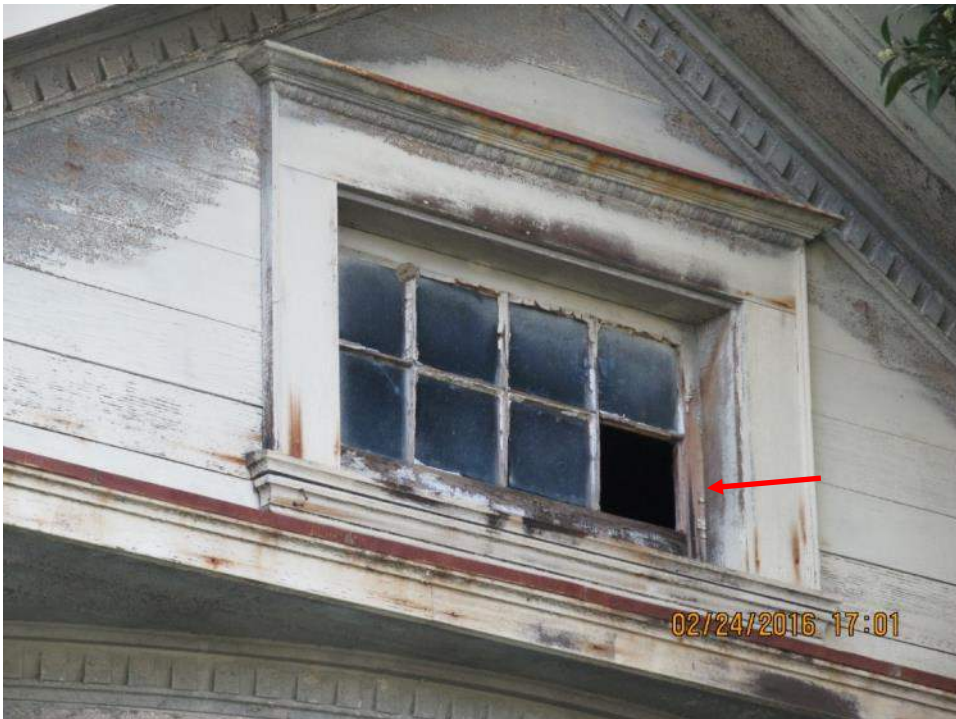
**Photo 19**

A window with a missing lite that will require replacement.

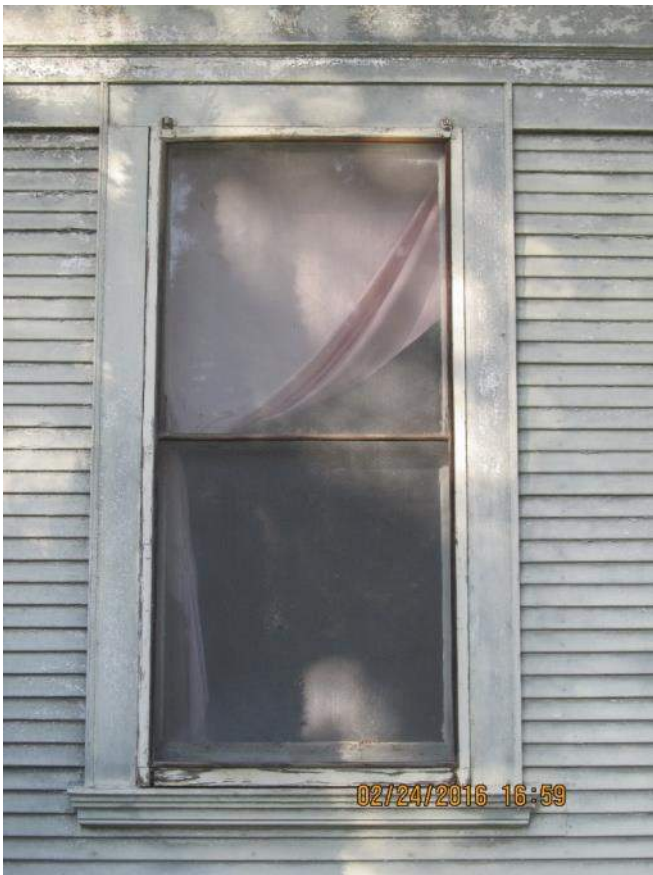
Some windows have awning screens installed to the exterior.

At other locations, there are no screens or they are missing.

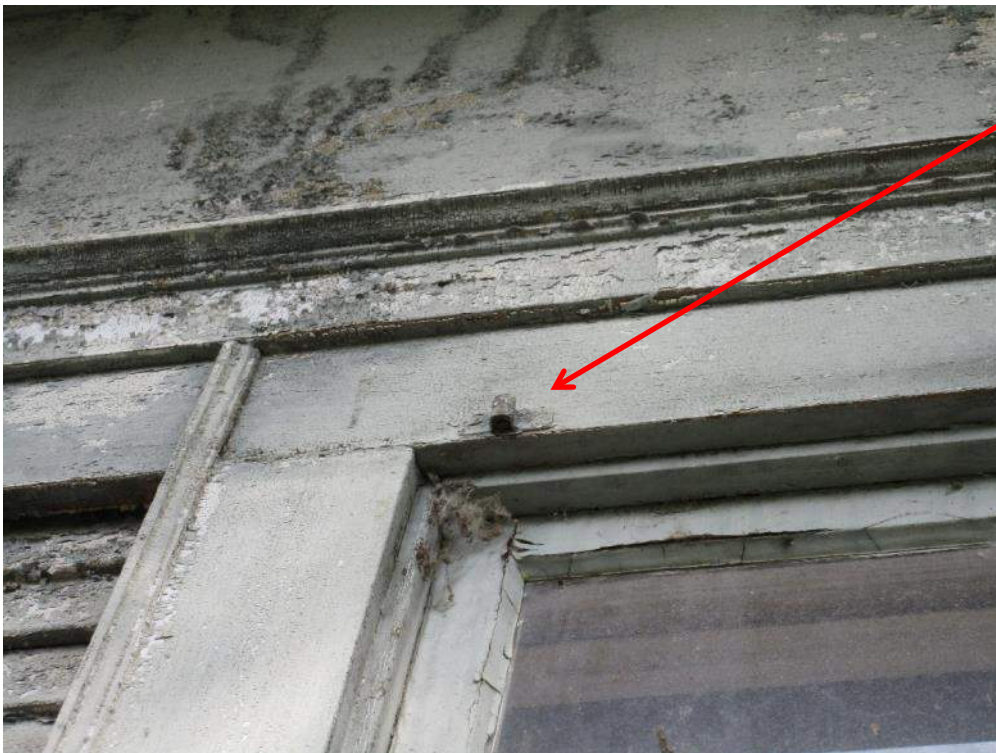
**Photo 21**

Some screens have fallen off the building due to deterioration of the external bracket fixing them in place.

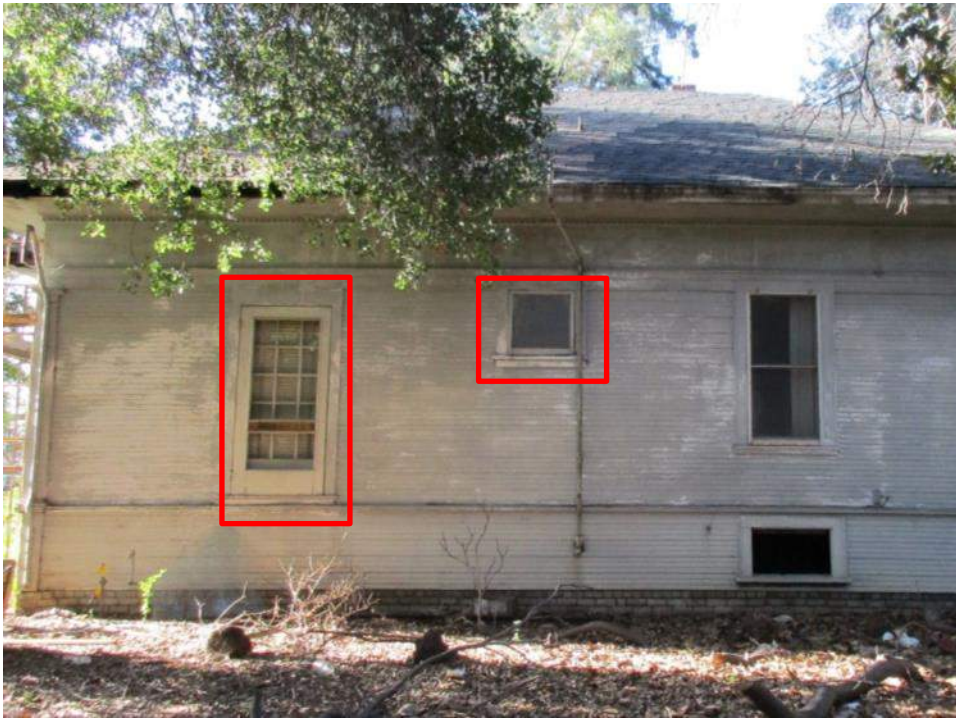
A window and door with trim that does not match the typical details used elsewhere on the home.

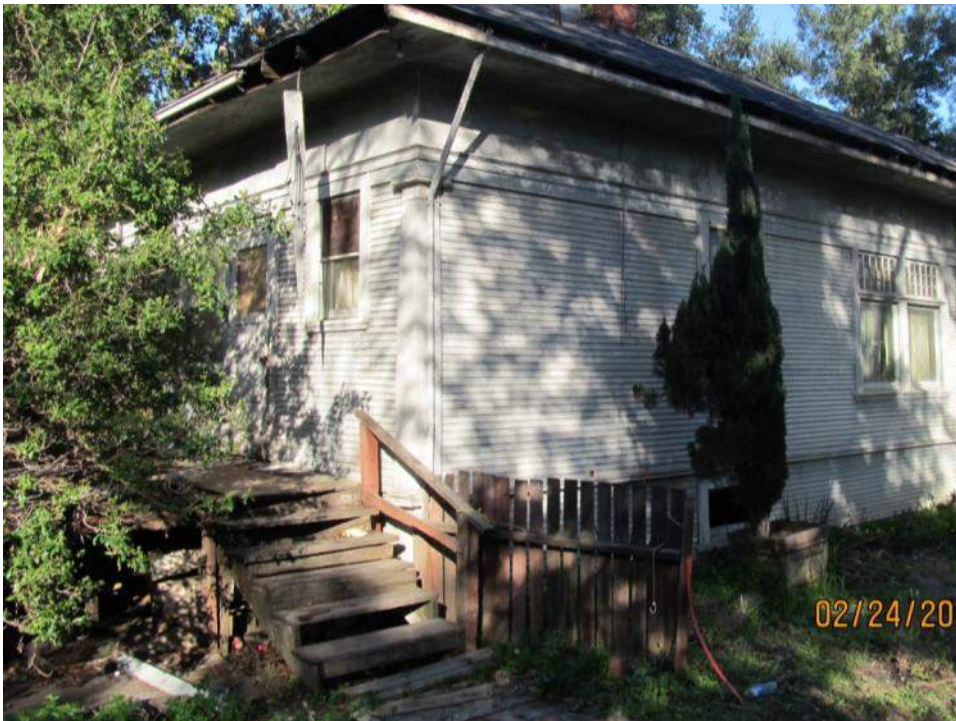
**Photo 23**

- Severely deteriorated wood deck on the north elevation. It is in a partial state of collapse and constructed in places with pressure treated lumber (Photo 24).

The deteriorated wood deck at the rear of the home is built from pressure treated wood which was not available at the time of the original construction. Furthermore, the original floor plan indicates a small stairway where the deck is currently. Based on these observations, we do not believe the rear deck was original to the home and appears to be an undocumented alteration.

The wood stairs to the deck are severely deteriorated.

- The wood deck located at the rear of the home is in poor condition and should be demolished or replaced. There is currently not enough documentation available to determine the details of the original rear porch and stairway.

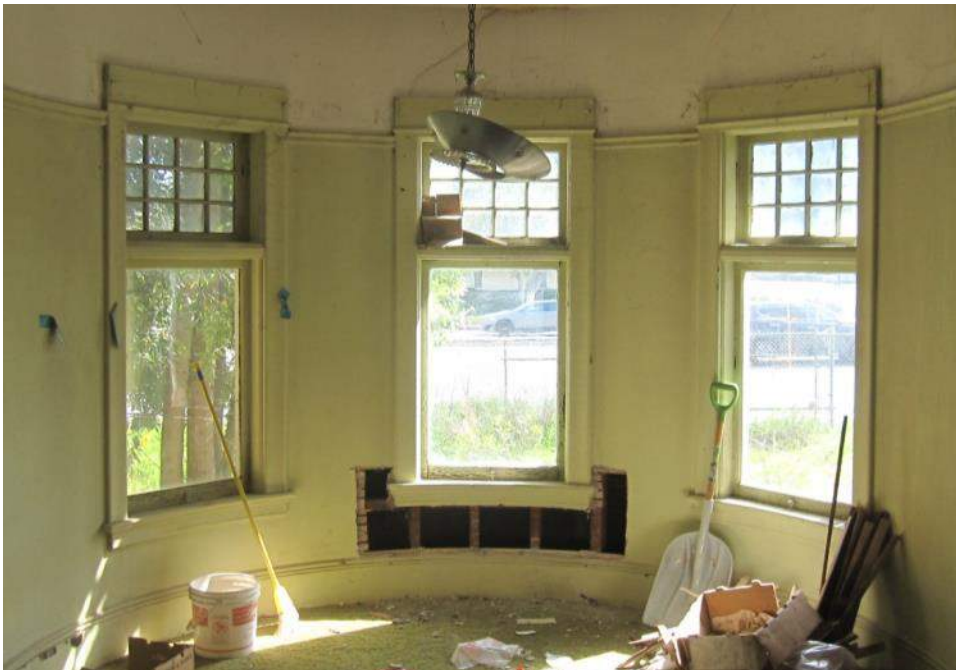
**Photo 25**

Interior view of  
investigative building  
envelope opening  
location 1.

Investigative opening  
shows wall cavity is in  
good condition.
