Assessment of and Recommendations for
Fifty-Two (52) Trees
at and adjacent to
675 Almanor
Sunnyvale, CA

Prepared at the Request of:
Chang Architecture

Site Visit:
Walter Levison, Consulting Arborist (WLCA)
8/28/2015
Report:
(WLCA)
10/5/2015
Revised 9/20/2016

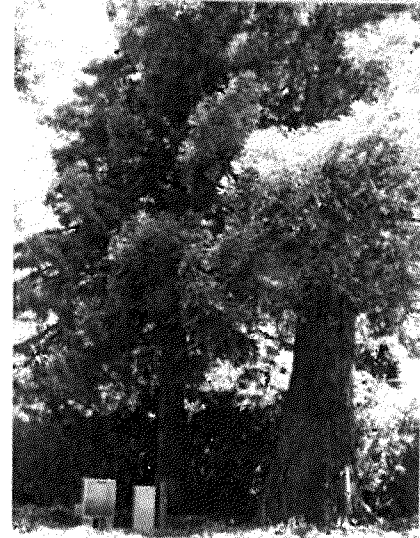
R to L
13 & 14

14			38.5						38.5	yes	coast redwood	<i>Sequoia sempervirens</i>	110/30	75/75	75% good	moderate to good										X	Located in irrigated dry groundcover area (Hetch Hetchy System Easement)	Maintain existing fence protection and irrigation. May need to segment fencing with additional chain link panels.	
15	X	(suggest removal)	est. 24						est. 24	yes	Monterey pine	<i>Pinus radiata</i>	45/30	56/56	99% fair	poor to moderate		E								X	Recommend removal of tree if condition declines below current 90% overall condition rating.	---	
16	X		36.0	36.0	30.0				102.0	yes	shamel ash	<i>Fraxinus uhdei</i>	45/55	55/50	93% fair	poor to moderate							3 feet			X			---
17	X	X	43.1						43.1	yes	shamel ash	<i>Fraxinus uhdei</i>	45/45	35/40	35% poor	poor					GR					X			---
18			43.3						43.3	yes	shamel ash	<i>Fraxinus uhdei</i>	45/55	50/50	95% fair	moderate	E	E								X		Crowded codominant mainstems fork at 8 feet.	W, TB, RPZ

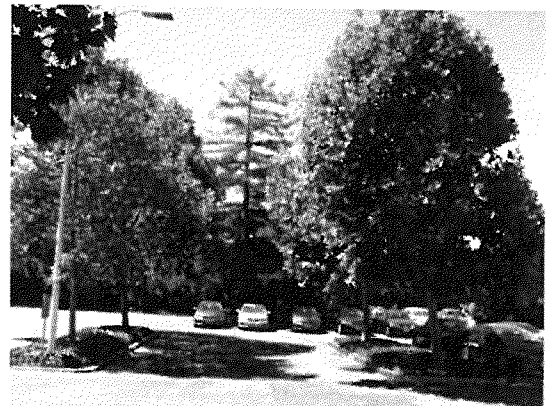
Left:
27 & 28

Right:
30 & 31

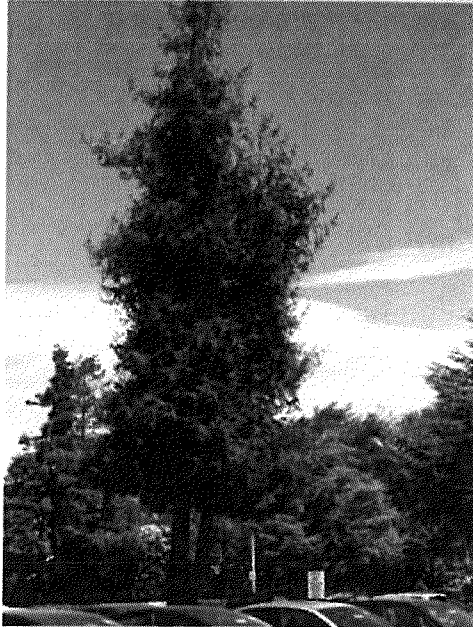
38			28.2						28.2	yes	coast redwood	<i>Sequoia sempervirens</i>	45/20	70/75	75% good	moderate									X	New exterior footprint will be approx. 18 to 12 feet from trunk edge, which may result in severe impacts to this tree in terms of above and below ground tree damages. May need to remove tree.	W, TB, RPZ	
39			17.2	12.8					30.0	yes	coast redwood	<i>Sequoia sempervirens</i>	40/18	35/35	35% poor	poor					throughout tree	zero to 3 feet elevation above grade			X	New exterior footprint will be approx. 18 to 12 feet from trunk edge, which may result in severe impacts to this tree in terms of above and below ground tree damages. May need to remove tree.	W, TB, RPZ	
40	X		8.8						8.8	no	shamel ash	<i>Fraxinus uhdei</i>	23/9	95/75	78% good	good											---	
41	X		8.4						8.4	no	shamel ash	<i>Fraxinus uhdei</i>	23/9	95/75	79% good	good											---

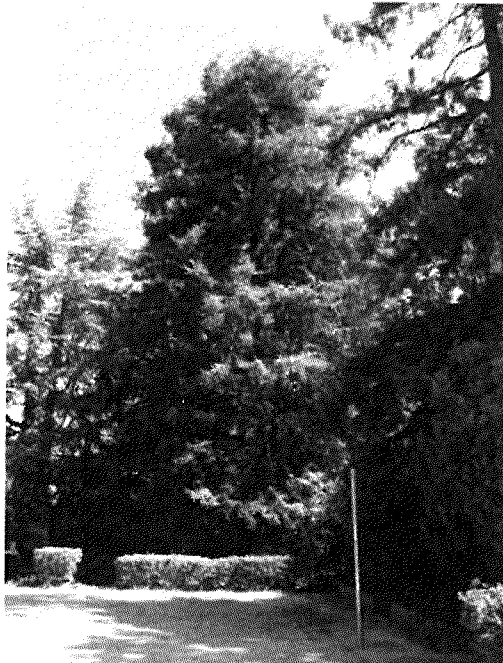
Center:
42 & 43
looking
east

-----	-----	-----	-----	-----	-----
Trees requiring special arborist maintenance measures if retained	(4)	#7, 10, 15, 43	Protected	#7, 43 to be retained. #10, 15 proposed to be removed.	#7: Will require cabling or removal of one of two codominant mainstems at fork at 80 feet above grade. #10: Would require cabling and/or through-bolt bracing per ANSI A300 standards for tree support systems. (Tree is currently slated for removal per project team.) #15: Monitor tree for decline, and remove entire tree if tree declines to "poor" overall condition (i.e. below its current overall condition rating of 50% "fair", which is only 1 percent above the 49% threshold between "fair" and "poor"). #43: Will require cabling per ANSI A300 standards for tree support systems.
