Assessment of and Recommendations for
Fifty-Two (52) Trees
at and adjacent to
675 Almanor
Sunnyvale, CA

Prepared at the Request of:
Chang Architecture

Site Visit:
Walter Levison, Consulting Arborist (WLCA)
8/28/2015
Report:
(WLCA)
10/5/2015
Revised 9/20/2016

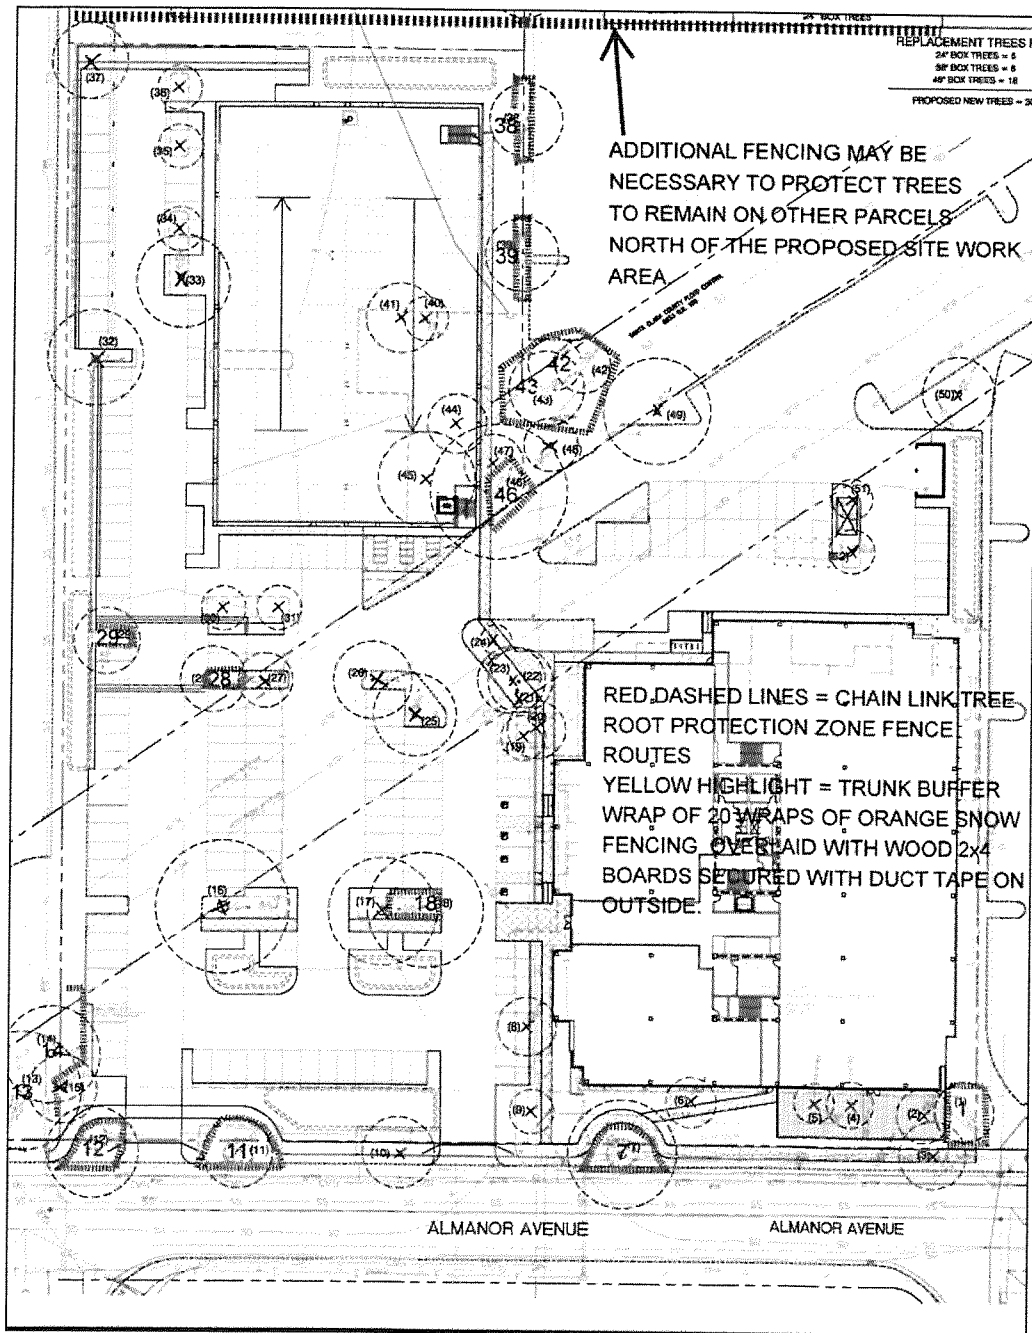
12 Tree Location Map Revised 9/20/2016 (WLCA)

Trees to be retained are shown in large type, with red dashing indicating WLCA's suggested minimum chain link root protection zone routing, and yellow highlight indicating trunk buffer wrap around each tree trunk as redundant protection for the above-ground trunk tissues. Recent 2016 decisions dictated that all trees located on the Hetch Hetchy water delivery system (SFPUC) right-of-way be indicated as to be removed.
