Assessment of and Recommendations for  
Fifty-Two (52) Trees  
at and adjacent to  
675 Almanor  
Sunnyvale, CA

Prepared at the Request of:  
Chang Architecture

Site Visit:  
Walter Levison, Consulting Arborist (WLCA)  
8/28/2015  
Report:  
(WLCA)  
10/5/2015  
Revised 9/20/2016

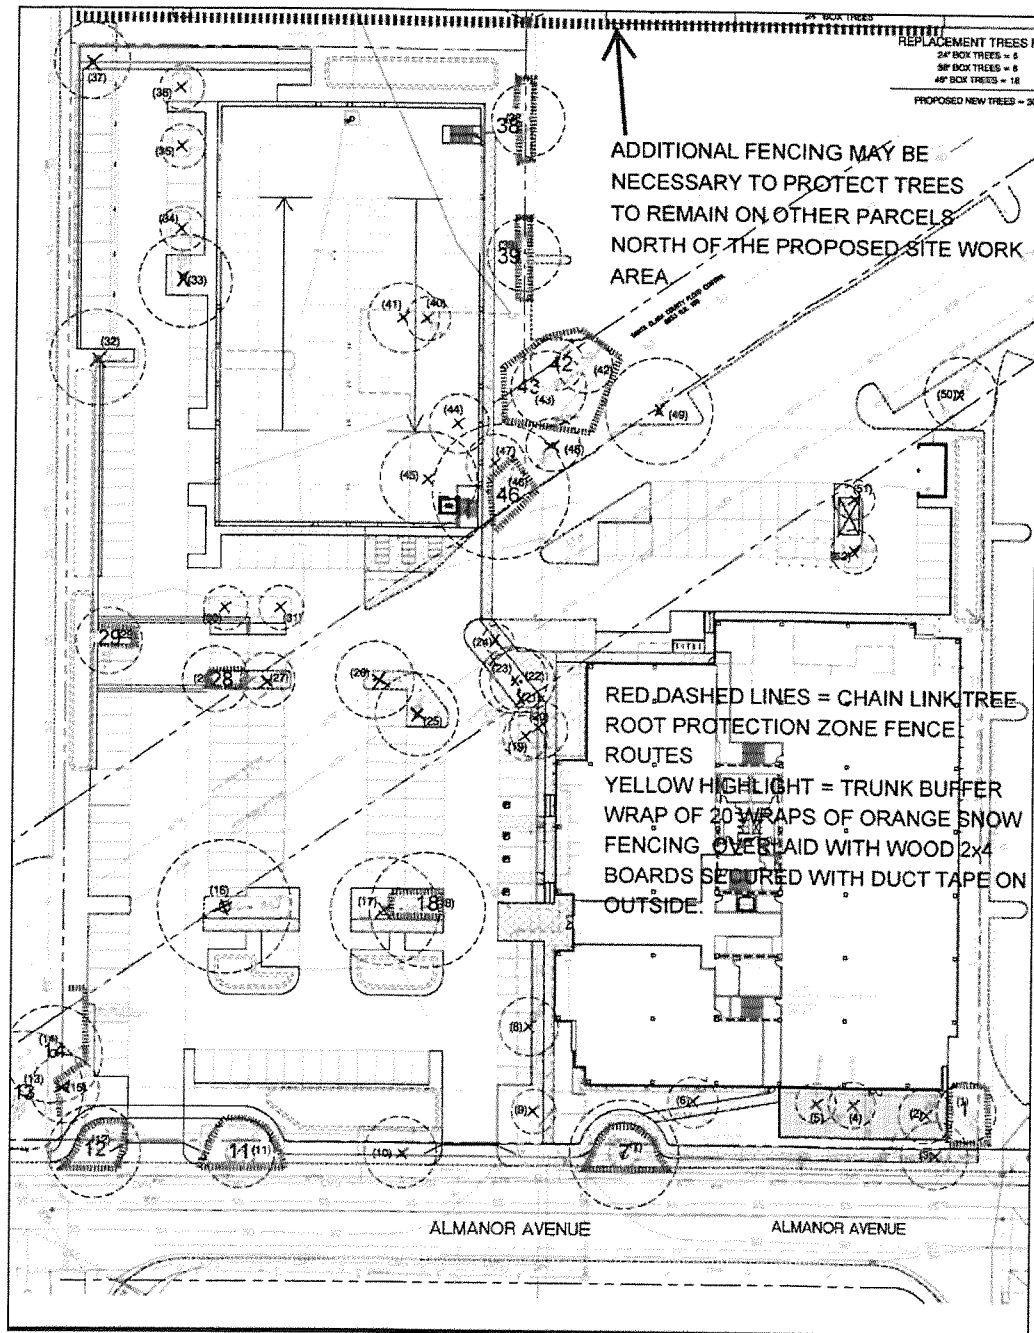
## 12 Tree Location Map Revised 9/20/2016 (WLCA)

Trees to be retained are shown in large type, with red dashing indicating WLCA's suggested minimum chain link root protection zone routing, and yellow highlight indicating trunk buffer wrap around each tree trunk as redundant protection for the above-ground trunk tissues. Recent 2016 decisions dictated that all trees located on the Hetch Hetchy water delivery system (SFPUC) right-of-way be indicated as to be removed.
