Seismic Evaluation

## Sunnyvale City Hall Annex

Sunnyvale, California

14 July 2017

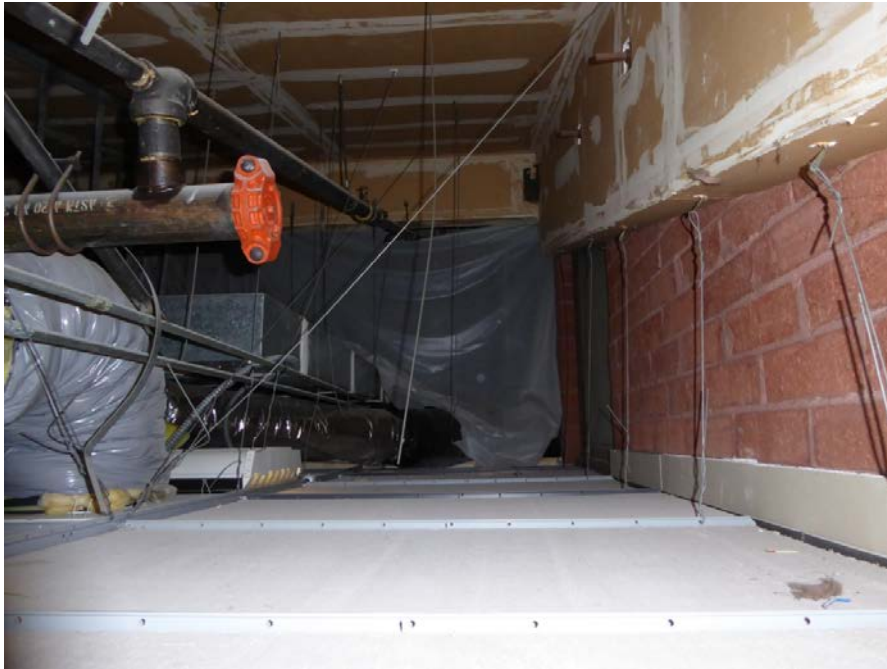
**Photo 7: North exterior brick wall at roof glulam beam ledger.**

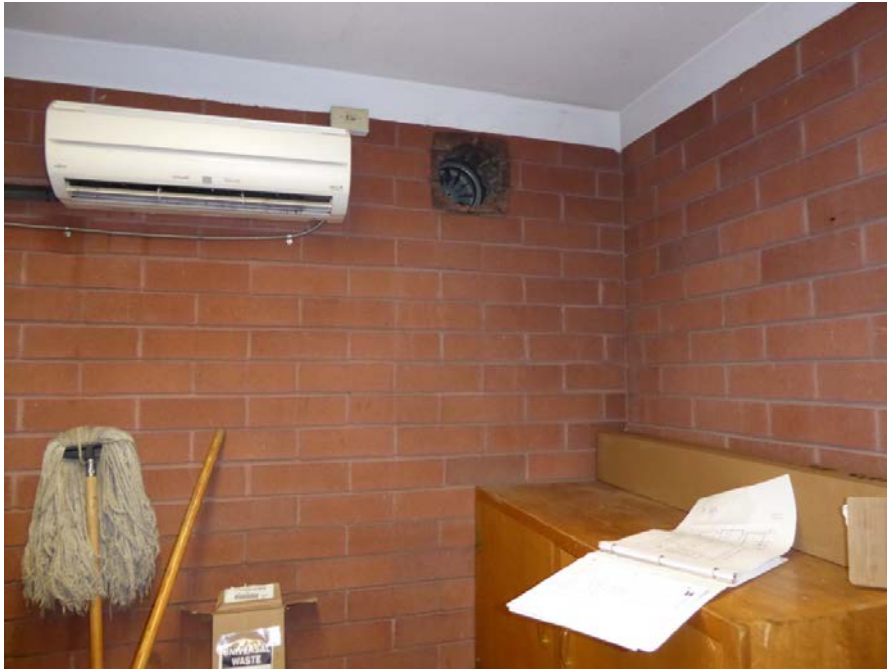
On-site investigations were limited to visual observations with the following exception: In the UPS room on the ground floor 3 3/8" diameter x 4" deep holes were drilled into the brick wall. One hole was into the brick face and 2 holes were into a mortar joint. No destructive or nondestructive testing was performed.

**Photo 11: Hole in exterior brick masonry wall in UPS room.**

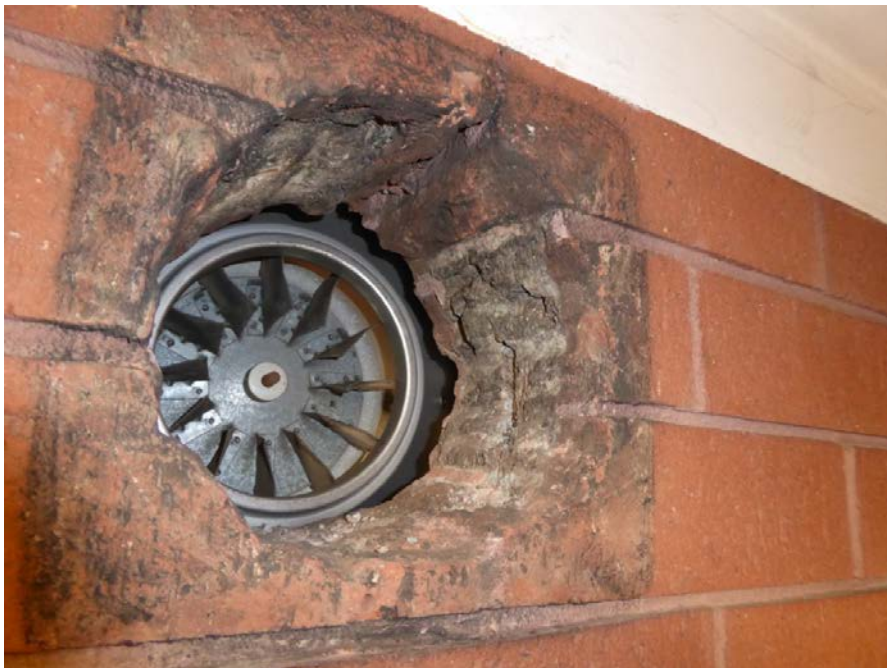
**Photo 12: Hole in exterior brick masonry wall in UPS room.**

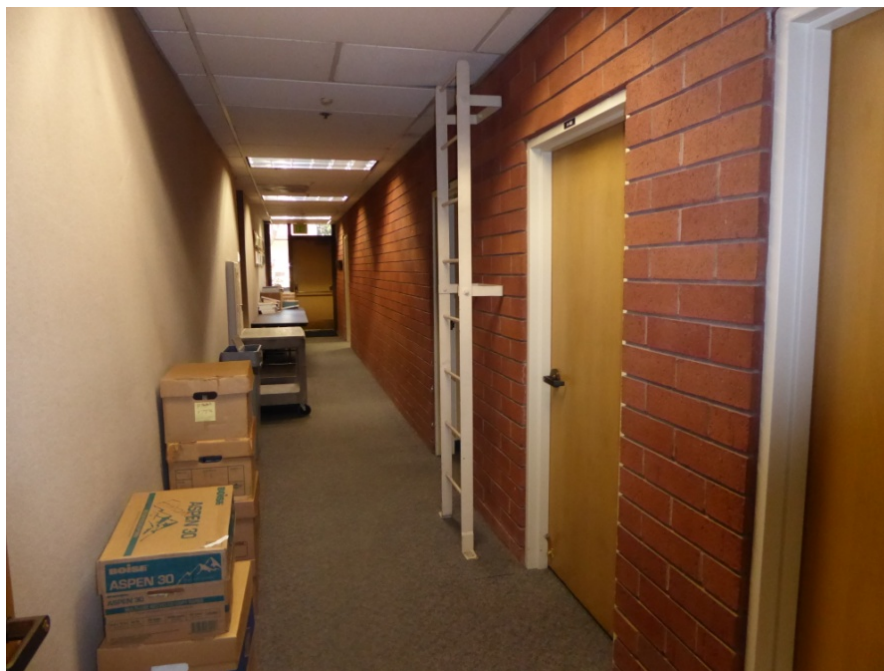
**Photo 18: South West Ground Level corridor with above-ceiling access hatch and ladder. The ceiling to the right of the brick walls is a 6" reinforced concrete ceiling. See Photo 14.**

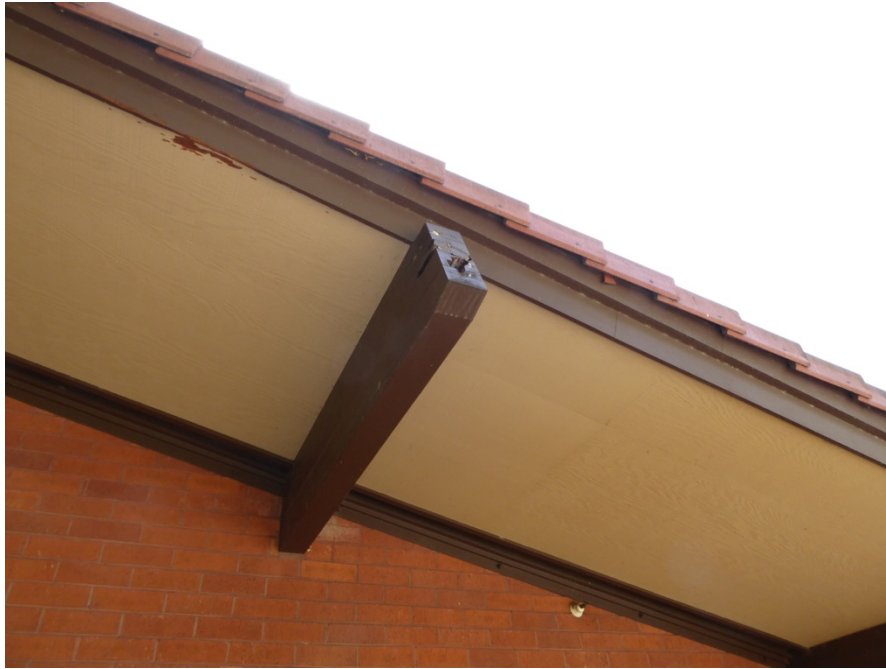
On-site investigations confirmed that the building is fairly well maintained, and appears to be in good condition. There is no evidence of deterioration of structural materials that would have significant effect on seismic performance. Portions of the ends of cantilever roof beams show signs of significant deterioration. Some appear to have been modified as part of a repair. This is a nonstructural item. However, repair of the condition should be included in the scope of work. See Photo 19 in Appendix D.

**Photo 19: Damaged exterior roof beam.**
