Arborist Report

**Costco Wholesale
Sunnyvale, CA**

January 19, 2017

REV # 2
w/ updated tree map

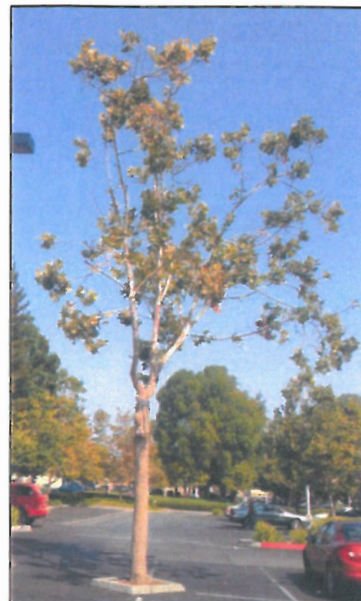
The most commonly encountered species was London plane, with 22 trees or 33% of the population. London planes were young to semi-mature, with diameters ranging from 5-15". Condition of the London planes was predominantly good (11 trees), with three (3) in poor condition and eight (8) in fair condition. Most trees were growing in small 3'x3' planters surrounded by asphalt. In general, London planes appeared water stressed; many trees had thin crowns and twig or branch dieback (photo 1).

Photo 1: London planes in the parking lot had restricted rooting space and were in fair condition with twig dieback and slightly thin crowns, an indication of water stress.

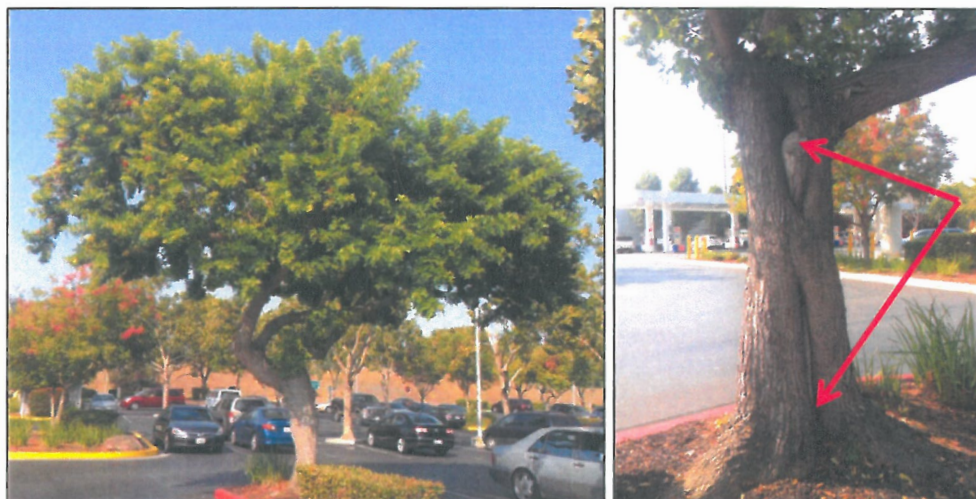
Ten (10) Brazilian pepper trees, representing 15% of the population, were evaluated. Eight (8) were in fair condition and two (2) were in poor condition (#31 & 112). Many trees were characterized by having dense crowns but poor structure (photo 2), with codominant trunks or multiple trunks emerging from one point, crossing branches and other defects. Others had thin crowns and exhibited twig and branch dieback.

Photo 2: Brazilian pepper trees on site often had full, dense crowns and structural defects. Tree #39 had a healthy crown and poor structure with a trunk cavity extending from the base to 6' (arrows).
