# Advanced Tree Care

1268 Poplar Ave, Sunnyvale

July 11, 2019

## Tree Survey

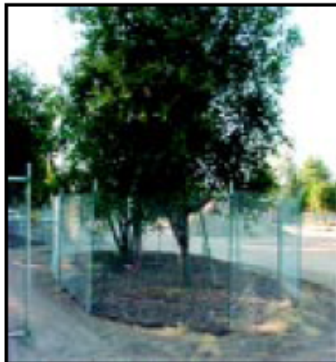
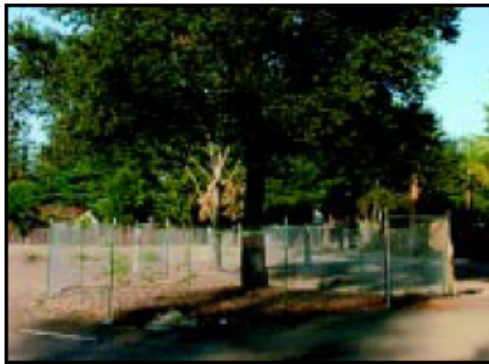
**IMAGE 2.15-1**

Tree Protection Fence at the Dripline

Tree #s 1 and 2 are at the entrance to the construction site, it may be necessary to wrap the low overhanging limbs of the tree with 2 inches of orange plastic fencing and wooden slats similar to Type III tree protection to prevent any physical damage to the trees from delivery trucks or construction machinery. Illustrated in image 2.15-1 and 2 <sup>(6)</sup>.

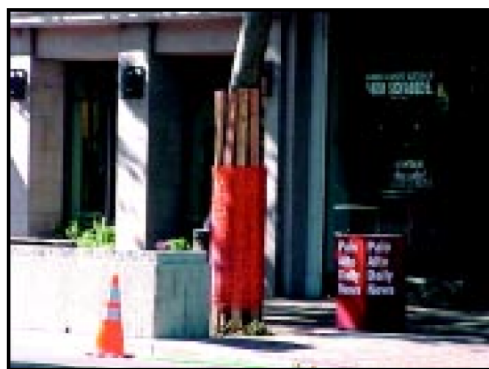
**IMAGE 2.15-4**

Trunk Wrap Protection

Trees situated in a small tree well or **sidewalk planter pit**, shall be wrapped with 2-inches of orange plastic fencing as padding from the ground to the first branch with 2-inch thick wooden slats bound securely on the outside. During installation of the wood slats, caution shall be used to avoid damaging any bark or branches. Major scaffold limbs may also require plastic fencing as directed by the *City Arborist*. (see *Image 2.15-4*)

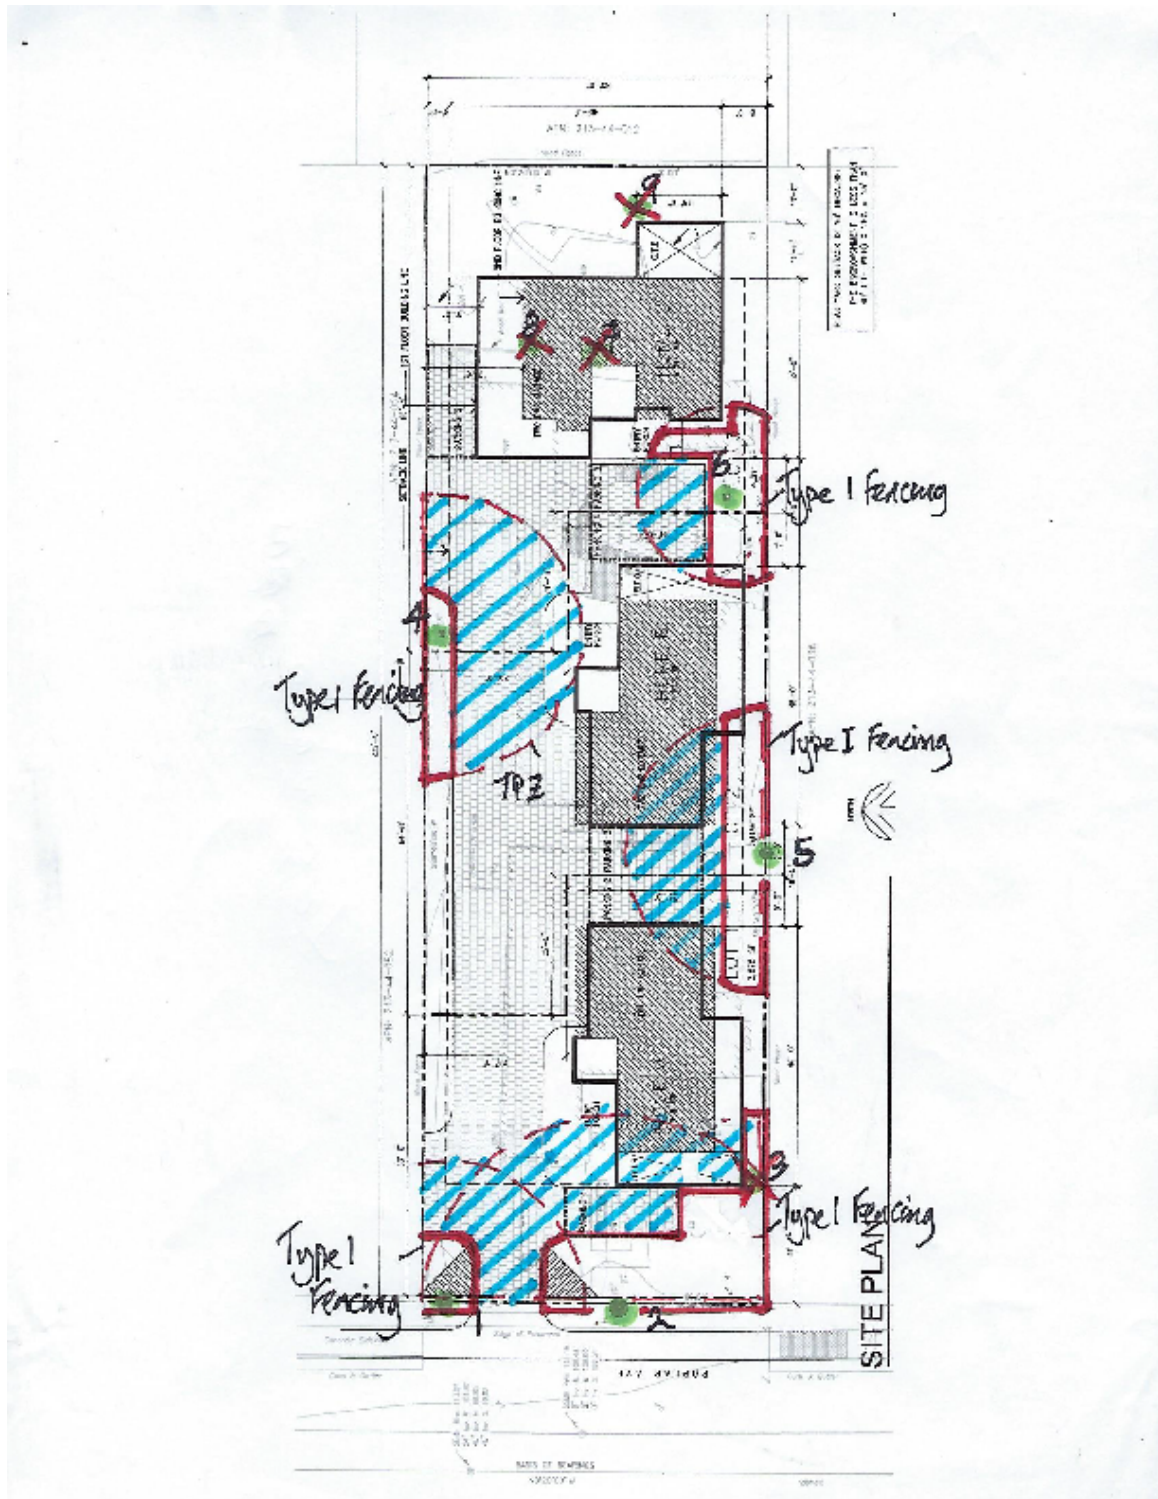
The tree protection fencing should be placed at its furthest radius from the tree where possible, but because this is such a narrow lot, the recommended location of the TPZ fencing would prevent the property from being developed. I have marked in a solid red line on the drawing the possible location of the TPZ fencing. The TPZ fencing should be Type I Tree Protection as outlined and illustrated in image 2.15-1 and 2 <sup>(6)</sup>. If work is required within the recommended TPZ fencing but outside the actual fencing (Area shaded in blue), the following recommendations should be followed.

Location of proposed new homes, protected trees and their Tree Protection Zones

Tree # 1: TPZ should be at 25' radius from trunk of tree

Tree # 2: TPZ should be at 35' radius from trunk of tree

Tree # 4: TPZ should be at 25' radius from trunk of tree

Tree # 5: TPZ should be at 25' radius from trunk of tree

Tree # 6: TPZ should be at 15' radius from trunk of tree
