Arborist Report

May 9, 2018

Faranak Pourghasemi
1005 E Homestead Road
Sunnyvale, CA 94087

On April 12, 2018 I was asked by Faranak Pourghasemi to inspect the site at 1005 E Homestead Avenue in Sunnyvale and give recommendations on the preservation or removal of the trees at this location in consideration of the upcoming construction project.

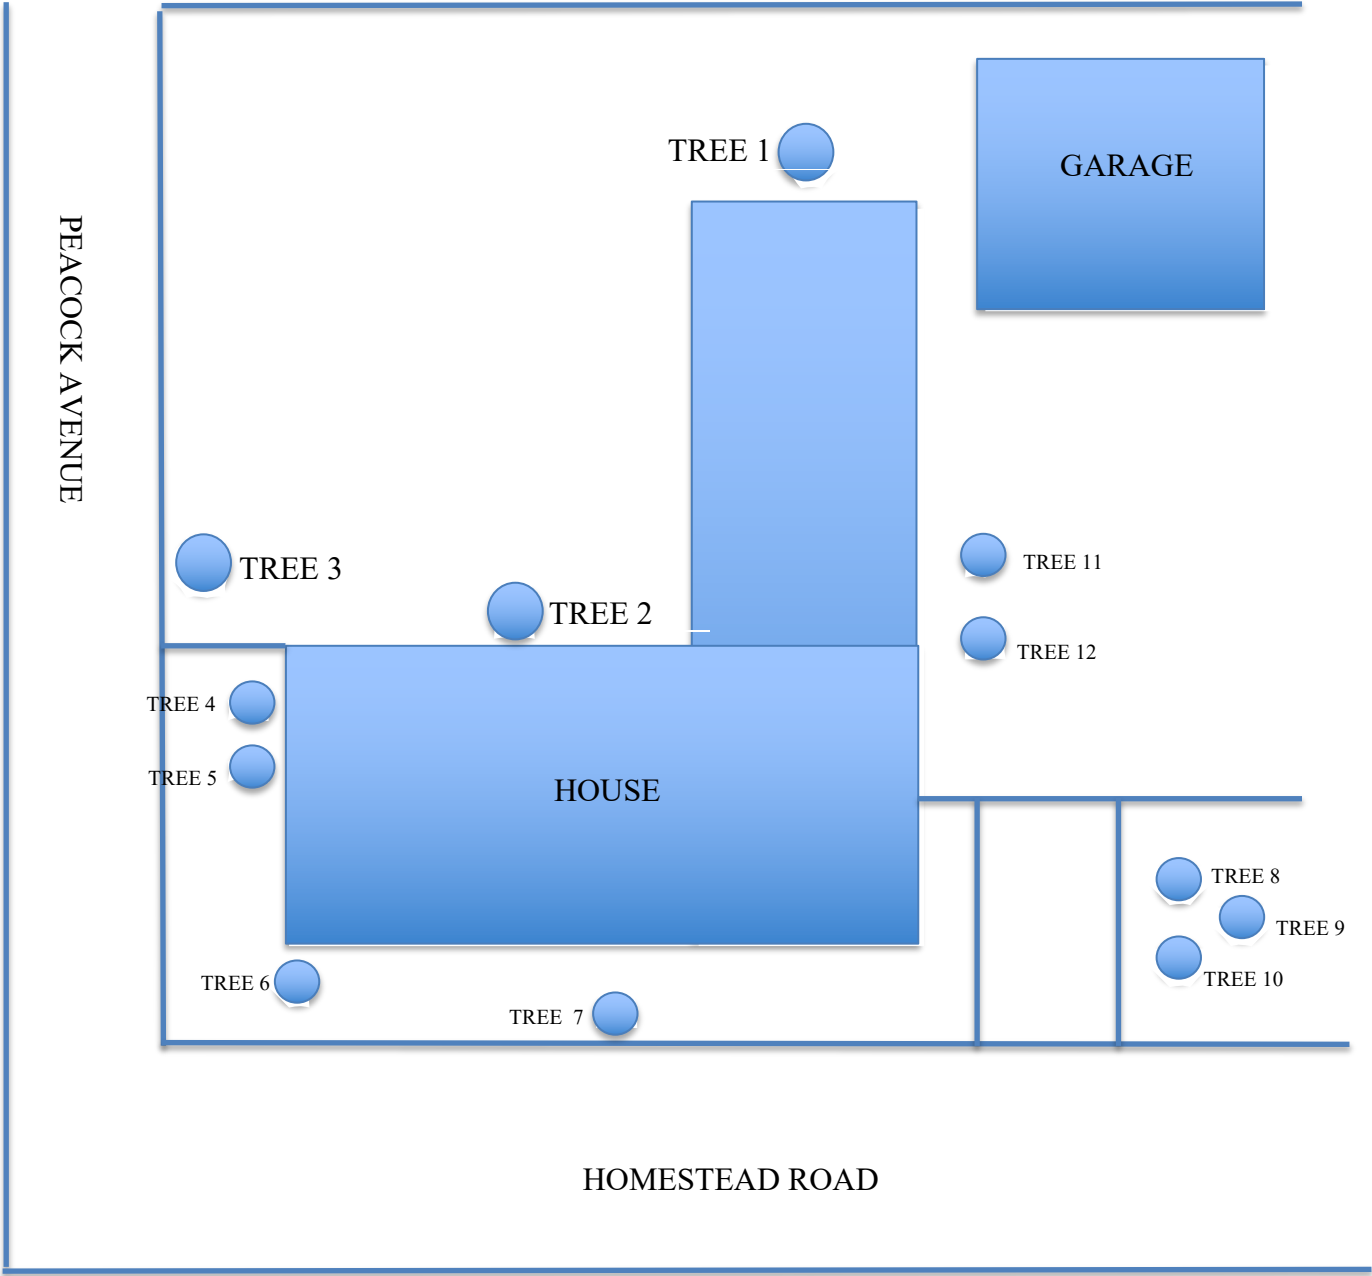
TREE MAP
1005 E Homestead Road, Sunnyvale CA

Tree No.	Species	Circumference	Health	Notes
#1 A	Bay	64"	Poor	Remove
#2 B	Cedar	27"	Poor	Remove
#3 C	Ash	26"	Good	Remove
#4	Bottle Brush	8"	Poor	Remove
#5	Bottle Brush	8"	Poor	Remove
#6	Palm	12"	Good	Remove
#7	Ash (city tree)	54"	Poor	Remain
#8	Olive	19"	Poor	Remove
#9	Olive	12"	Poor	Remove
#10	Olive	8"	Poor	Remove
#11	Apricot	12"	Poor	Remove
#12	Apricot	7"	Poor	Remove
