## Kielty Arborist Services LLC

November 4, 2019

Site: 1561 Barton Drive , Sunnyvale CA

As requested on Thursday, October 24, 2019, I visited the above site for the purpose of inspecting and commenting on the trees. A new home is being designed for this site, and as required a tree survey and tree protection plan is required as a part of obtaining the building permits for this site.

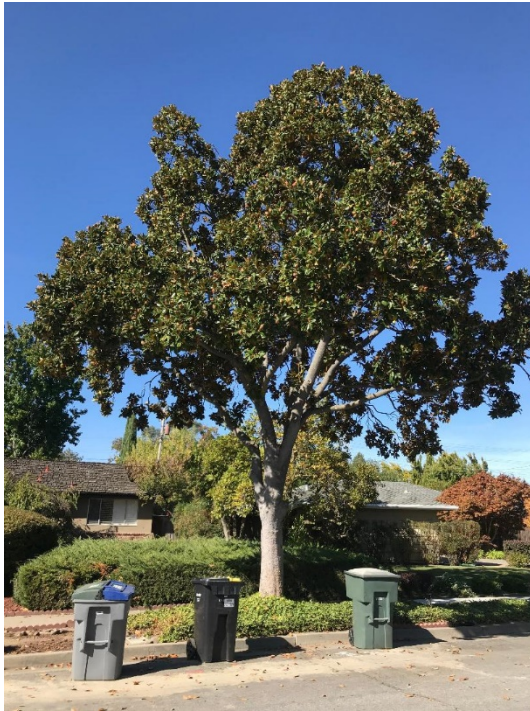
| Tree# | Species | DBH | CON | HT/SP | Comments |
|---|---|---|---|---|---|
| 1P | Magnolia<br>( <i>Magnolia grandiflora</i> ) | 16.0 | 70 | 30/30 | Good vigor, fair form, street tree. |

**Showing magnolia street tree #1 to be retained**

All trees measuring 12 inches or greater in diameter are protected trees in the city of Sunnyvale. Trees #1, 4, 5, and 8 are protected trees due to their recorded diameter. Magnolia tree #1 is a street tree in good condition and is to be retained and protected for this project. It is recommended to heavily irrigate the tree protection zone for the magnolia tree once a week. The remaining protected trees are all in poor condition and proposed for removal. Below is a description of the protected trees proposed for removal, followed by a tree protection plan for Magnolia street tree #1 to be retained.

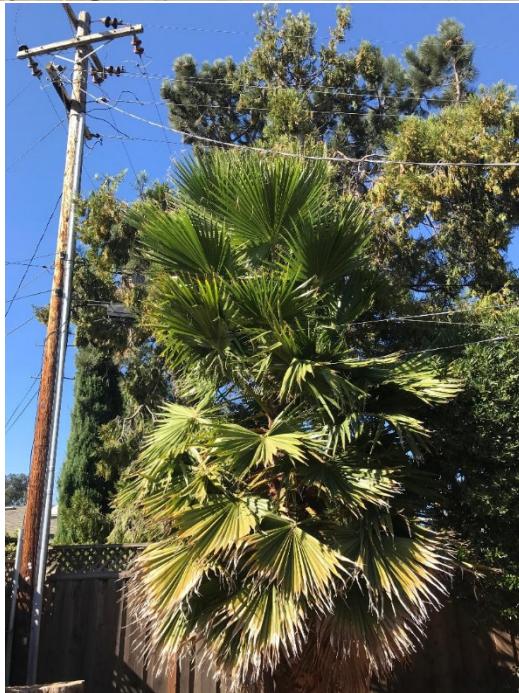
| Tree# | Species | DBH | CON | HT/SP | Comments |
|---|---|---|---|---|---|
| 4P | Mexican fan palm<br>( <i>Washingtonia robusta</i> ) | 18.0 | 45 | 20/6 | Fair vigor, fair form, poor location, directly under high voltage lines. |

Mexican fan palm tree #4 is located directly underneath high voltage lines. Once the tree reaches the vertical height to be in contact with the high voltage lines, the tree will need to be removed. Palm trees are monocots not dicots, and only have one apical growing point. Once this is lost because of the necessary pruning, the tree will die. Tree removal is imminent soon regardless of the proposed construction.

**Showing palm tree #4 directly under high voltage lines**

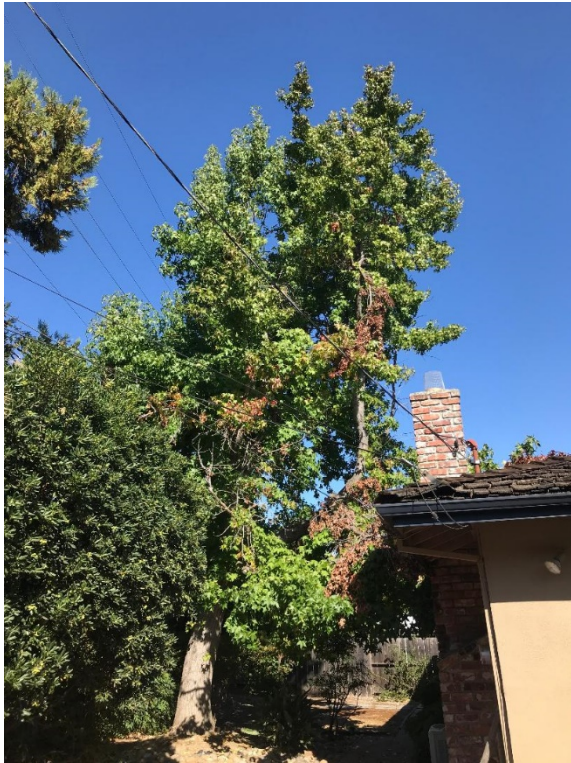
| Tree# | Species | DBH | CON | HT/SP | Comments |
|---|---|---|---|---|---|
| 5P | Liquidambar<br>( <i>Liquidambar</i> ) | 21.7 | 40 | 50/30 | Fair vigor, poor location, pruned for utilities on one side of canopy, heavy towards home, 2 large broken limbs in tree, 4" failed limb resting on roof, hazard. |

Liquidambar tree #5 is in poor condition. The tree has been repeatedly pruned for high voltage line clearance only on one side of the tree's canopy. The remaining portion of the canopy has been left to grow heavy over the existing home on site. The off balanced canopy has resulted in limb loss. A total of 3 widow makers (actively failing limbs) were observed in the tree's canopy. A large failed limb measuring 4 inches in diameter was observed resting on the roof of the home. Due to the off balanced canopy, the tree is at high risk of limb failure. Tree removal is recommended as this is the only way to eliminate the high risk of limb failure.

**Showing liquidambar tree #5**

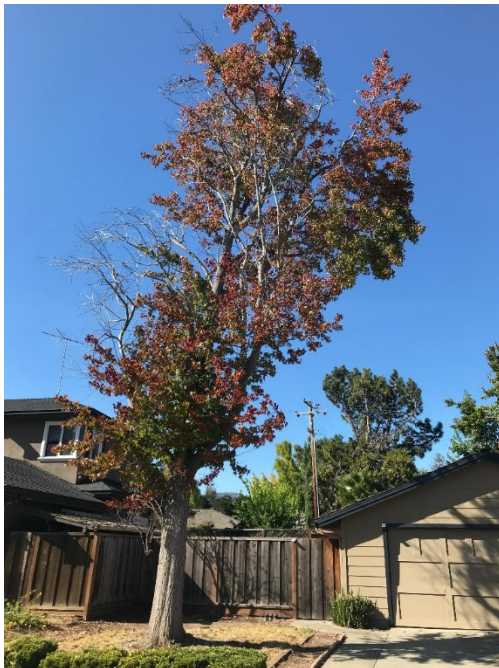
| Tree# | Species | DBH | CON | HT/SP | Comments |
|---|---|---|---|---|---|
| 6P | Liquidambar<br>( <i>Liquidambar styraciflua</i> ) | 18.0 | 40 | 50/20 | Poor vigor, poor form, abundance of dead limbs, history of limb loss, drought stress, heavy towards home and driveway. |

Liquidambar tree #6 is in poor condition. This tree is located near the existing driveway on site. Large dead sections were observed within the tree's canopy. A history of limb loss was also observed. The tree is in decline likely due to drought stress. Tree removal and replacement is recommended as the tree is not expected to improve with mitigation measures applied.

**Showing liquidambar tree #6**
