## Preliminary Arborist Report

### Cityline Block 3 South, Sunnyvale

*Prepared for:*  
**Sares Regis**  
901 Mariners Island Blvd, Ste. 700  
San Mateo, CA 94404

*Prepared by:*  
**HortScience | Bartlett Consulting**  
325 Ray Street  
Pleasanton, CA 94566

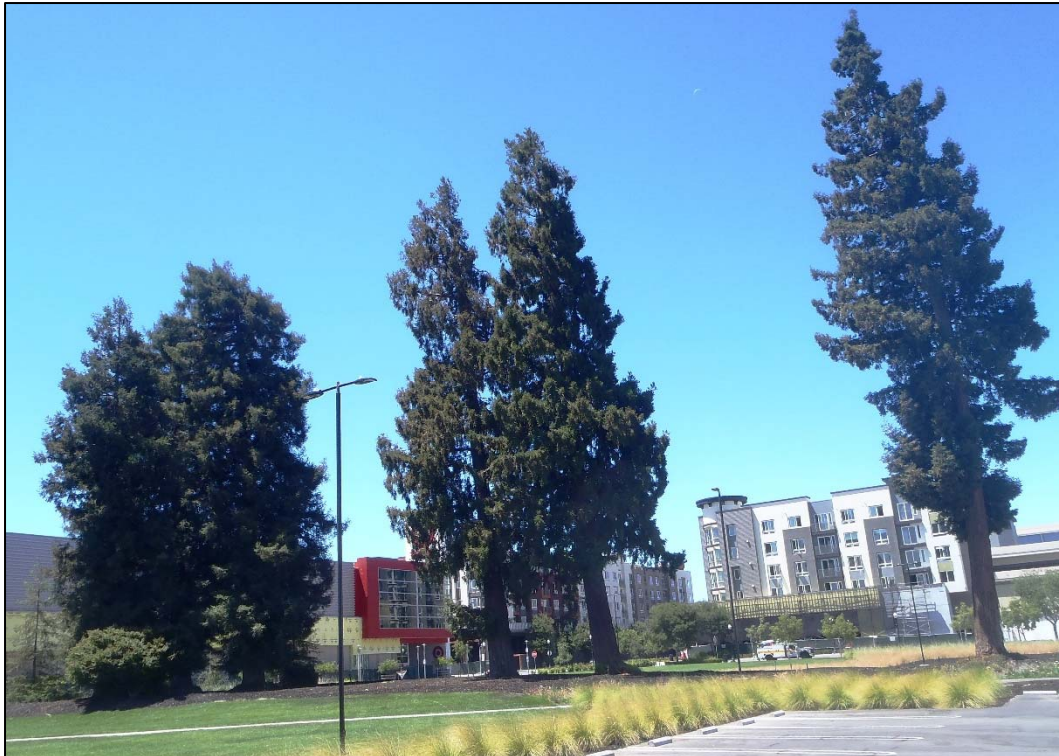
All 6 coast redwoods were mature in form and development. Trunk diameters ranged from 31" to 51" and tree condition varied from fair (trees #4 and 5) to good (#1-3 and 6). Foliar density ranged from 75% to 90% and all of the trees showed vigorous new growth. Trees #3, 4 and 5 all showed some dieback, especially in the upper crown. All of the trees had the pyramidal shape typical of the species. However, coast redwoods #1 and 2 had lost their tops, producing several new leaders at the top of trees. Coast redwood #4 had a large trunk wound on the south side where the bark had separated from the trunk. The cause of the injury was not evident.

Photo 1: Looking southwest at coast redwoods #1-6 (L to R). The trees are currently preserved in an open park-like setting, with a plan to construct an underground garage and residential units around them.

This group of 5 trees is centrally located along the southern boundary of Block 3 South, adjacent to McKinley Avenue. All 5 redwoods are proposed for preservation in their existing locations.

With the exception of tree #5, excavation for the underground garage will occur from approximately 30' to 60' from the trees, providing ample room to successfully preserve the trees. Tree #5 would be located approximately 12' south of the underground garage excavation. At this distance, some root loss will occur.

The current design for the courtyard surrounding coast redwoods #1-5 includes construction of seat walls at the limits of the planting areas surrounding the trees. I have worked with the design team to locate seat walls at the or beyond the limits of the **TREE PROTECTION ZONES (TPZ)** I defined early in the process. Where seat walls will encroach into the TPZ, grade beams or other design approaches to span the TPZ and minimize root loss will be employed.

In addition, decking will be placed around the trees within the TPZs. Again, the exact design and location of deck supports has not been finalized but alternative footings such as ground screws or diamond piers have been evaluated. I will continue to work with the design team to minimize intrusions and potential root loss within the TPZs.

Coast redwoods #1-5 are preliminarily identified for preservation, pending more information on the design of the seat walls and decking around them. Street tree #336 on S. Taaffe St. can be preserved. Preservation will require the establishment of a **TREE PROTECTION ZONE**, and other design considerations described in the **Tree Preservation Guidelines** (following page).
