JSR Micro Tree Inventory and Sidewalk Modifications

Arborist Report

JSR Micro
1280 N Mathilda Ave,
Sunnyvale, CA
94089

7/21/2020

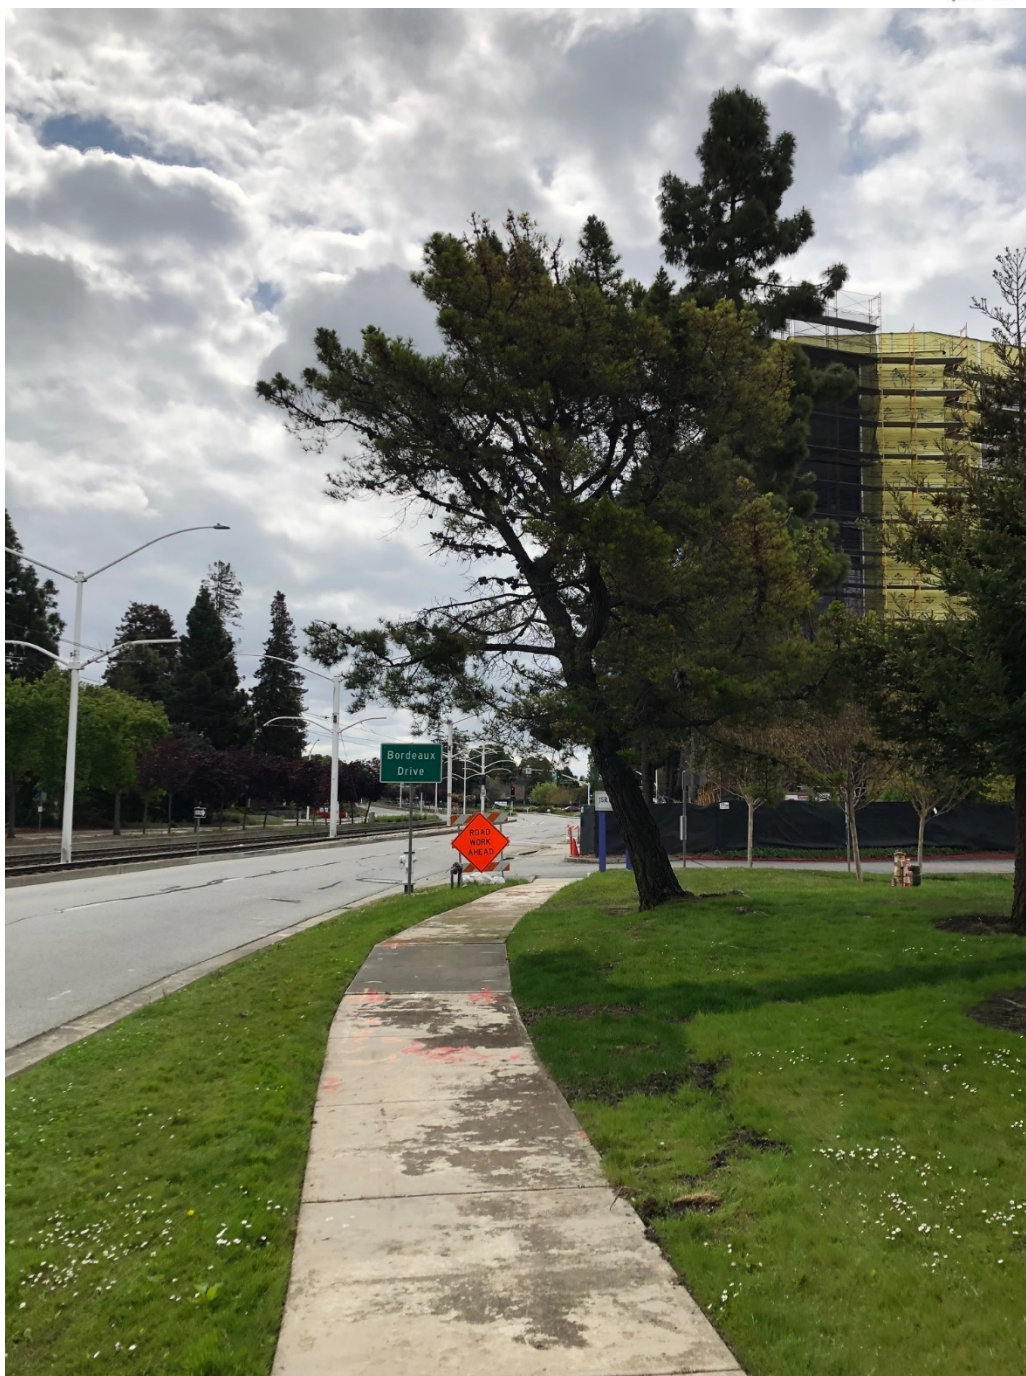
Tree #302 Aleppo pine with significant lean that would have roots cut very close to its trunk

Either these specific trees are removed prior to the project and replaced or the sidewalk designs are changed to where root pruning does not occur so close to the trees. The last option would be to continue with the current plans and evaluate the trees for how they respond over time, this last option is not advised.

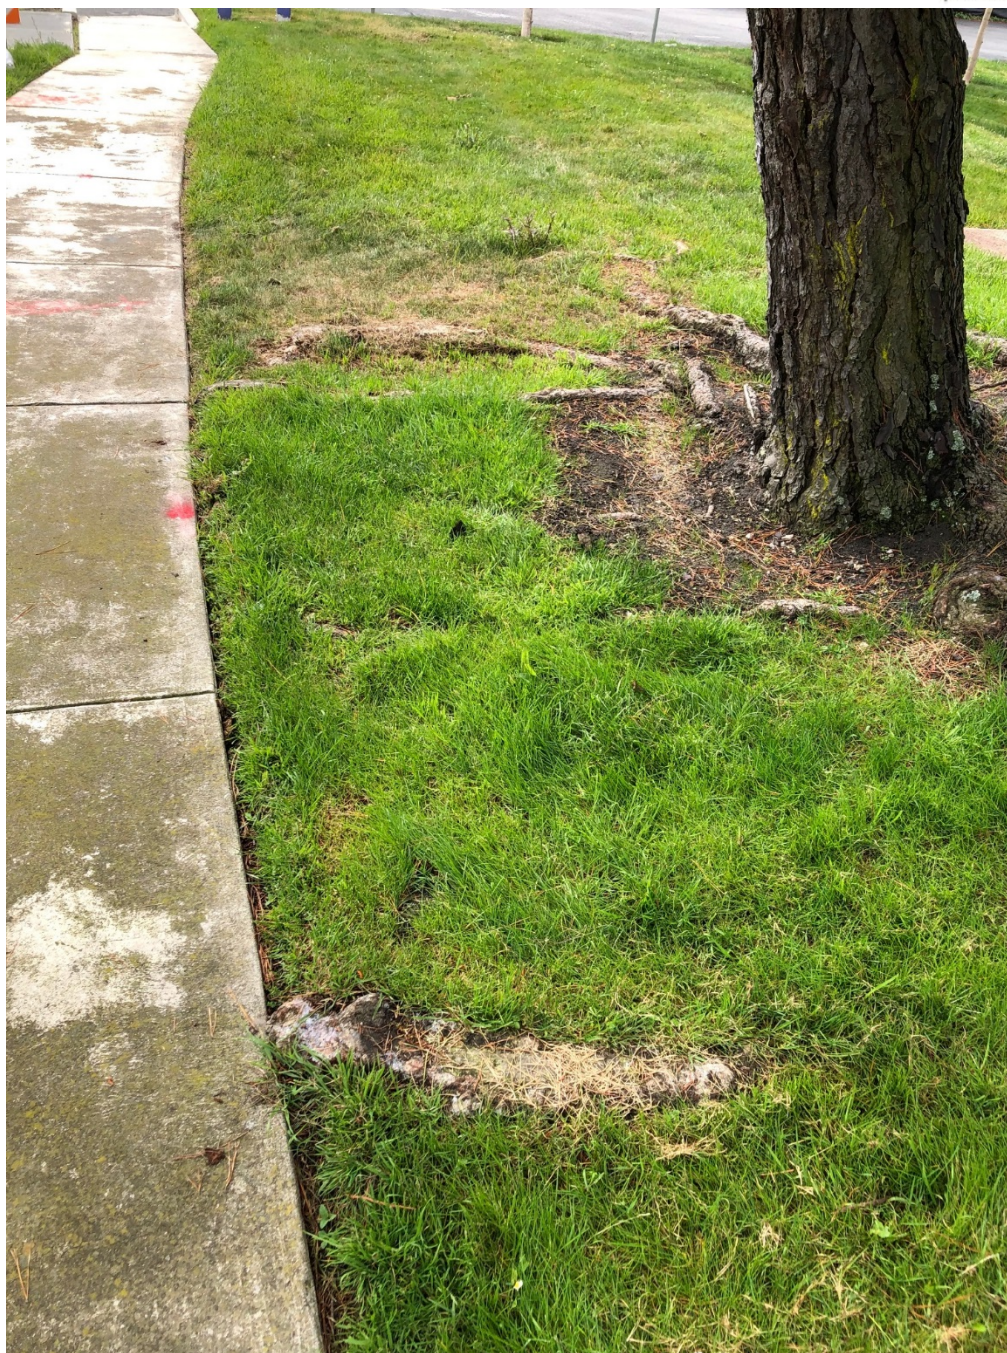
Tree #302 close up photo showing the size and amount of surface roots that would need to be cut.

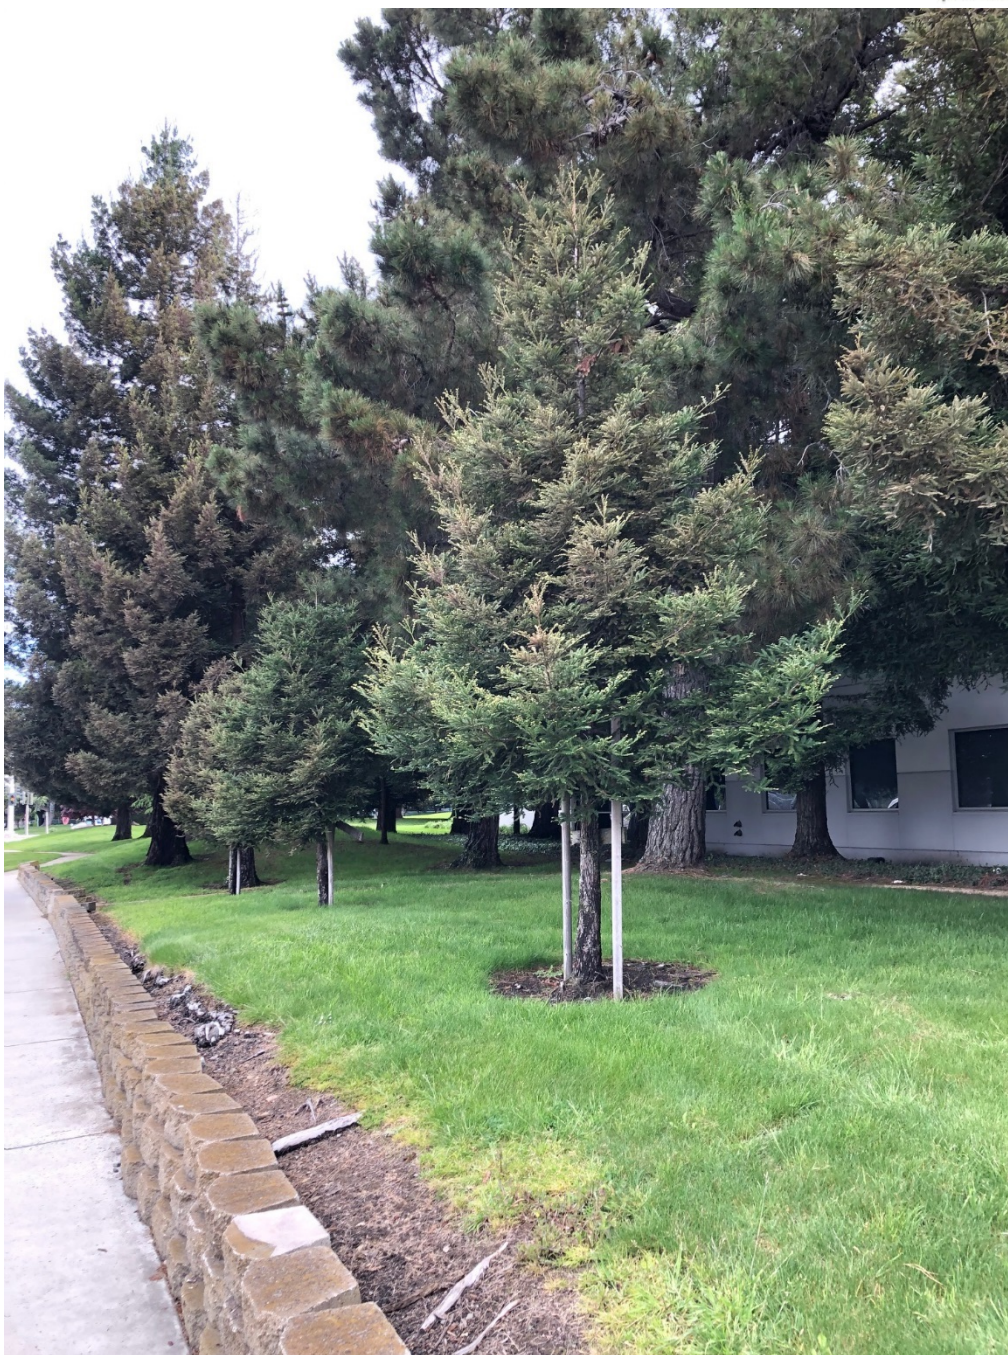
The other issue will be changes in grade. There are 8 trees on N. Mathilda growing many inches above the grade of the current sidewalk in a raised grass area lined with stacked bricks along the sidewalk. Cutting the roots will destabilize the trees and then they will also be perched on an edge directly next to the new sidewalk. The difference in grade between the trees and the sidewalk will increase the likelihood of whole tree failure for these 8 trees as an entire side of the trees would have their roots and soil removed.

Tree # 136, 141, 142 visible in raised grass area with staked bricks showing current difference in grade between trees and sidewalk

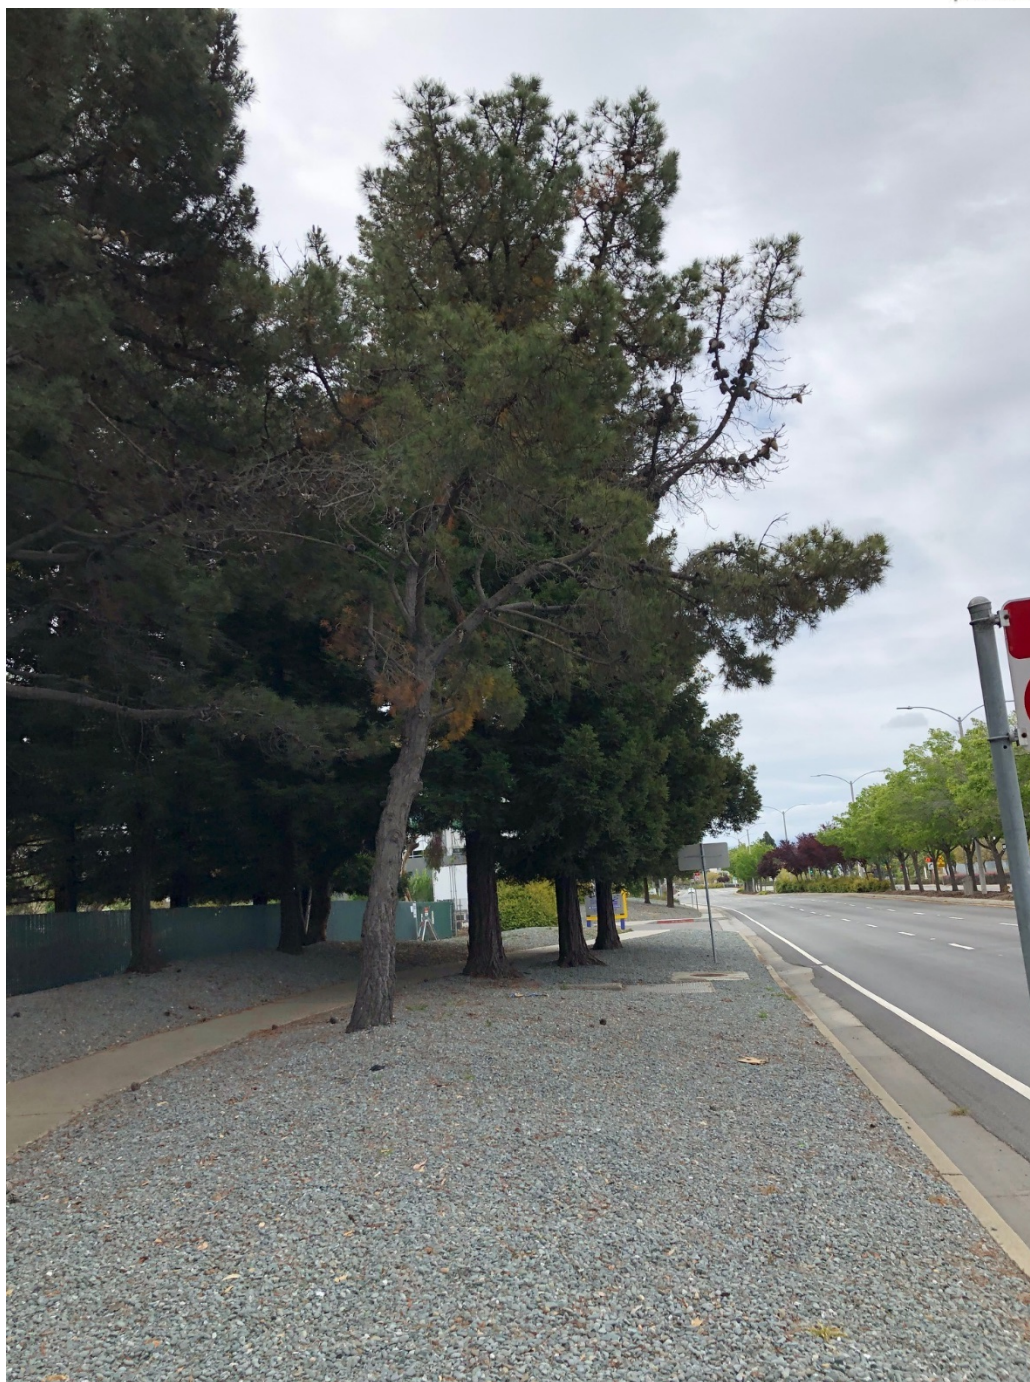
Tree #118 Monterey pine. Tree is infected with bark beetles. Orange flagging on lower branches is an indicator of bark beetles and the trees health decline

The 4 Monterey pines that are shown on the BFK Engineering maps with an X through their tree point have been slated for removal due to the significant bark beetle infestation that has gone past the point of saving the trees. These trees are showing signs of decline in the form of orange flagging/dead branches throughout their canopies and numerous pitch tubes at the bases of their trunks. The trees will not survive the infestation and there are no treatment measures that would eradicate the beetles and increase their vigor. The trees should be removed.

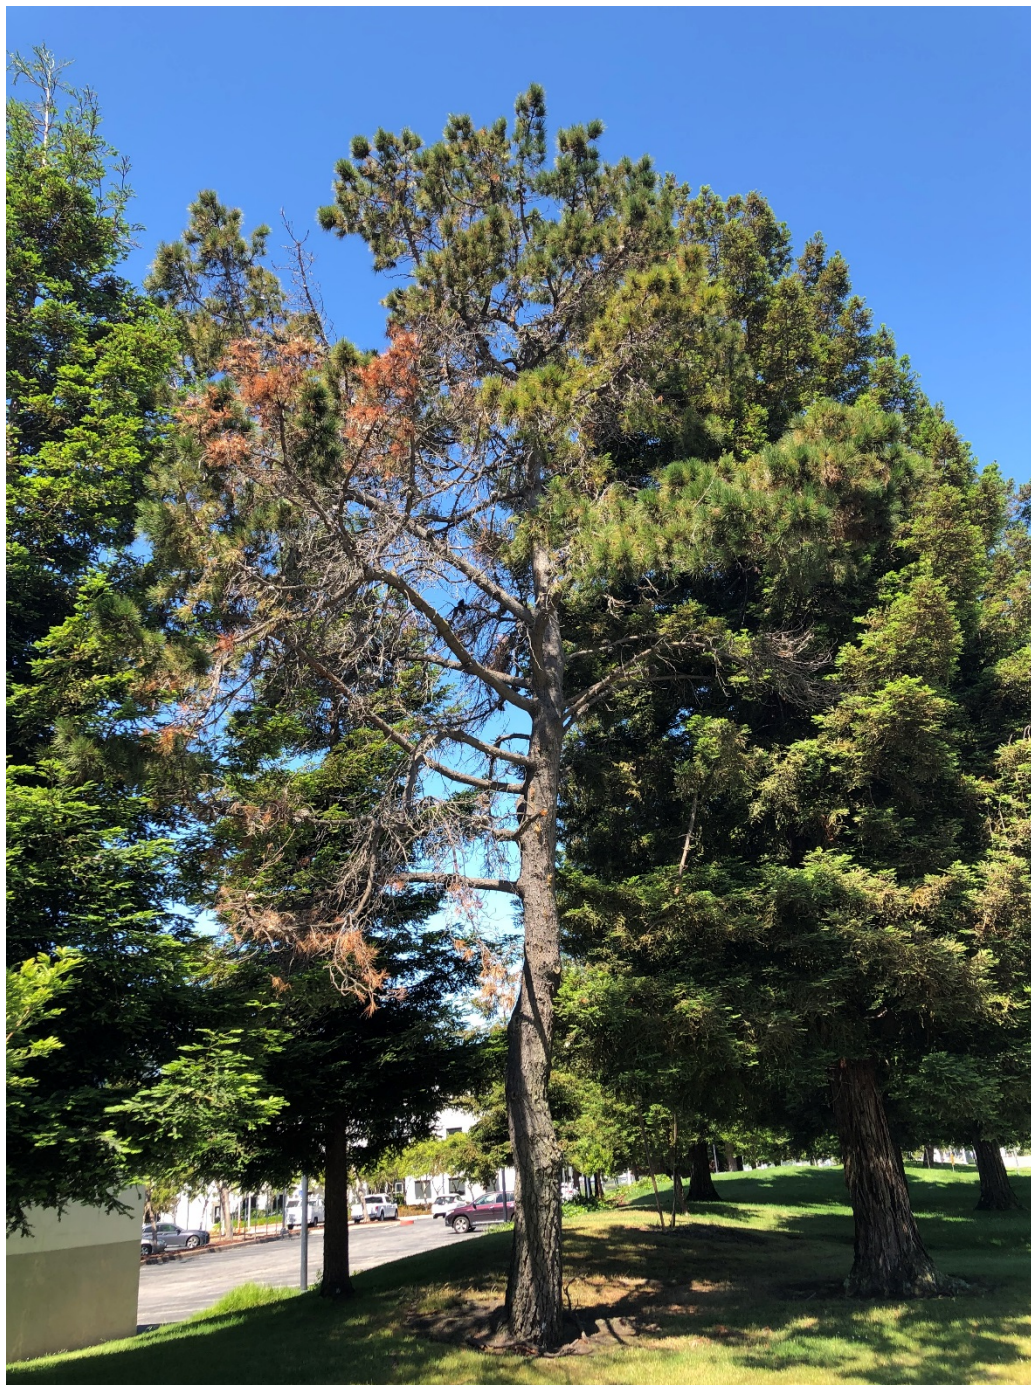
Tree # 306 Monterey Pine. Tree is nearly dead from bark beetle attack.
