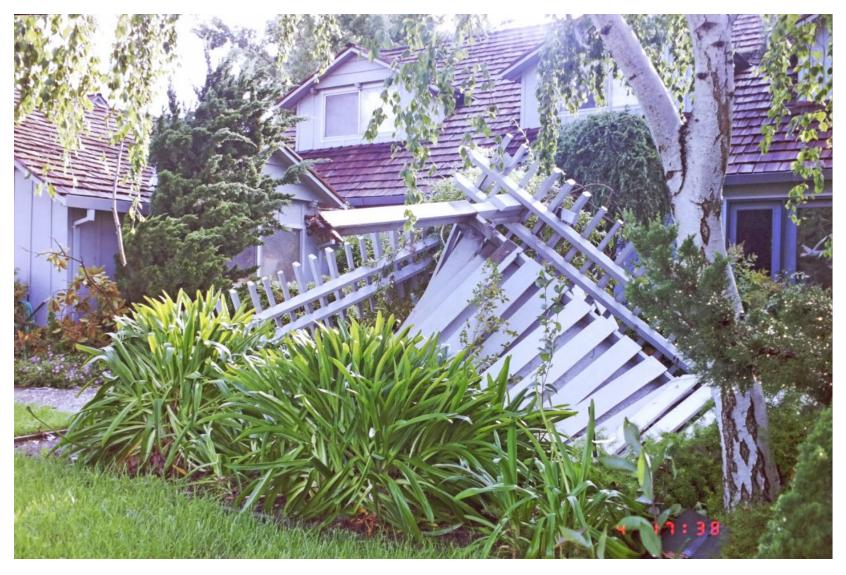
Tornado Damage in 1998

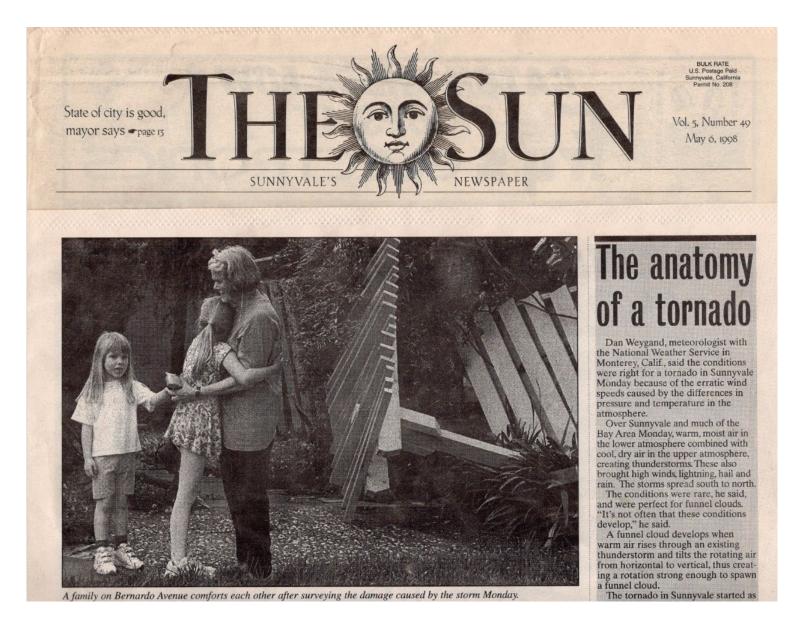
Tornado Damage in 1998

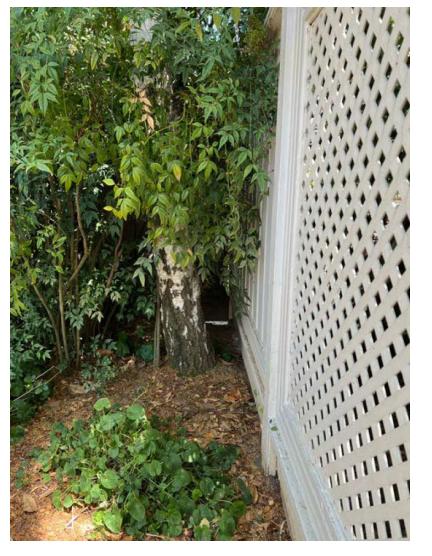
Tree within One Feet of Fence (Inside)

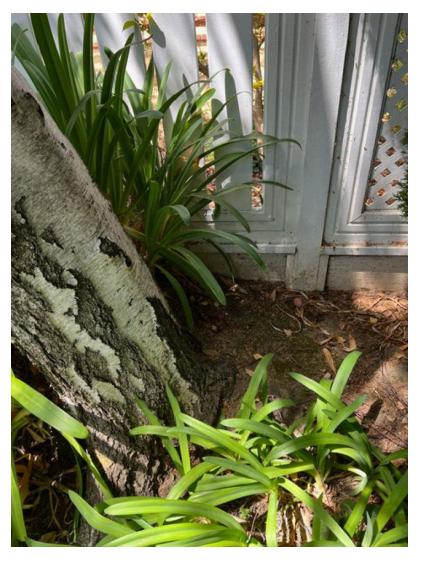
Tree within One Feet of Fence (Outside)
