Sunnyvale

# Sunnyvale Fire Station Master Plan Study Session 21-0534

Chip Taylor, Director of Public Works  
September 28, 2021

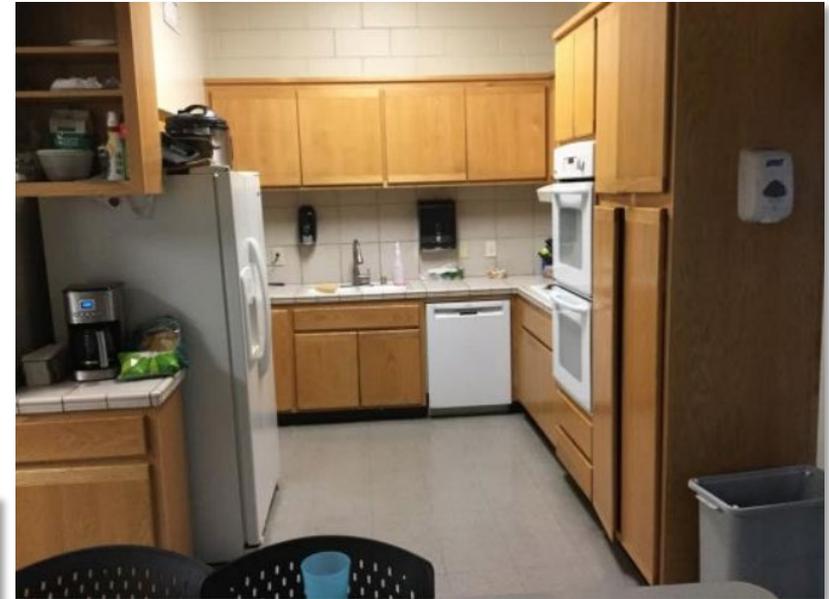
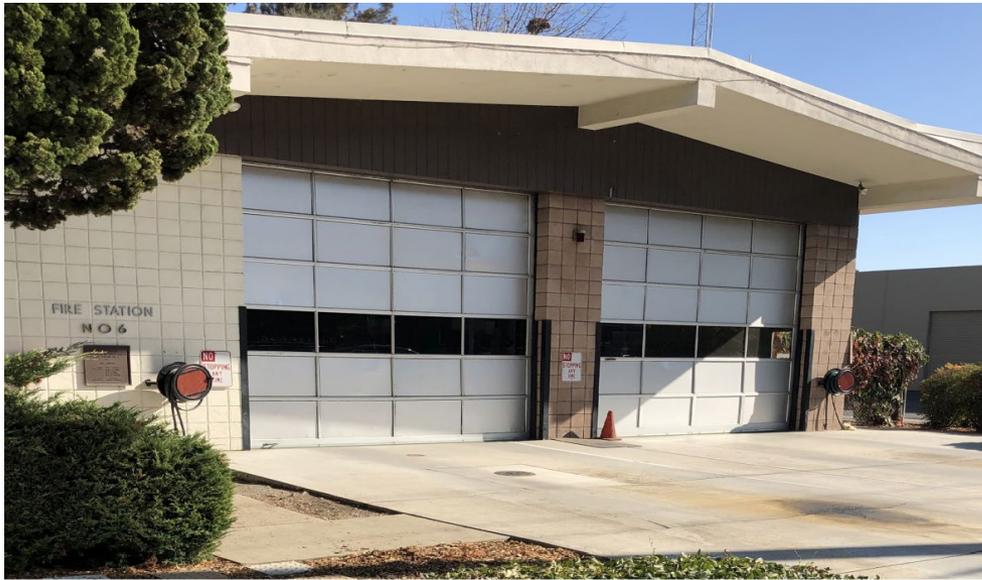
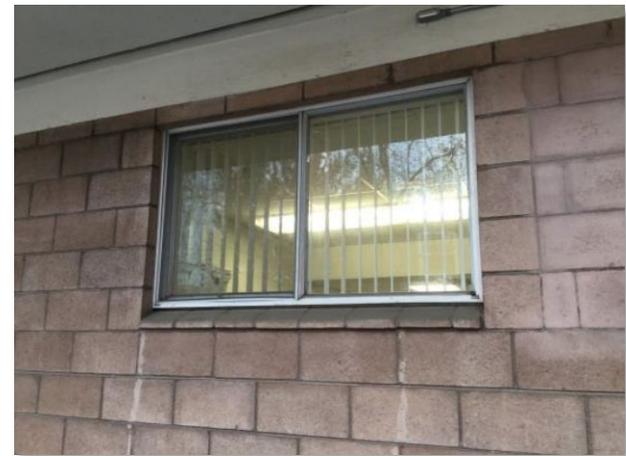
- 6 Stations, Built in 1960s (except Station 5)
- Wood frame and concrete block buildings
- Generally well maintained

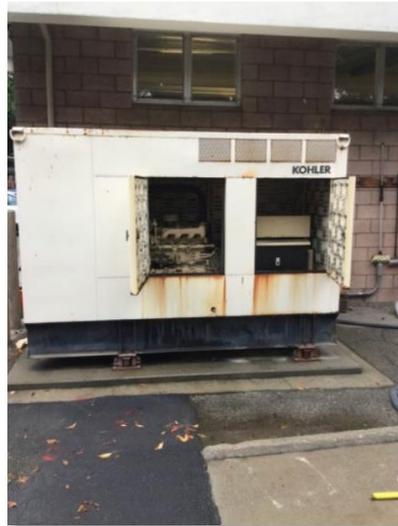
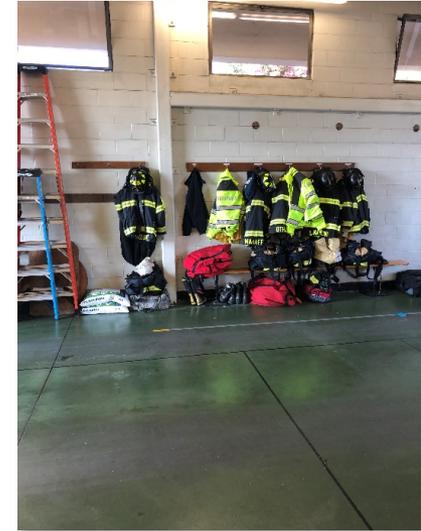
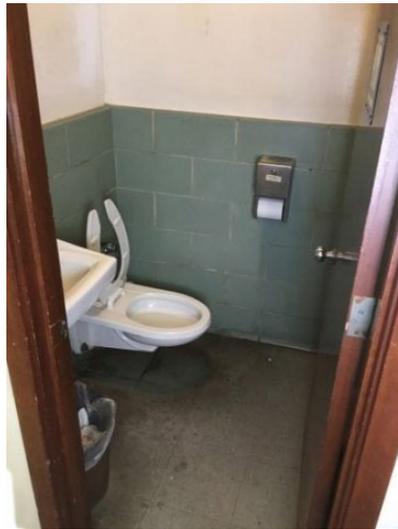
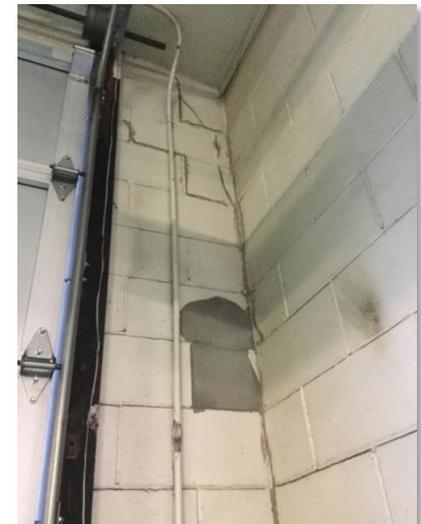
- Outdated electrical distribution systems
- Inadequate apparatus rooms
- Lack of PPE Turnout Storage rooms
- Fire services have evolved requiring different equipment
- No locker room for female fire fighters at the training center
- Ineffective ventilation
