City of Sunnyvale

Notice and Agenda - Final Heritage Preservation Commission

DRAFT
DESIGN GUIDELINES
FOR
MURPHY STATION
HERITAGE LANDMARK
DISTRICT
April 2019 Version

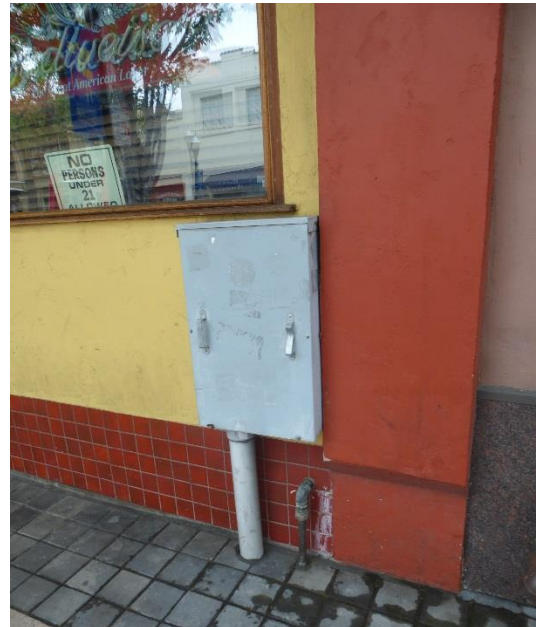
Above: Electrical box and conduit that distract from the buildings architectural features.

- Conduit and meters should be minimized at Murphy Avenue façade and priority given to relocating these (if possible).
- Consider enlarging (restoring) size, shape and configuration of storefront windows. Uncover door windows.
- Paint electrical panel on Murphy Avenue façade to match building.
- Remove ATM signs on the awning (not allowed).
- Replace entry doors with a door type that is more compatible with the building and the District.

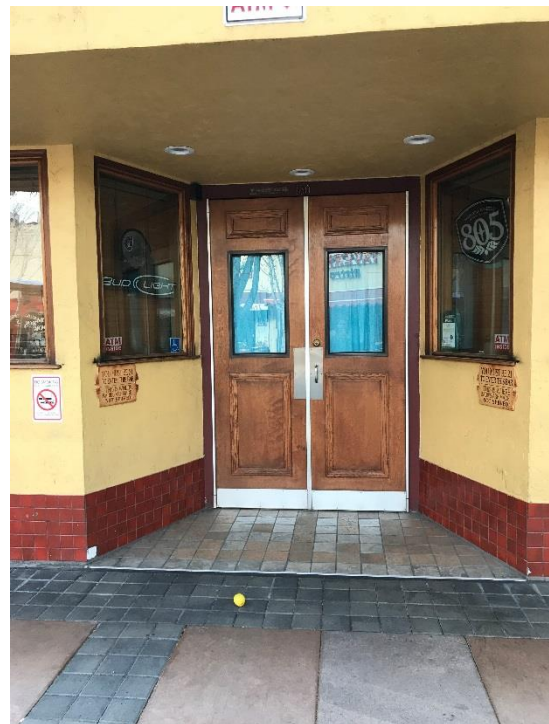
Above: Current entry doors are not historic and could be replaced with doors that are more in keeping with commercial buildings of this era

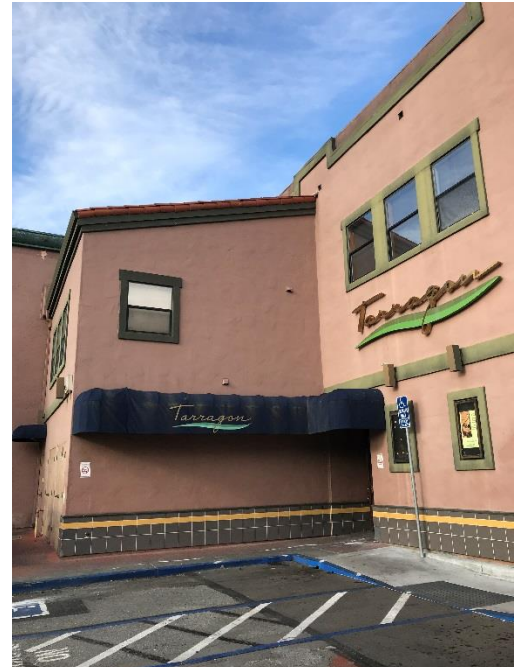
Above: The rear façade has an awkwardly placed awning that should be reconfigured or removed.

- Future modifications to the building should strive to contribute more to the character of the overall District
- Remove the current awning and replace with one that is more compatible with the building and the District (e.g. an awning that spans across the front façade).
- Remove/reconfigure rear awning.
- Consider a change in color scheme by lightening the main paint color and using a darker color for the accents and trim.
- Consider removal of the tile from the second level roof to make the building more compatible with adjacent structures, and contribute better to the District.
- Ensure consistent building trim colors on front and rear facades.
- Replace marble base with a tile base that is more compatible with the District.

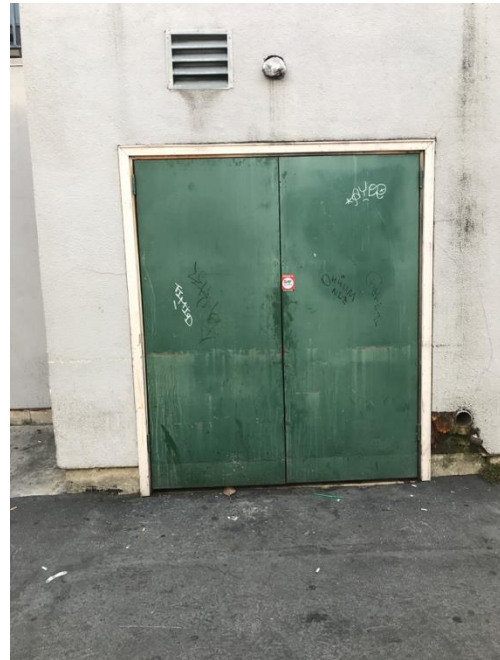
Above: Rear doors require repair and improvement.

- Conduit and meters should be minimized at Murphy Avenue façade and priority given to relocating these (if possible).
- Install smaller tile at the base; the tiles currently employed are over-scaled for this feature.
- Carry compatible colors over from the first floor to the second floor/mezzanine.
- Consider exterior lighting (e.g. gooseneck lamps) on the second floor front façade (around sign).
- Improve rear doors and surrounding wall.
- Remove graffiti from trash enclosure at rear of building.
- Refrain from using the second story deck as a storage area: storage should be contained within the building.

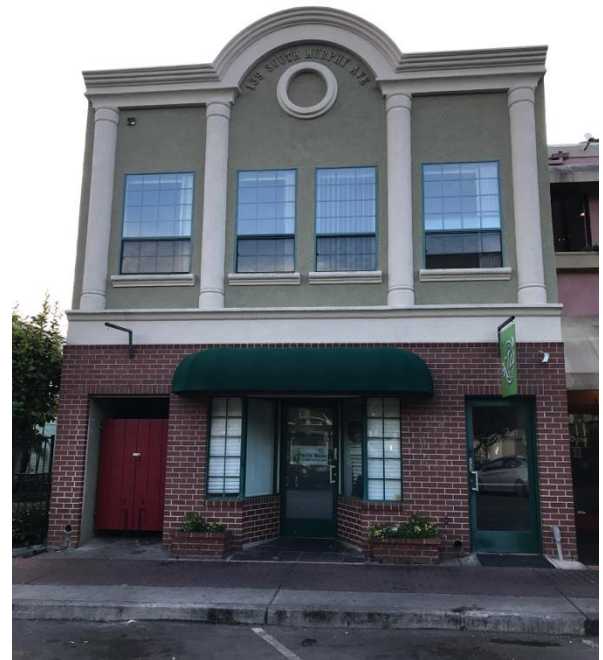
Above: Rear elevation with varying materials that do not provide a uniform or consistent appearance.

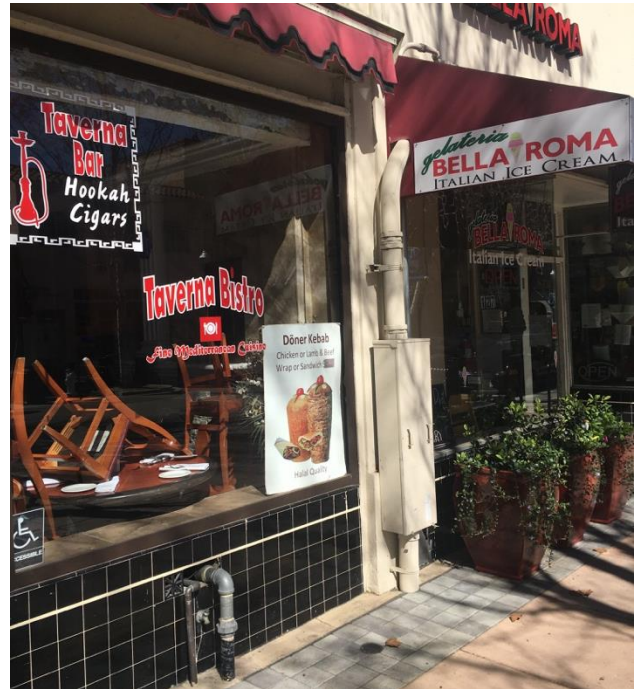
Above: Piping and conduit that distracts from the buildings architectural features.

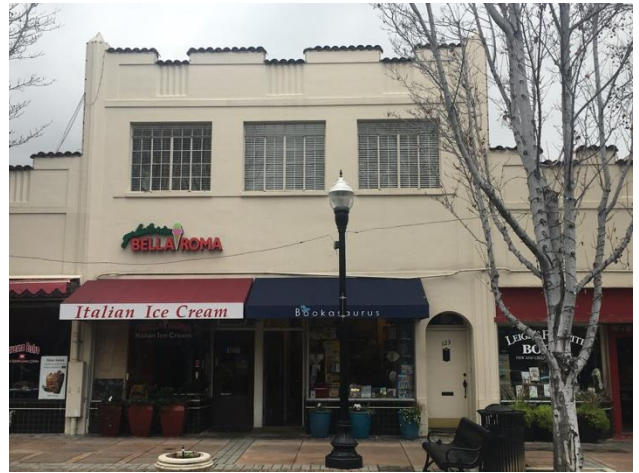
Above: The awnings on each storefront are different colors, sizes and materials. Uniformity of the awnings in shape, size and material could be considered.

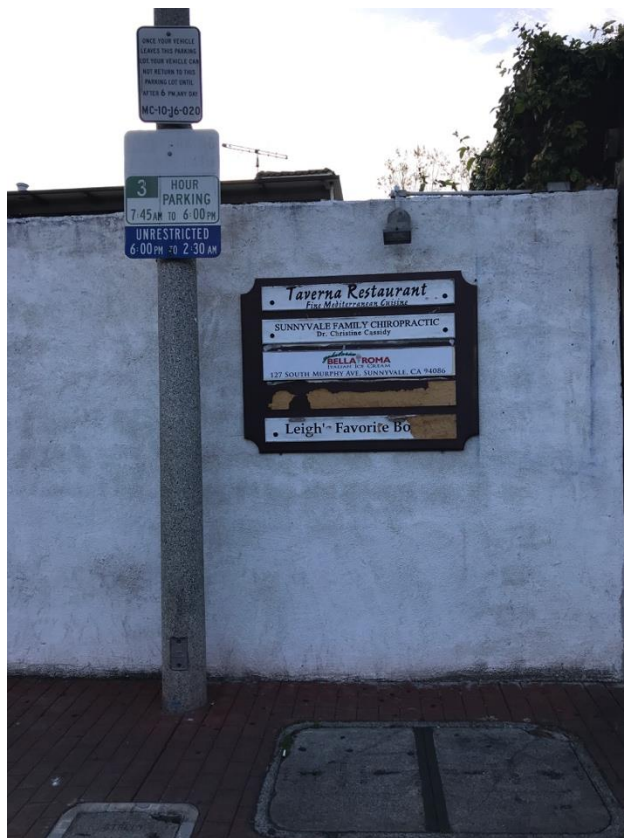
Above: The rear wall and rear façade of this building would benefit from repairs, signage improvements and fresh paint.

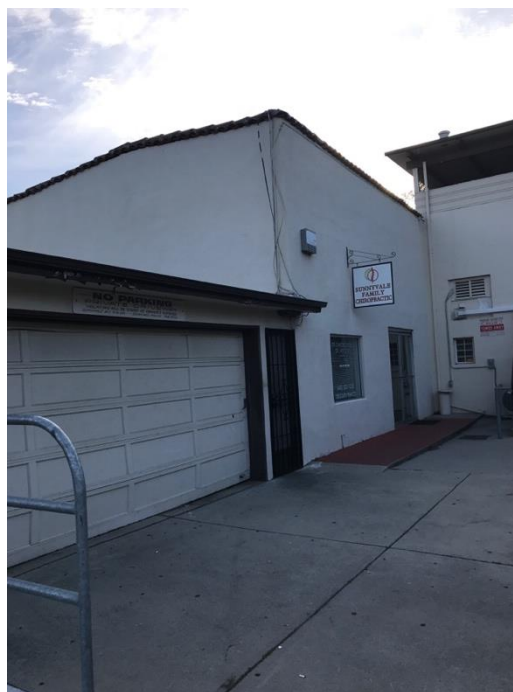
Above: The rear wing and garage are in need of repair, paint and on-going maintenance.

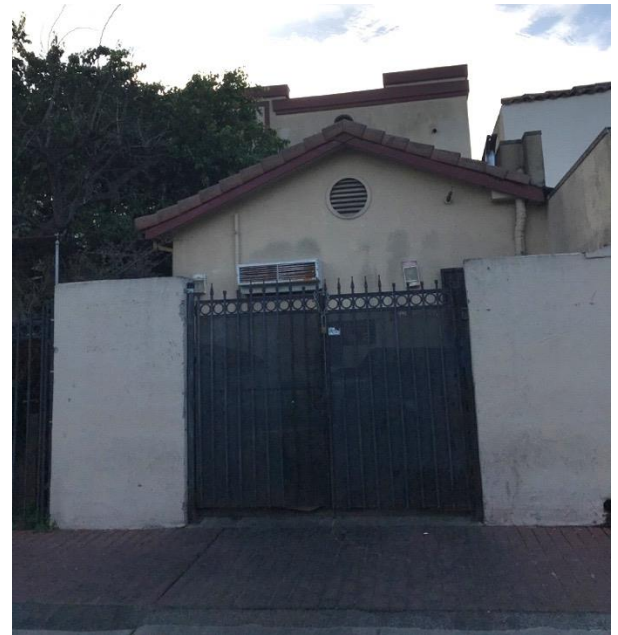
Above: A view of the rear elevation showing the metal gate and lack of design details or interest to engage the pedestrian at this side of the building.

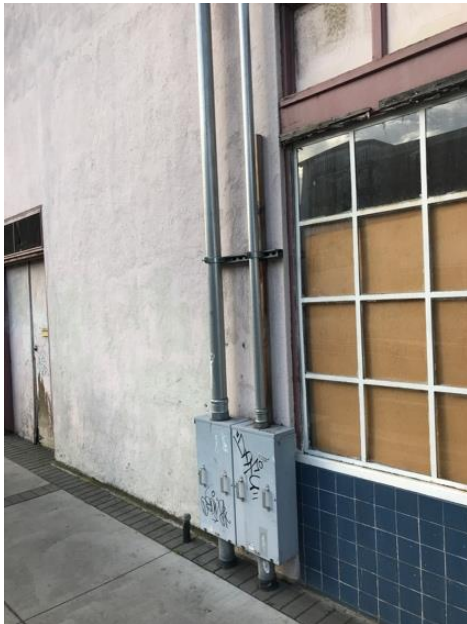
Above: Detail of utility boxes mounted at elevation.

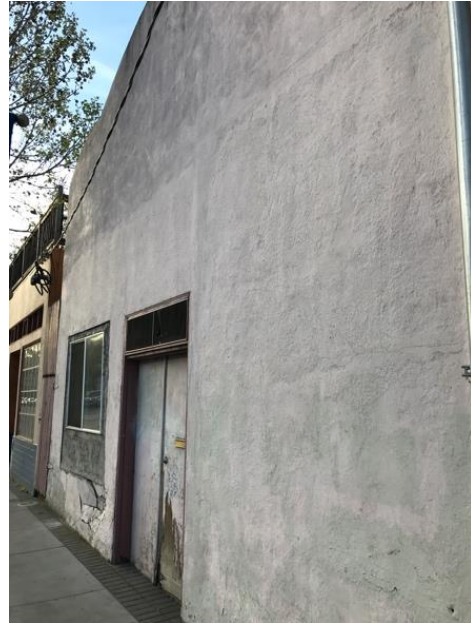
Above: View of required repairs to stucco, windows and doors at the Evelyn Avenue façade.
