September 14, 2016 - DRAFT
Carey & Co. / a TreanorHL Company

Project Analysis for Adherence to
The Secretary of the Interior's Standards for the Treatment of Historic Properties

221 North Mathilda Avenue Sunnyvale, CA

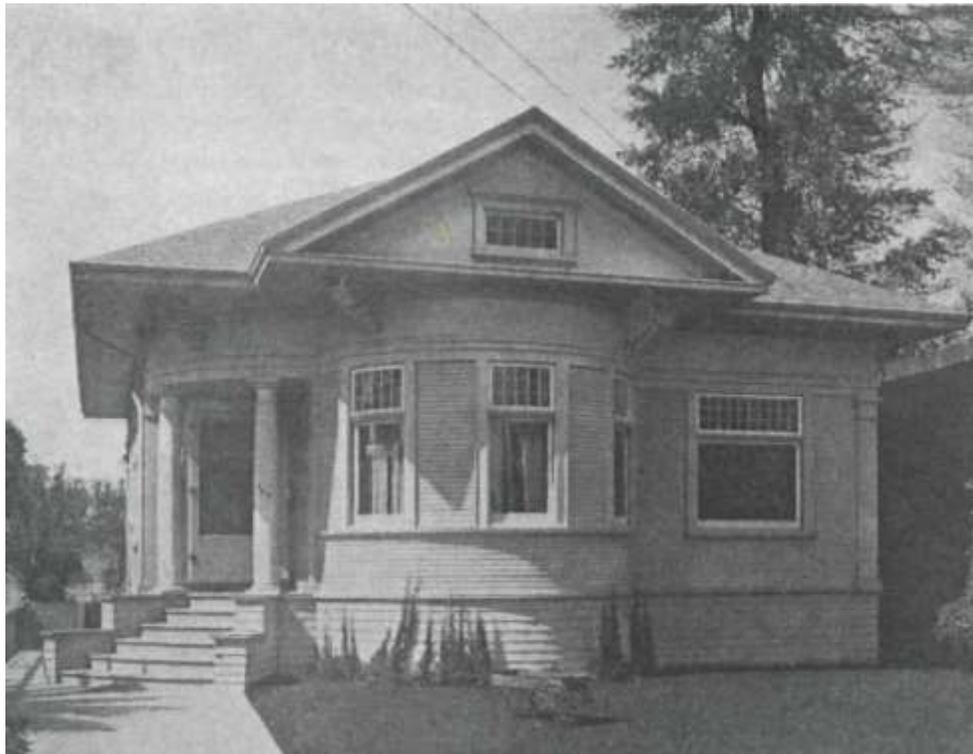
fig. 1. Photograph of the front elevation in 1907

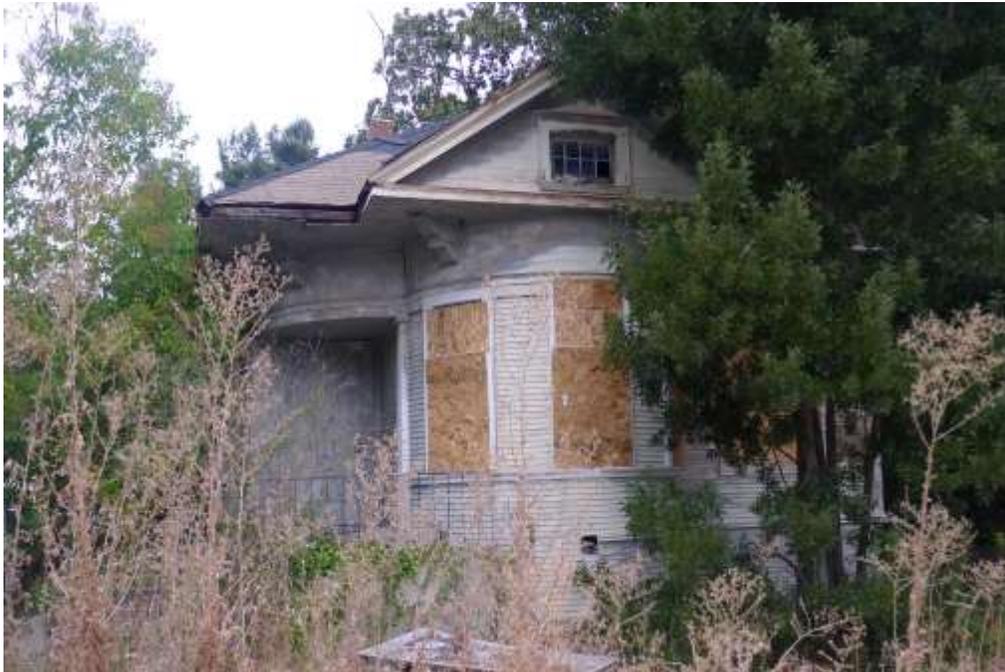
The walls are vertically divided into a three part composition with a 4 foot high base clad in narrow teardrop siding capped with a water table molding. Above the base is the "field" or main wall area containing the windows, also clad in teardrop siding. This portion ends at the window heads in a narrow molding. The uppermost section of wall is between the window head and soffit, and is a fascia clad in a flush tongue and groove siding creating a flat surface. The intersection of the wall and soffit is articulated with a dentil molding. The corners of the house and the porch opening are defined by Tuscan pilasters which bear on the water table molding and end at the window head line. Additional ornament includes three console brackets between the wall and soffit - one centered on the porch, and two at the curved bay. The windows serving the main rooms also have a three part division with the top third being fixed multi-lite sash and the bottom two thirds being single lite moveable sash. The attic pediment contains a multi-lite window, and the rear of the house contains one over one double hung windows. The windows throughout are surrounded with molded trim and sills. At the rear of the house is a deteriorated wood entry deck serving the back door (figs. 1 & 2).

fig. 2. Photograph of the front elevation in 2016

- Roof - Repair deteriorated framing as required. Install new wood shingle or composition shingle cladding, depending upon fire code requirements. Replace missing or deteriorated wood gutters in-kind with material and profiles to match the historic condition.

- Windows - Retain historic glazing. Remove windows for repair and installation of new glazing compound.. Reinstall windows and make all moving sash operable.
- Walls - The walls are generally in good condition. Where damaged or deteriorated the wood siding will be replaced in-kind with matching materials and profiles. A non-historic door on the north elevation will be removed and the opening patched with in-kind wood siding.
- Painting and Ornament - The house has many layers of paint that in particular obscure the details in the architectural ornaments and moldings. The original paint will be carefully removed with particular care given to ornamental elements to preserve the definition of their forms. The house will be primed, patched and repainted (figs. 5, 6, 7 and 8).

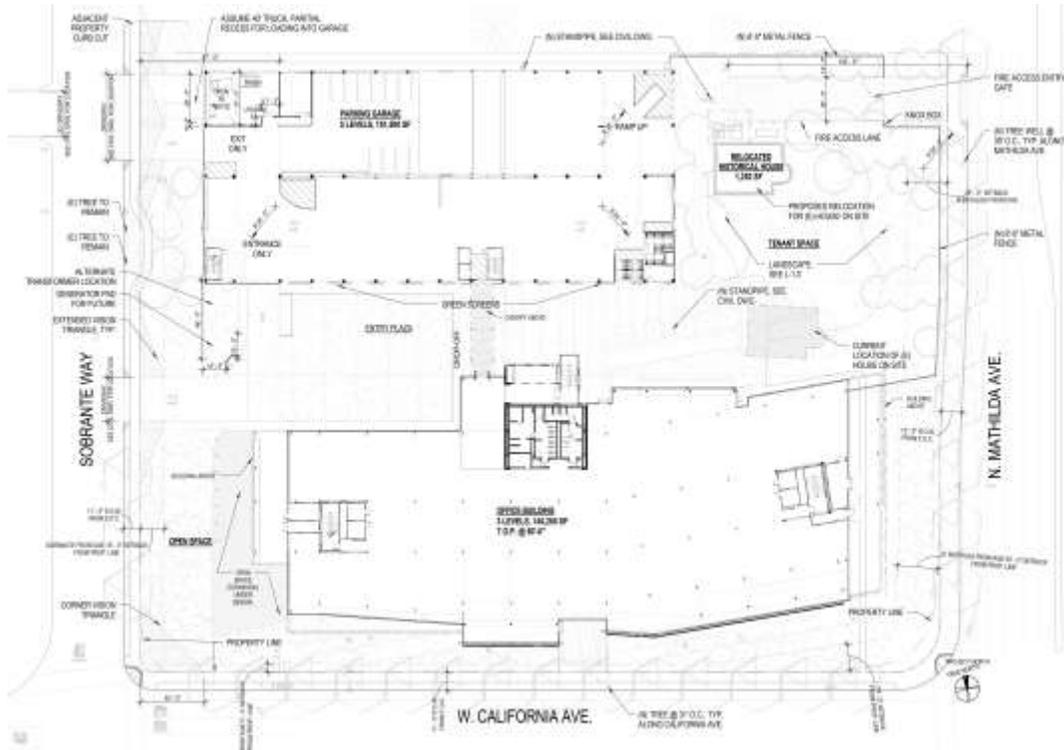
fig. 3. Site Plan showing full site development. The historic house is at the upper right.

- Move the house to its new location and pour new foundations providing seismic resistance and code compliance. Repair understory framing as required. The new foundations will be designed so as not to impinge on the root systems of the trees which will remain on site.
- Remove the existing brick chimney. Construct a brick veneer chimney above the roof line at the original location to serve as a mechanical vent. The chimney will match the height and dimensions of the original.
- Abandon and demolish the existing, non-historic concrete porch, steps and iron railing. After the move, construct a wood porch and steps and install two Tuscan columns following the plan and photograph published in 1907.
- Abandon and demolish the existing, non-historic back entry steps and deck. After the move, construct a new accessible, A.DA - compliant back entry deck (figs. 3 & 4).

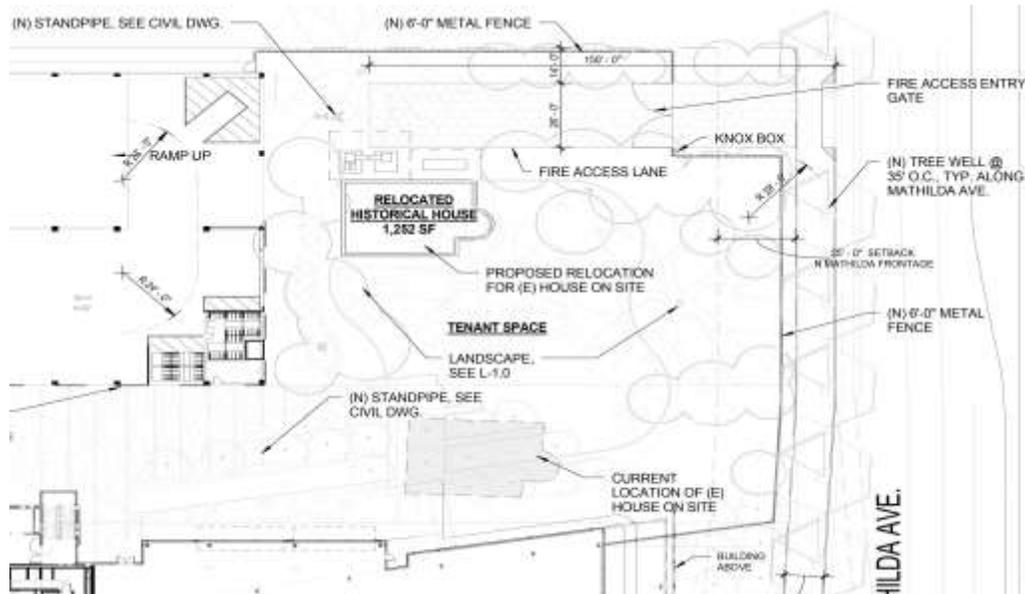
fig. 4. Site Plan detail showing the existing and proposed historic house locations

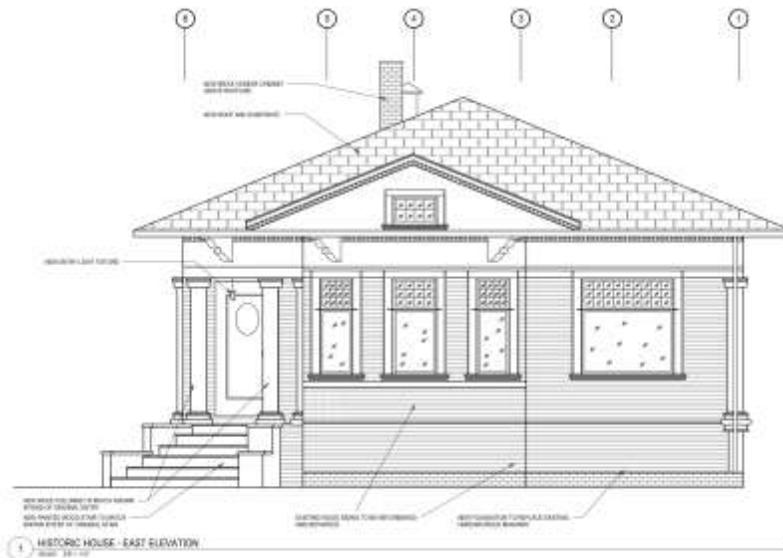
fig. 5. Front or East Elevation facing North Mathilda Avenue showing restored porch

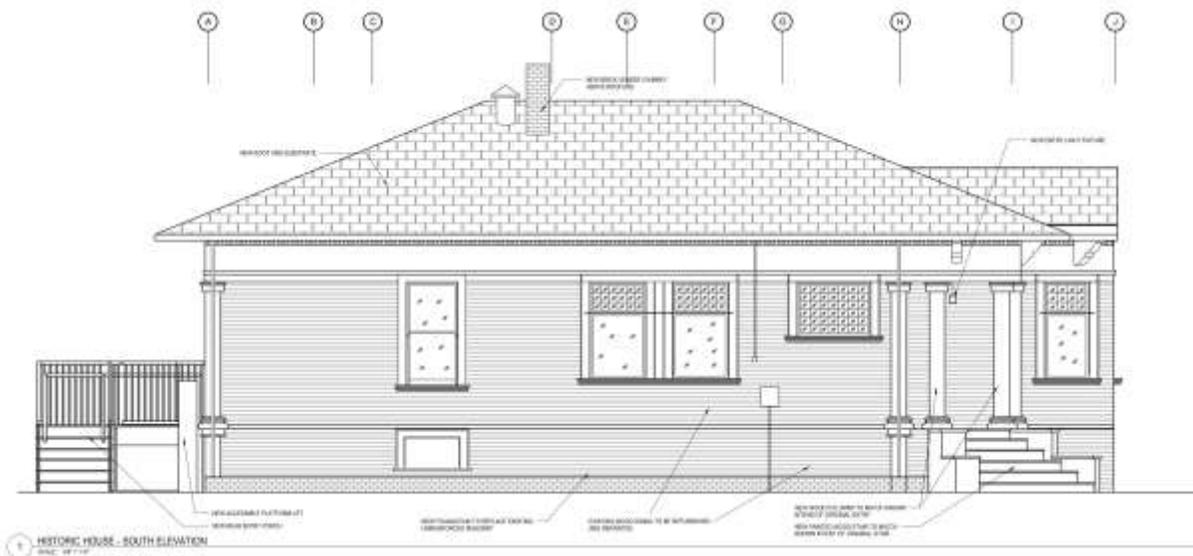
fig.6. South Elevation facing North Mathilda Avenue showing restored porch

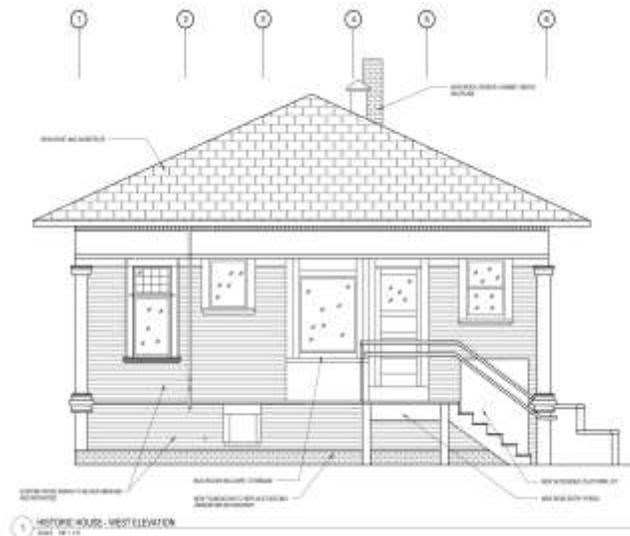
fig. 7. Back or West Elevation showing new entry deck and accessible lift (to right).

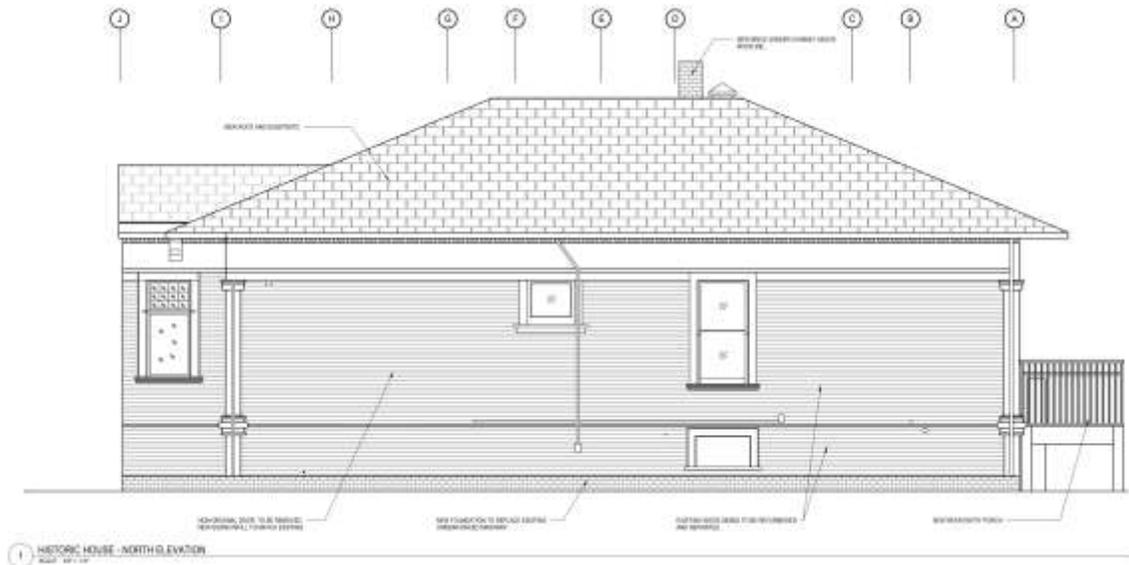
fig. 8. North Elevation showing new entry deck (to right)

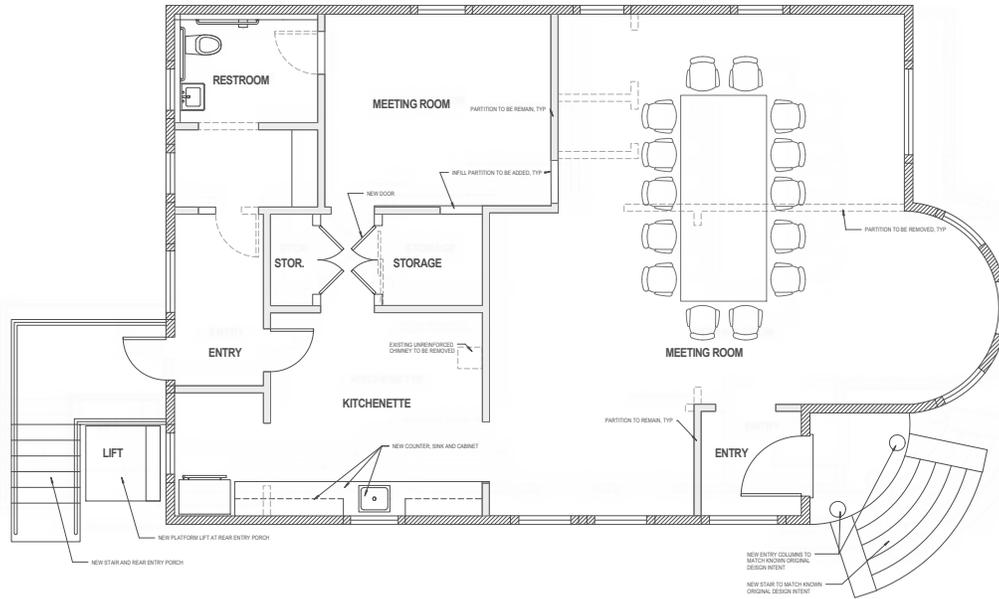
fig. 9. Plan showing interior alterations

- Wood stud wall framing will be repaired as required. There is no ornamental plaster on the interior giving the opportunity for seismic strengthening using plywood shear panels applied to the inside of the walls. Walls will be patched to match adjacent plaster.
- The east-west wall dividing the parlor and curved bay, and the adjacent room to the north will be removed to create a single, meeting room (fig. 9).
- Several walls at the back of the house will be reconfigured to better meet accessibility requirements, and to provide accessible toilet facilities.
- Interior doors and their hardware will be retained and reused where feasible..
- All existing light fixtures are non-historic. There will be new lighting throughout.
