RESOLUTION NO. _____

A RESOLUTION OF THE CITY COUNCIL OF THE CITY OF SUNNYVALE UPDATING THE MURPHY AVENUE DESIGN GUIDELINES, NOW TO BE KNOWN AS THE DESIGN GUIDELINES FOR THE MURPHY STATION HERITAGE LANDMARK DISTRICT, AND FIND THAT THE ACTION IS EXEMPT FROM CEQA

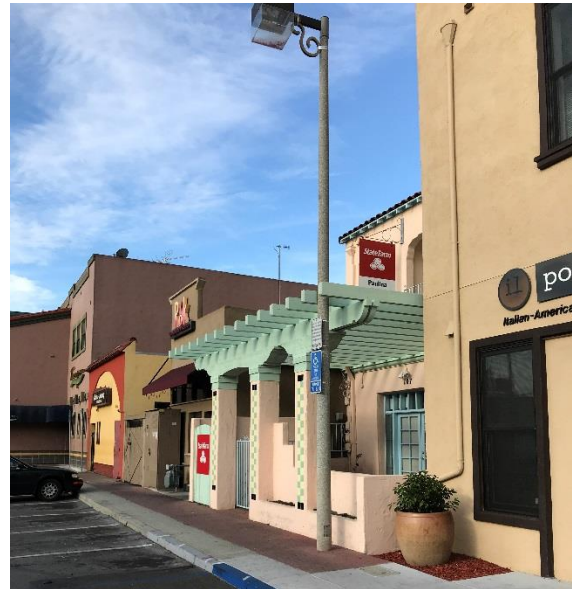
Above: Rear elevation from parking lot

Below: Unpermitted State Farm sign on rear elevation

- Conduit and meters should be minimized on the Murphy Avenue façade and priority given to relocating these (if possible).
- Remove unpermitted signage (State Farm) on the rear façade/gate of the building.
- Replace awning on front facade.

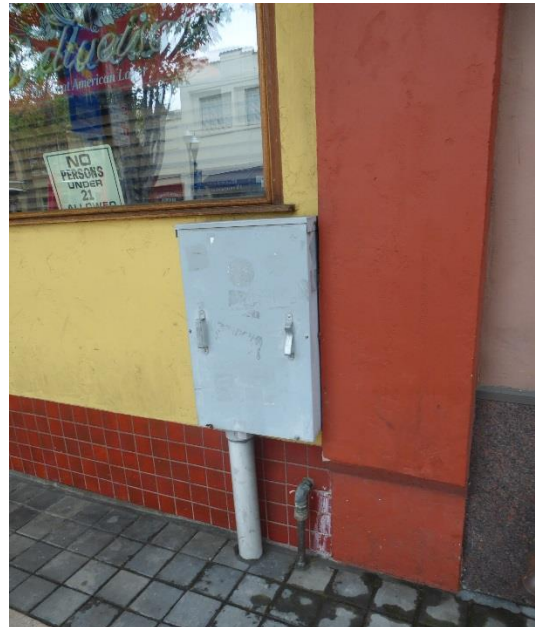
Above: Electrical box and conduit that distract from the buildings architectural features.

- Conduit and meters should be minimized at Murphy Avenue façade and priority given to relocating these (if possible).
- Consider enlarging (restoring) size, shape and configuration of storefront windows. Uncover door windows.
- Paint electrical panel on Murphy Avenue façade to match building.
- Remove ATM signs on the awning (not allowed).
- Replace entry doors with a door type that is more compatible with the building and the District.

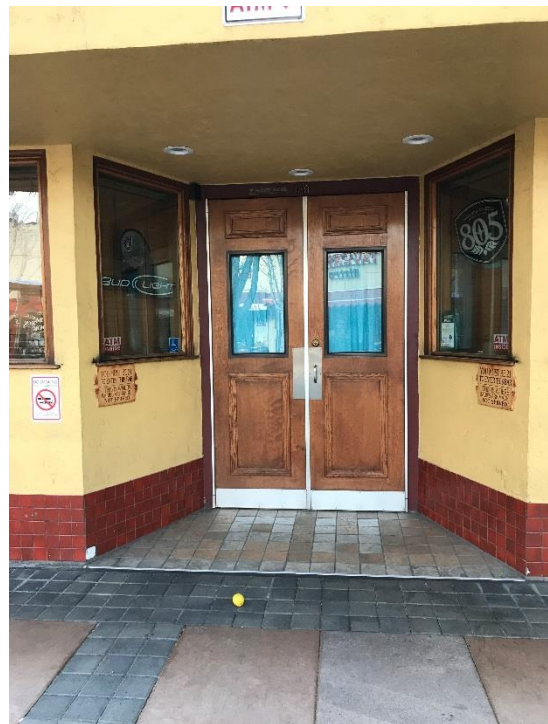
Above: Current entry doors are not historic and could be replaced with doors that are more in keeping with commercial buildings of this era

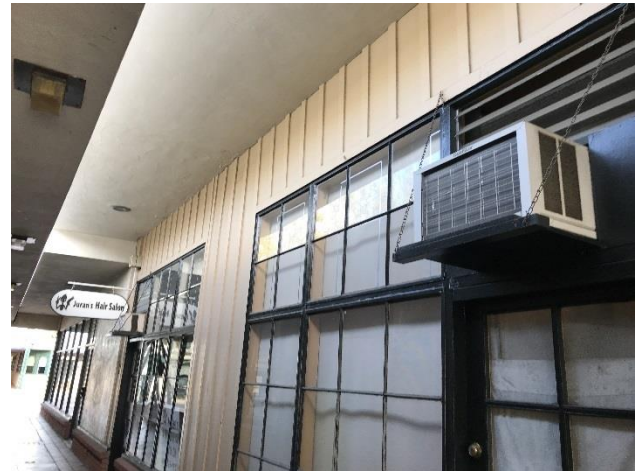
Above: Overdoor AC unit in breezeway.

- Strive to make the building more compatible with the character of the District with future modifications.
- Redesign façade and storefront doors to be consistent with the District (e.g. recessed entryway).
- Remove stucco parapet as it is not compatible with the building due to its height, material and use of triangular element. Replace with a parapet design that is more compatible with the District.
- Replace current awning with an awning that is more angular; curved awnings are not compatible with this type of storefront.
- Remove tile accents from wall.
- Remove and relocate air conditioning units from doorways along breezeway.
- Enhance and activate the breezeway through future modifications.

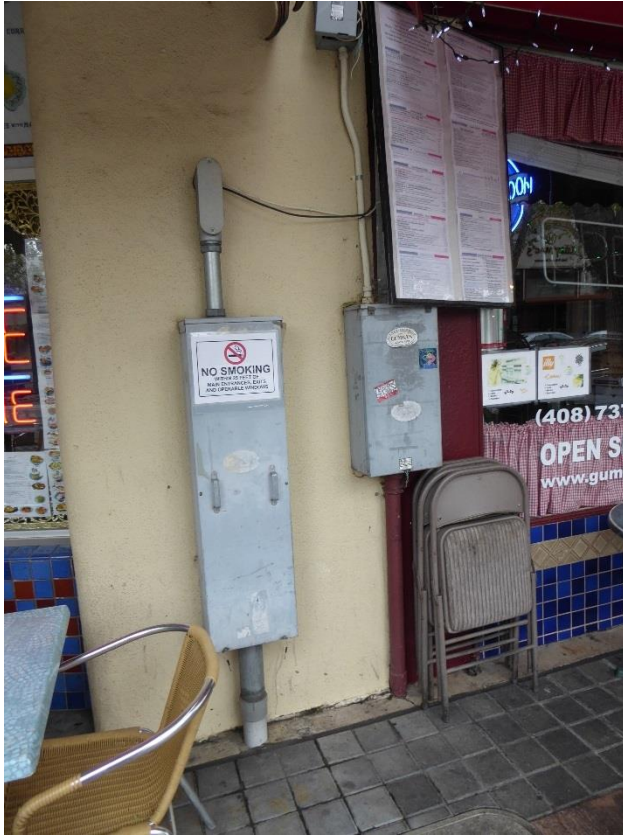
Above: Detail showing meters and conduit applied to exterior of building.

- Future modifications to the building should strive to contribute more to the character of the District.
- Replace faded awning.
- Restore transom window over doorway.
- Replace door with one that is more compatible with the District.
- Extend tile base across the entire front façade (except doorway).
- Minimize Conduit and meters on the Murphy Avenue façade and relocated (if possible).
- Per existing planning approval, remove existing rear structure and provide trash enclosure/storage that is consistent with the building and District.
- Remove potted trees on rear side of building, currently in plastic buckets from the nursery.

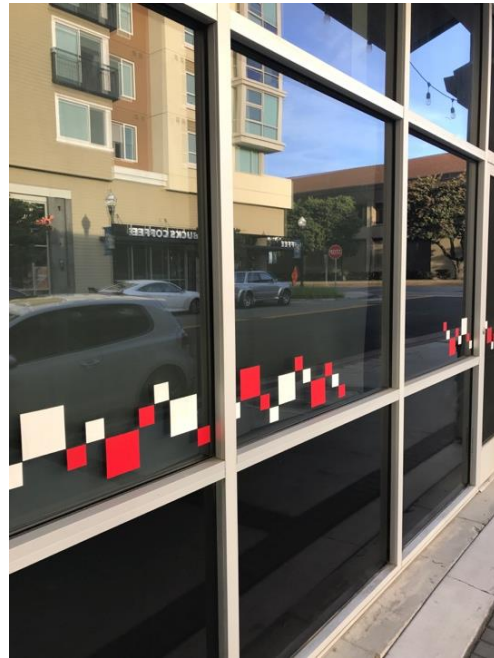
Above: A detail of the tinted windows on Frances Street.

- Conduit and meters should be minimized at Murphy Avenue façade and priority given to relocating these (if possible).
- Replace tinted windows at storefront with clear glass.

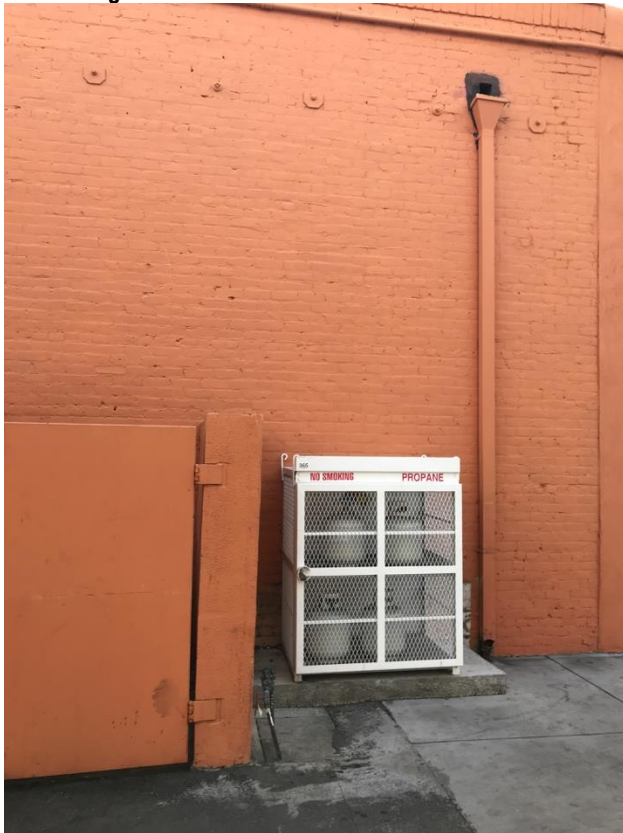
Below: The side elevation at the alley. Note the propane tank storage which is not recommended to continue.

- Maintain paint coatings at the upper story window surrounds and sills.
- Remove propane tank storage from alleyway off Washington Avenue.
- Replace windows on one-story Washington tenant space to a style that is more compatible with the District/building. The current windows are too contemporary.
- Remove gateway structure at rear of building.

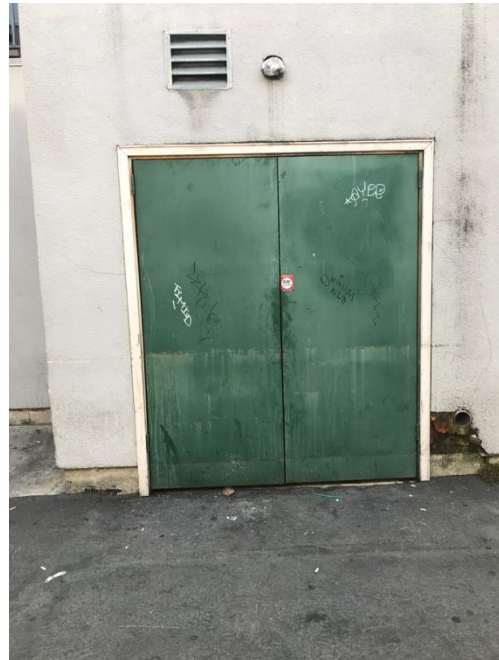
Above: Rear doors require repair and improvement.

- Conduit and meters should be minimized at Murphy Avenue façade and priority given to relocating these (if possible).
- Install smaller tile at the base; the tiles currently employed are over-scaled for this feature.
- Carry compatible colors over from the first floor to the second floor/mezzanine.
- Consider exterior lighting (e.g. gooseneck lamps) on the second floor front façade (around sign).
- Improve rear doors and surrounding wall.
- Remove graffiti from trash enclosure at rear of building.
- Refrain from using the second story deck as a storage area: storage should be contained within the building.

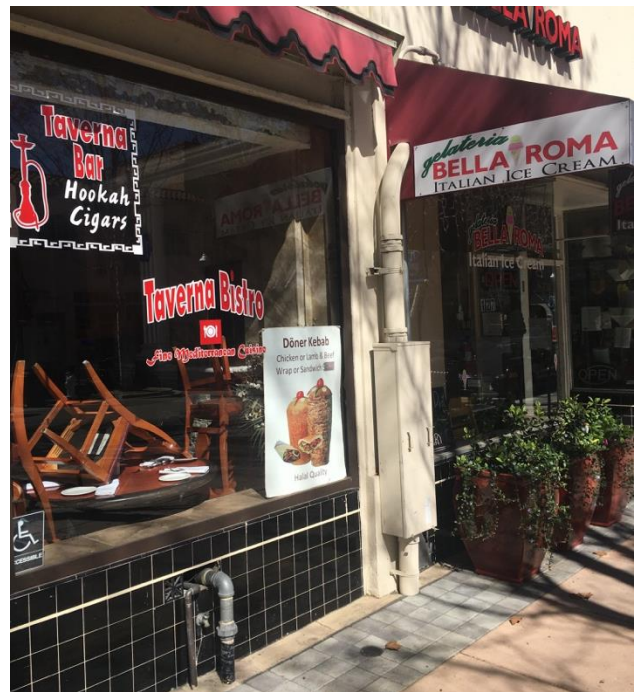
Above: Piping and conduit that distracts from the buildings architectural features.

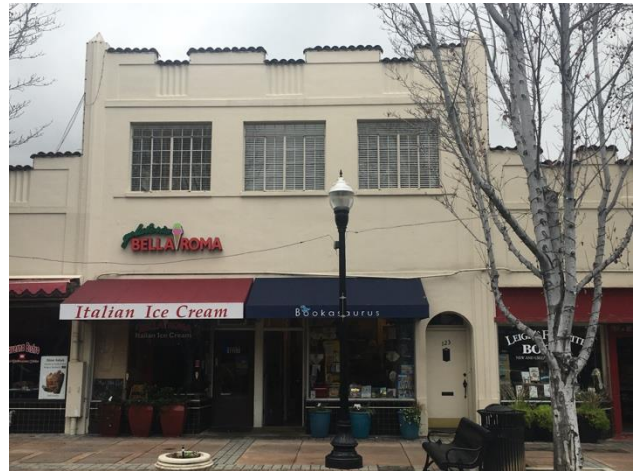
Above: The awnings on each storefront are different colors, sizes and materials. Uniformity of the awnings in shape, size and material could be considered.

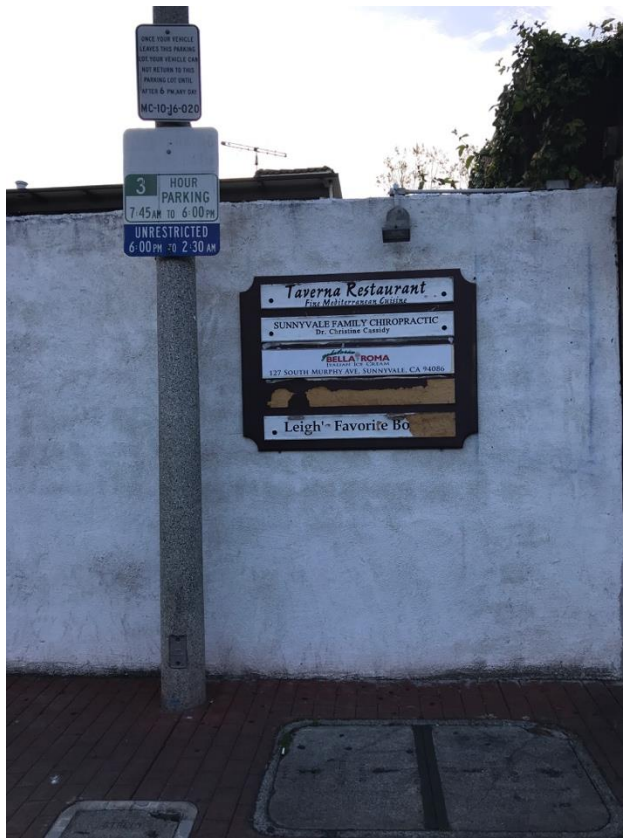
Above: The rear wall and rear façade of this building would benefit from repairs, signage improvements and fresh paint.

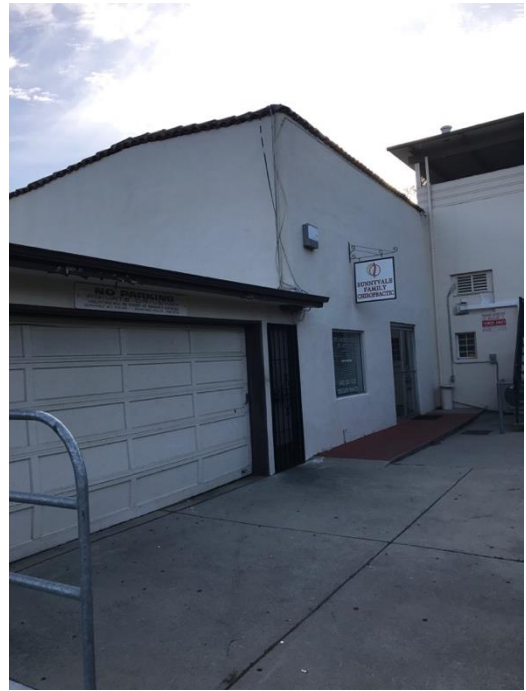
Above: The rear wing and garage are in need of repair, paint and on-going maintenance.

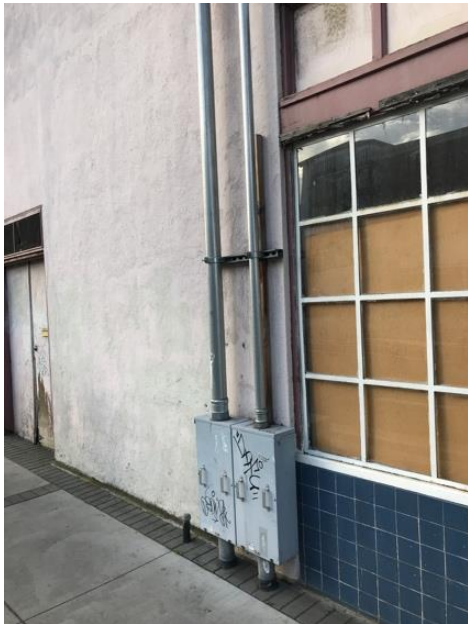
Above: Detail of utility boxes mounted at elevation.
