156 CRESCENT AVENUE, SUNNYVALE, CALIFORNIA  
SECRETARY OF THE INTERIOR STANDARDS COMPLIANCE REVIEW

*Revised*

March 27, 2023

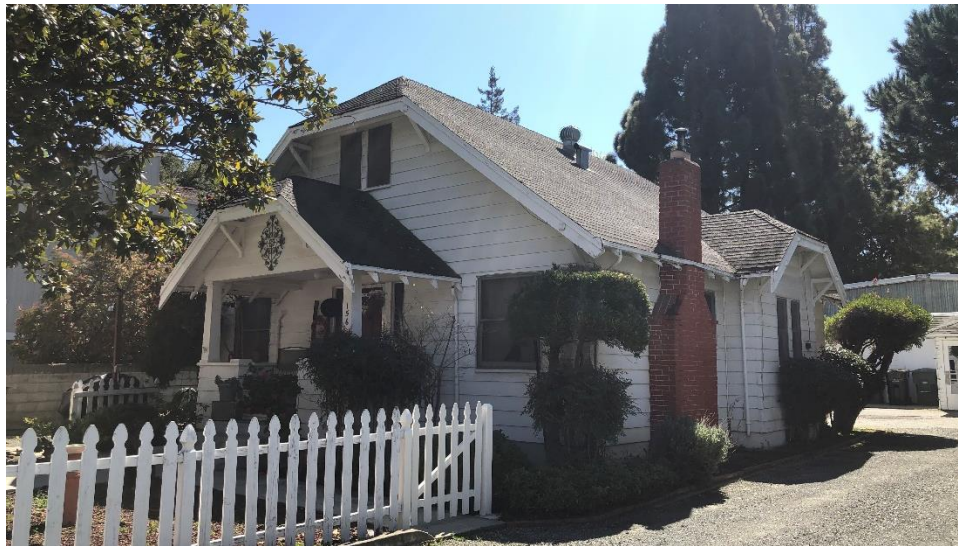
Figure 1. The front (north) and west façades of 156 Crescent Avenue.

The house is rectangular in plan and features a broad, asphalt shingle-clad gable roof with chamfers at the gable ends, and exposed rafters at the sides. Knee-brace brackets support the overhanging gable ends. The main entry is accessed via a projecting porch centered on the primary (north) elevation, which is covered by a similarly chamfered gable roof. A slight projection at the west elevation also features a chamfered gable. An exposed chimney graces the west side. Horizontal vinyl siding clads the house. Windows are double-hung wood sash with aluminum screens.

On the primary elevation, a pair of double hung windows are centered in the gable end. Larger double hung windows flank the entry porch. The entry door is a solid, paneled wood door covered by an aluminum screen door. Sidelights with vertically striated glass flank the door.

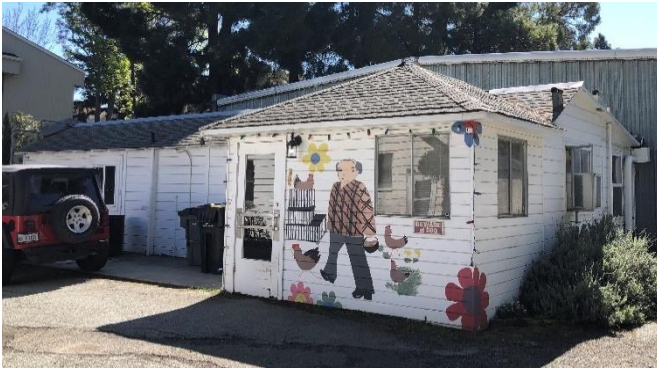
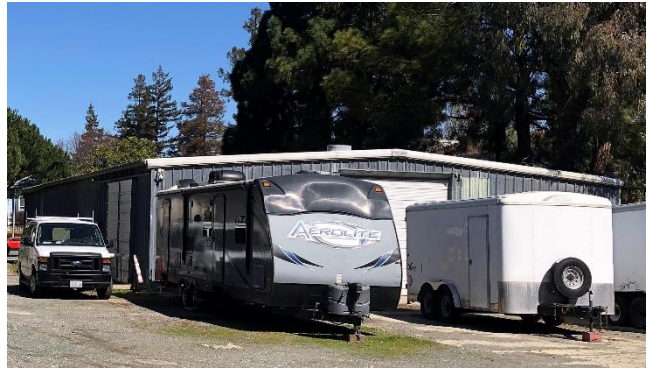
Figures 2 and 3. The accessory structure and the warehouse at the 156 Crescent Avenue property.

Four accessory structures are also found on the parcel. One is an L-shaped one-story structure with a gable roof over the long arm and a hipped roof over the shorter arm of the "L." The building has horizontal wood cladding, and metal casement and vinyl windows. Painted graphics on the building include a man, chickens, and flowers. A second accessory structure is a one-story metal warehouse building with a shallow gable roof. This structure has vertically ribbed metal cladding. It features large garage/loading doors. A third accessory structure is a square-plan hipped roof garage, with horizontal wood cladding, that appears to be of similar vintage to the house. This structure has a hipped roof, a large garage door on its primary elevation, and a person-door on its side elevation. The fourth structure is a large shed, with a barn door and exposed rafters. It features a low-sloped shed roof with exposed rafter tails, aluminum slider windows, and smooth, vertically placed plywood panels.<sup>2</sup> (Figures 1-5)

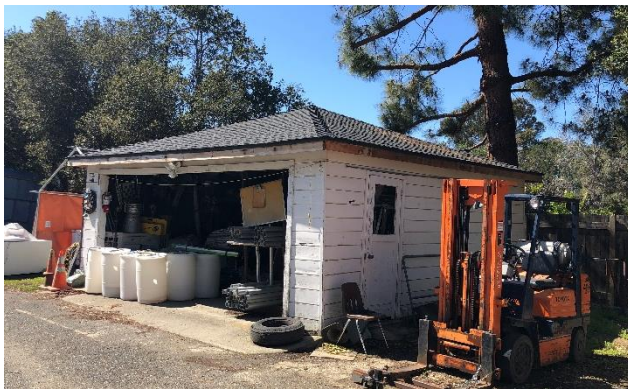
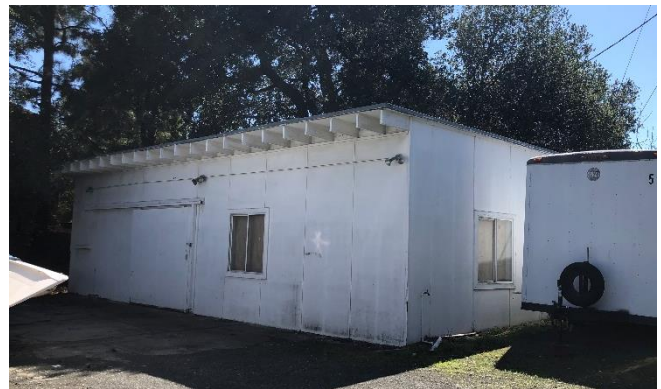
Figures 4 and 5. The one-story garage and the shed on the 156 Crescent Avenue property.

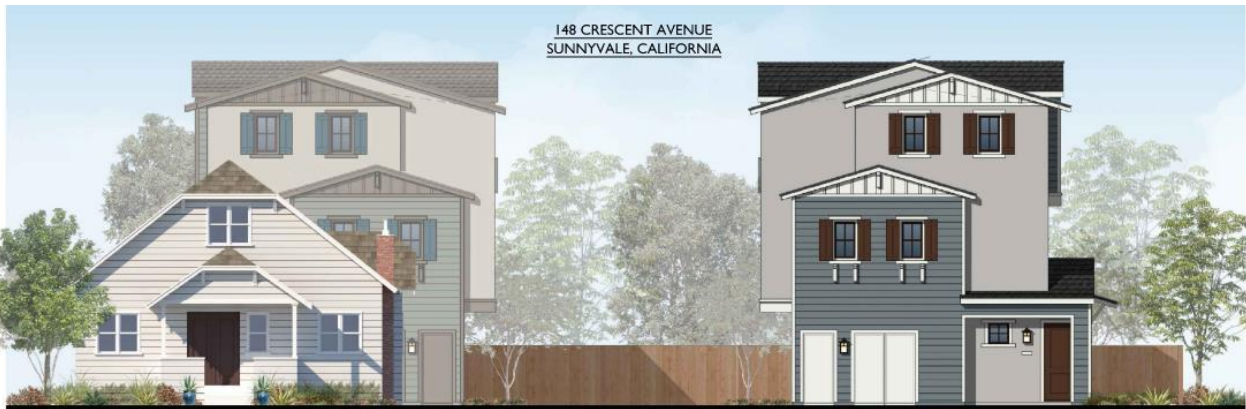
Figure 7. View from Crescent Avenue of the 156 Crescent Avenue with the proposed new buildings.

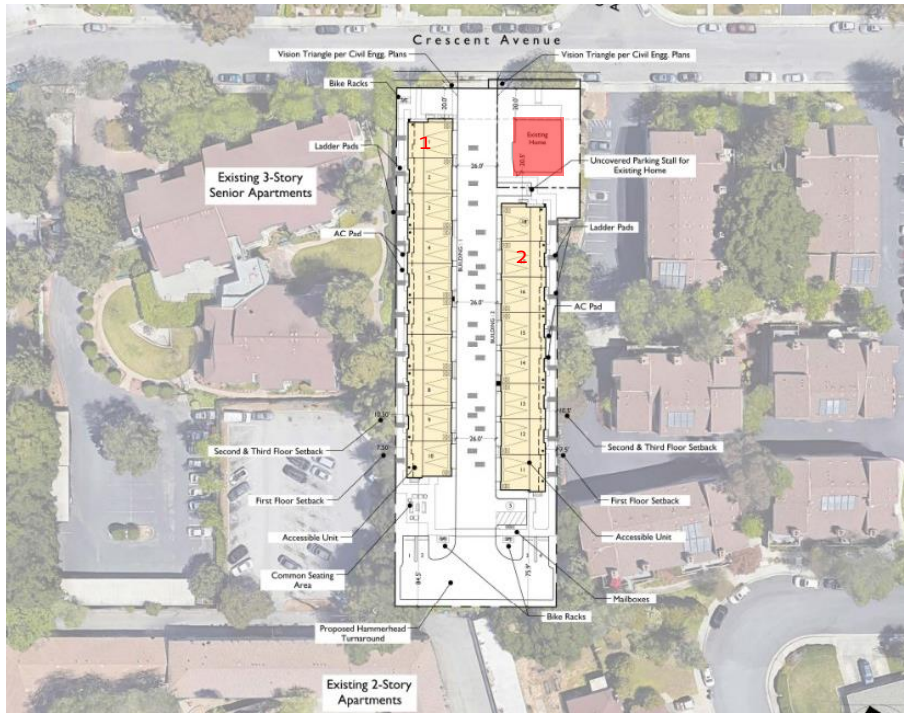
Figure 8. The proposed site plan with new buildings labeled in red, and the existing house at 156 Crescent Avenue blocked out in red (Bassenian/Lagoni Architecture, November 2022).

Two new multi-family buildings, Buildings 1 and 2, will be constructed south of 156 Crescent Avenue. The new buildings essentially mirror each other. However, Building 1 includes 10 units, while Building 2 has 8, for a total of 18 condominium townhouses. The garage elevations face each other, creating an internal courtyard that is essentially the driveway for the complex. The main entries to the units are located on the outward-facing elevations, which appear to be accessed by long, narrow pathways.

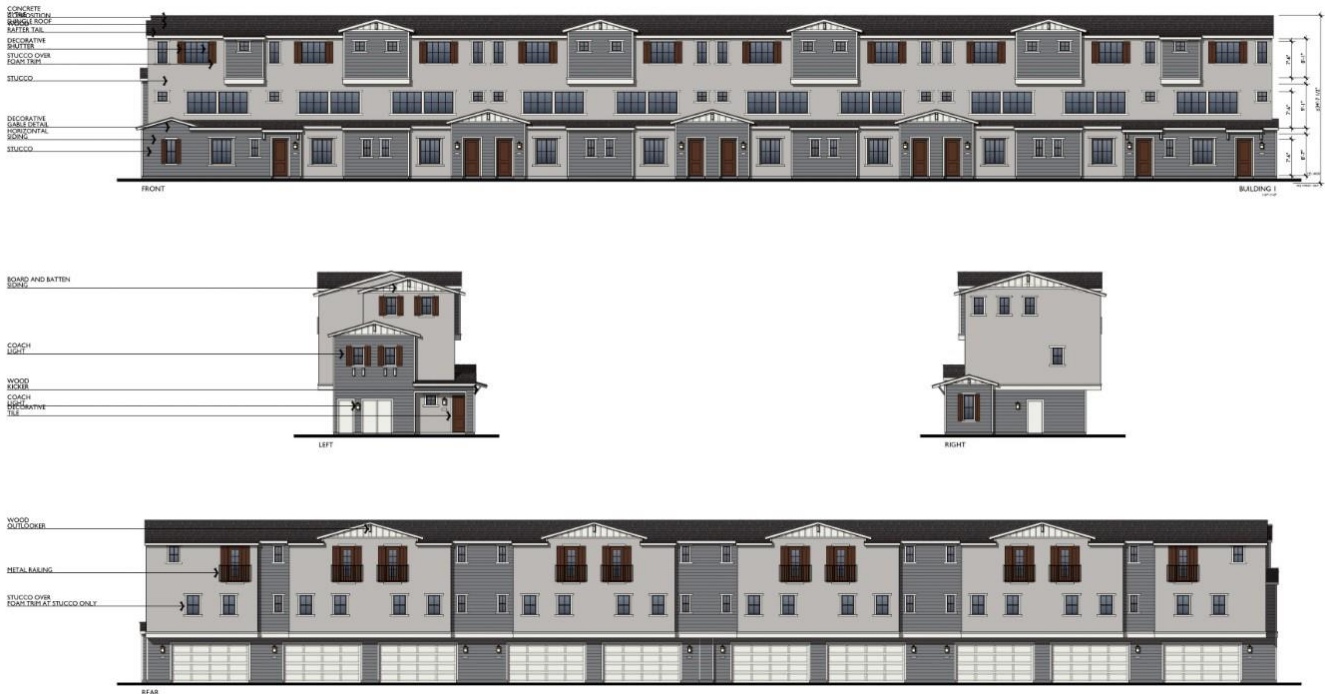
Figure 9. View of all elevations of Building 1 (Bassenian/Lagoni Architecture, November 2022).

A layered wall of shallow projecting and recessed sections with two gable ends comprise the north façades of both buildings. A single door is tucked into a recessed entryway with a small divided lite window to the west. Three other doors sit to the west on the first floor. Divided lite windows with shutters are on the second and third floors. The south elevations feature a single door, and five divided lite windows (figure 9).

than the overall roofline, although the idea of introducing cross-gables is fine. It is just that the elevation detailing below these cross-gables is less effective. On the west elevation of Building 1 (east elevation of Building 2), for example, these cross gables are located above shallow projections that are primarily black walls with two small windows. On the east elevation of Building 1/west elevation of Building 2, there are larger projections with small gables over tall windows with faux shutters and balconies. The relationship of the gable ends with the much wider projection is rather awkward.

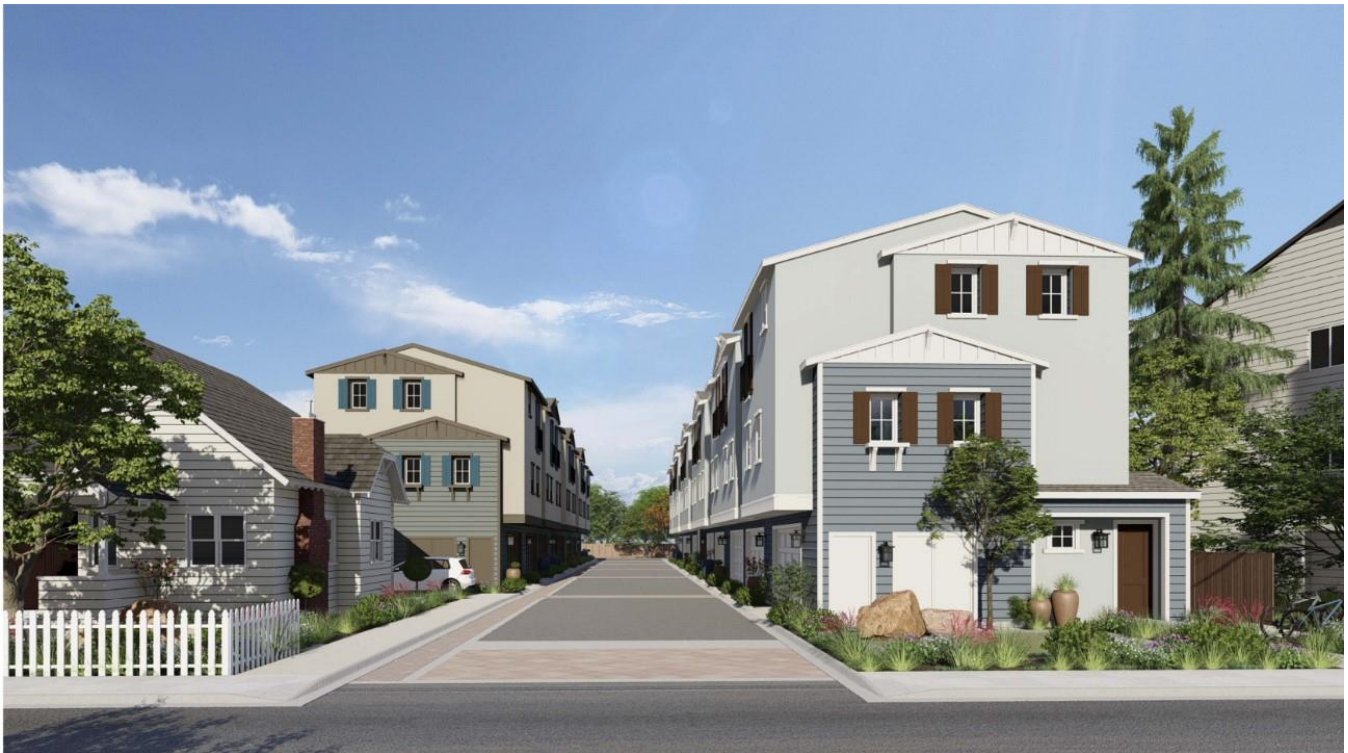
Figure 11. Rendering of a street view from Crescent Avenue, view of the existing building and the 2 proposed buildings (Bassenian/Lagoni Architecture, November 2022).

While these buildings are taller than the historic house, the layering of the street-facing facades helps to transition from the smaller single-family house to the taller multi-family house. While the detailing is too literally "historic," this layering is effective. We also appreciate that roofs will be gabled with a lower slope than that of the existing house. The designers tried to further break up the roofline with small cross gables perpendicular to the main roofline. We find this less effective
