Brad Cox, **Architect**, Inc.

# Las Palmas Tennis Center Needs Assessment

Marlon Quiambao, Senior Engineer  
Public Works  
April 10, 2024

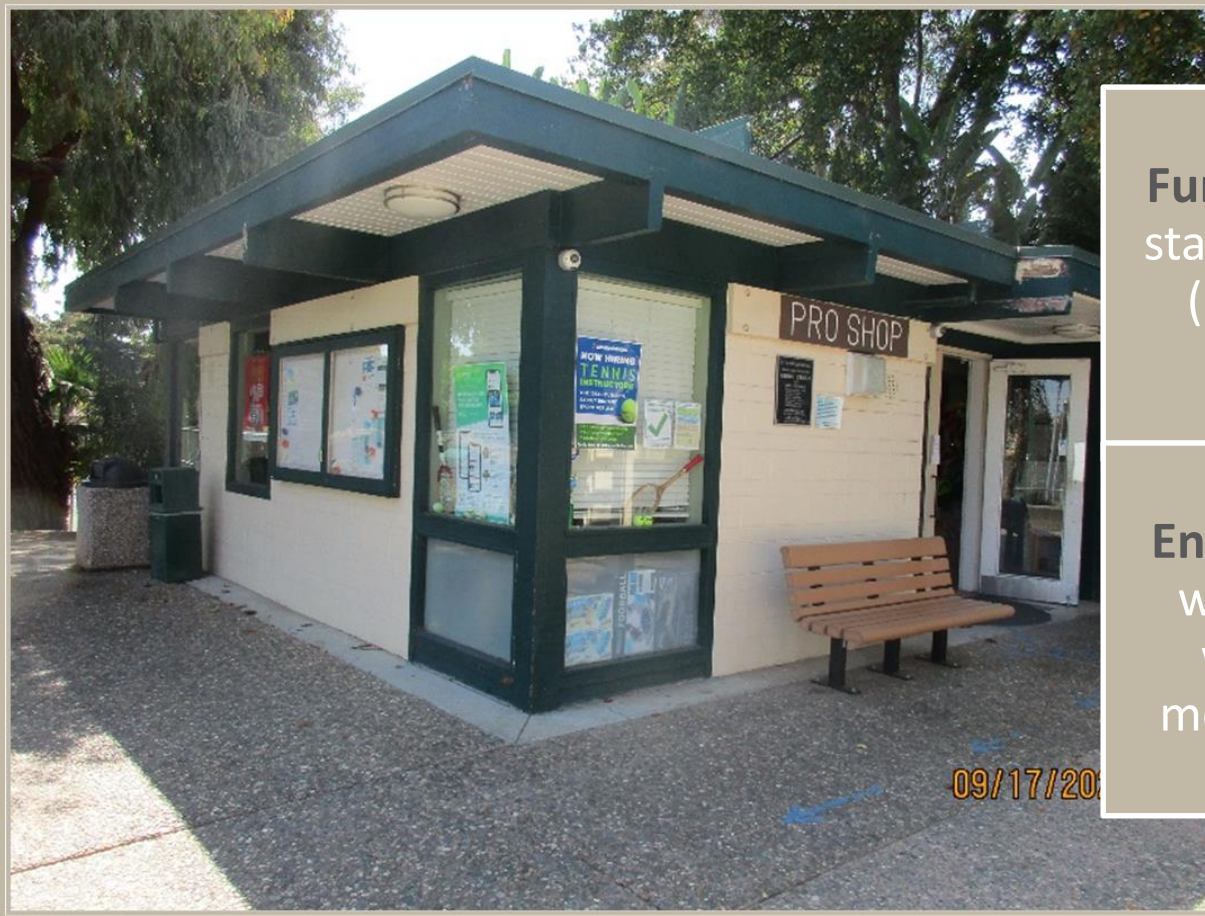
# Building Conditions: Pro Shop (1975)

**Function:** Undersized for staff of current programs (e.g. workspaces and storage).

**Access:** Handrails are not in accordance with accessibility requirements.

**Energy Use:** Single-pane windows, uninsulated walls, and outdated mechanical equipment.

**Haz-Mat:** Asbestos was detected in original building material. No lead detected above reportable limits in paint.

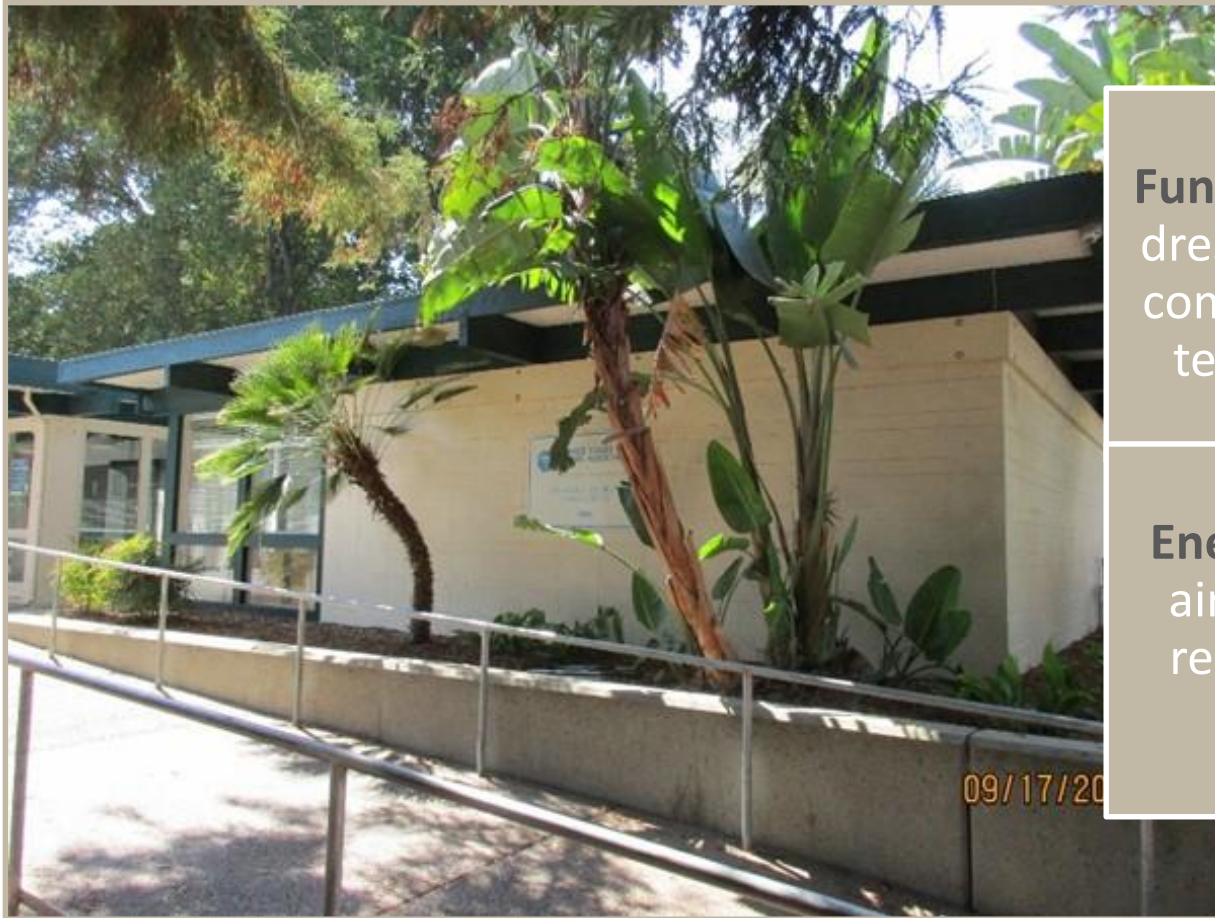
# Building Conditions: Restrooms (1975)

**Function:** No showers and dressing areas are limited compared to neighboring tennis center facilities.

**Access:** No accessible women's toilet stall and non-compliant knob hardware.

**Energy Use:** Heating and air conditioning for the restrooms is not a high priority.

**Haz-Mat:** No asbestos containing materials or lead based paints were detected.

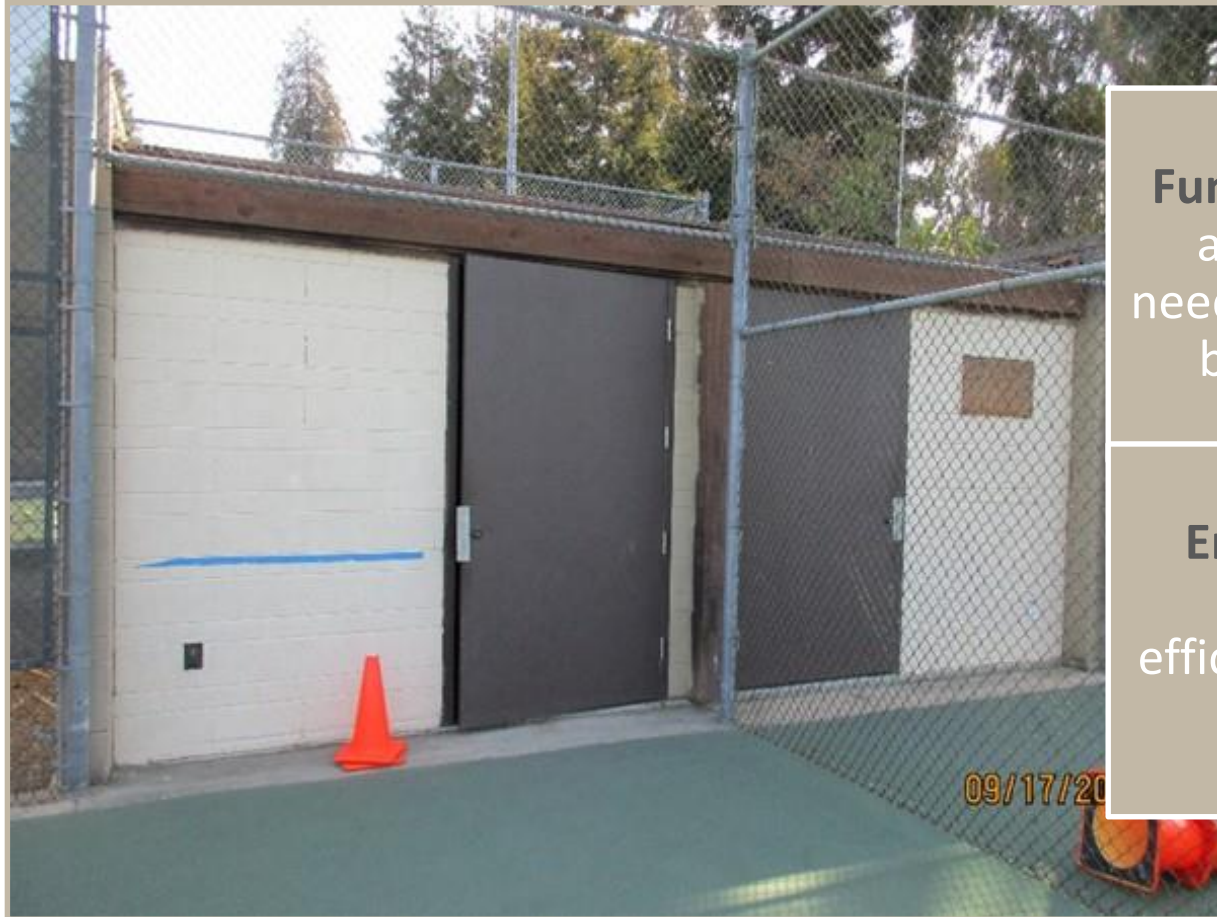
# Building Conditions: Storage Shed (1975)

**Function:** The capacity is about half of what is needed. Distribution could be more spread out.

**Access:** Storage shed is only accessed by staff and instructors, but was not built to current code.

**Energy Use:** Electrical system and energy efficient lighting upgrades recommended.

**Haz-Mat:** No asbestos containing materials or lead based paints were detected.

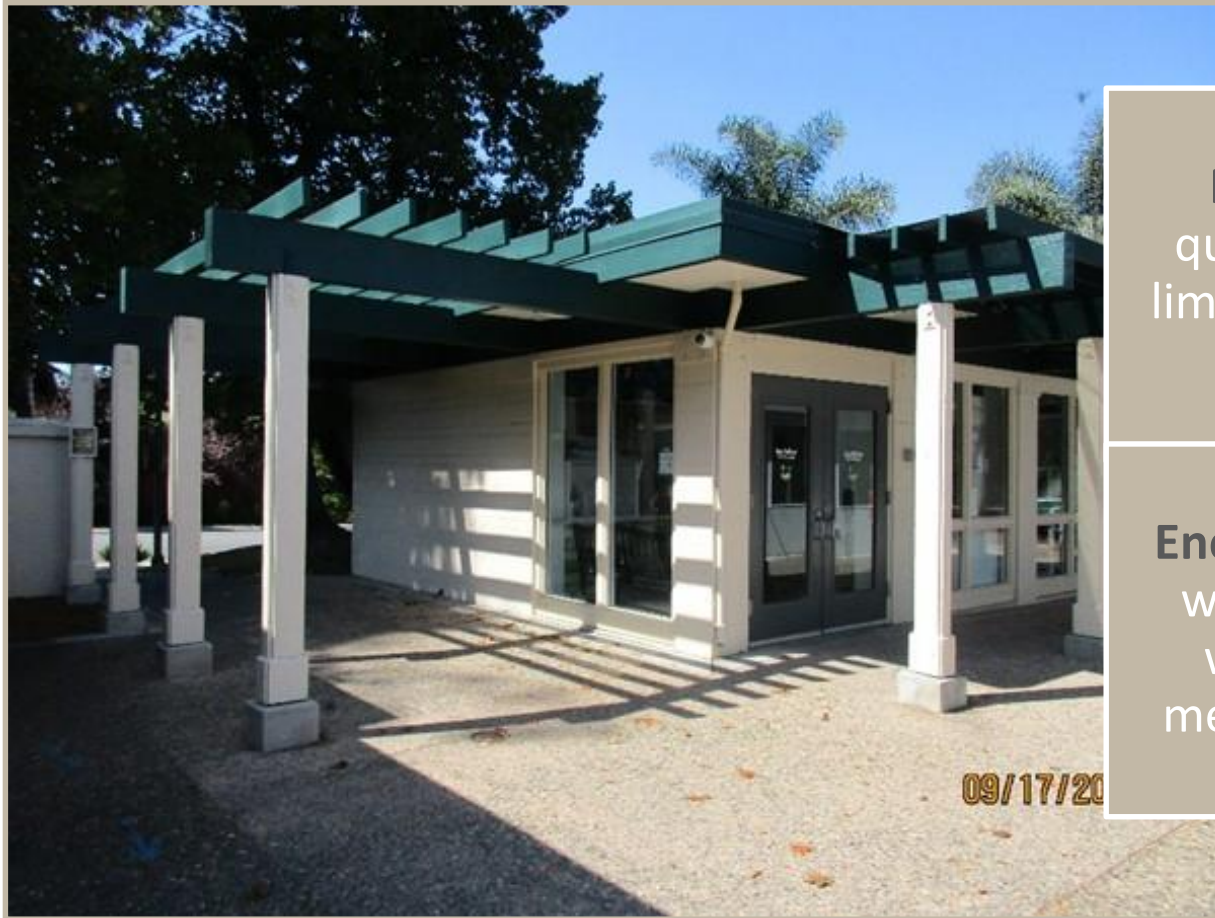
# Building Conditions: **Café (2000)**

**Function:** Type and quantity of offerings is limited by the size of the food service area.

**Access:** Food service side has limited access. Due to space constraints, there is limited ability to remodel.

**Energy Use:** Single-pane windows, uninsulated walls, and outdated mechanical equipment.

**Haz-Mat:** Likely asbestos-free because remodeling occurred in the early 2000s.

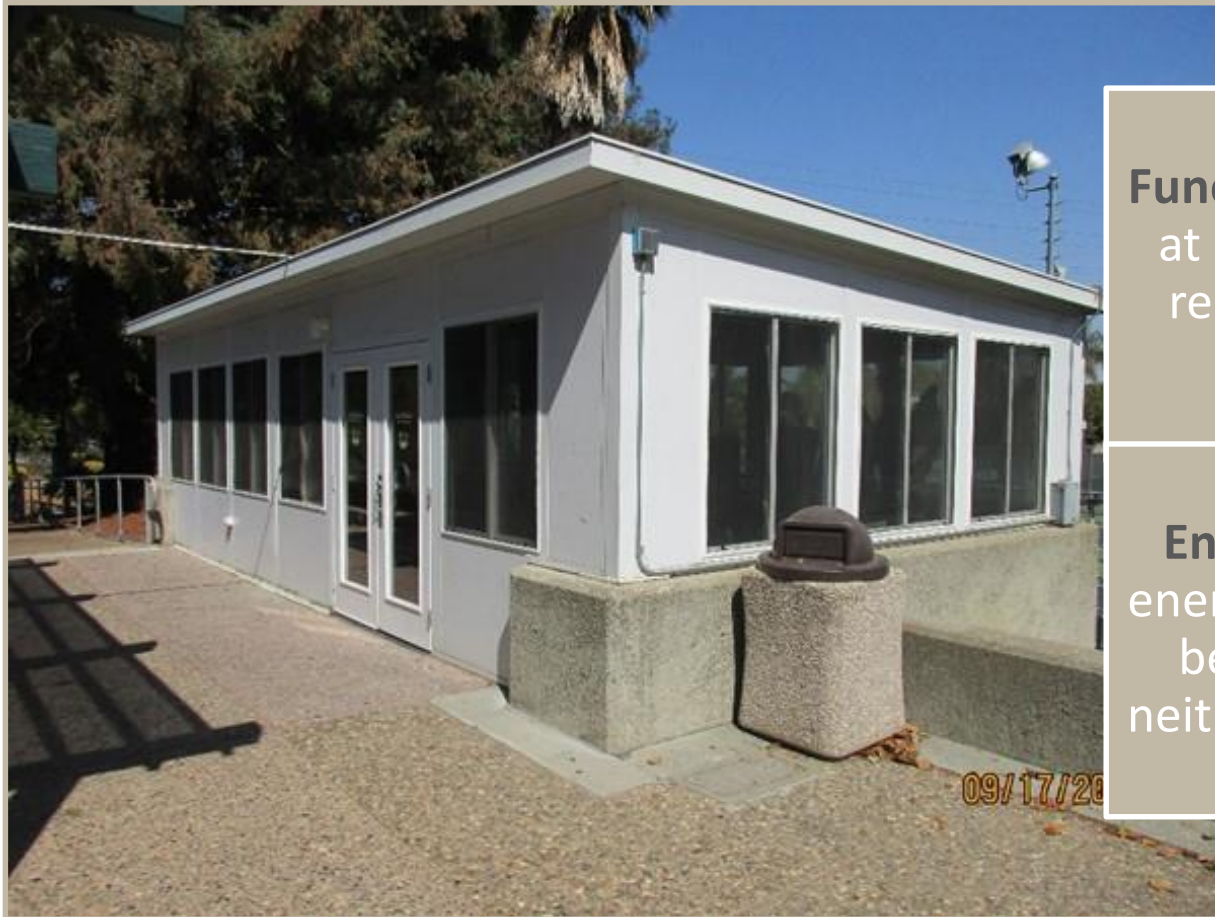
# Building Conditions: Lounge (after 2000)

**Function:** Occupancy is set at 32, but typical events require room for 50-60 occupants.

**Access:** Other than occupancy limitations, there are no accessibility issues with the facility.

**Energy Use:** No specific energy-efficiency concerns because the Lounge is neither heated nor cooled.

**Haz-Mat:** No samples were collected because it's a modular metal panel and no suspected asbestos or lead-containing material is evident.
