Sunnyvale Civic Center

MEP Facilities Assessment Report

June 26, 2017

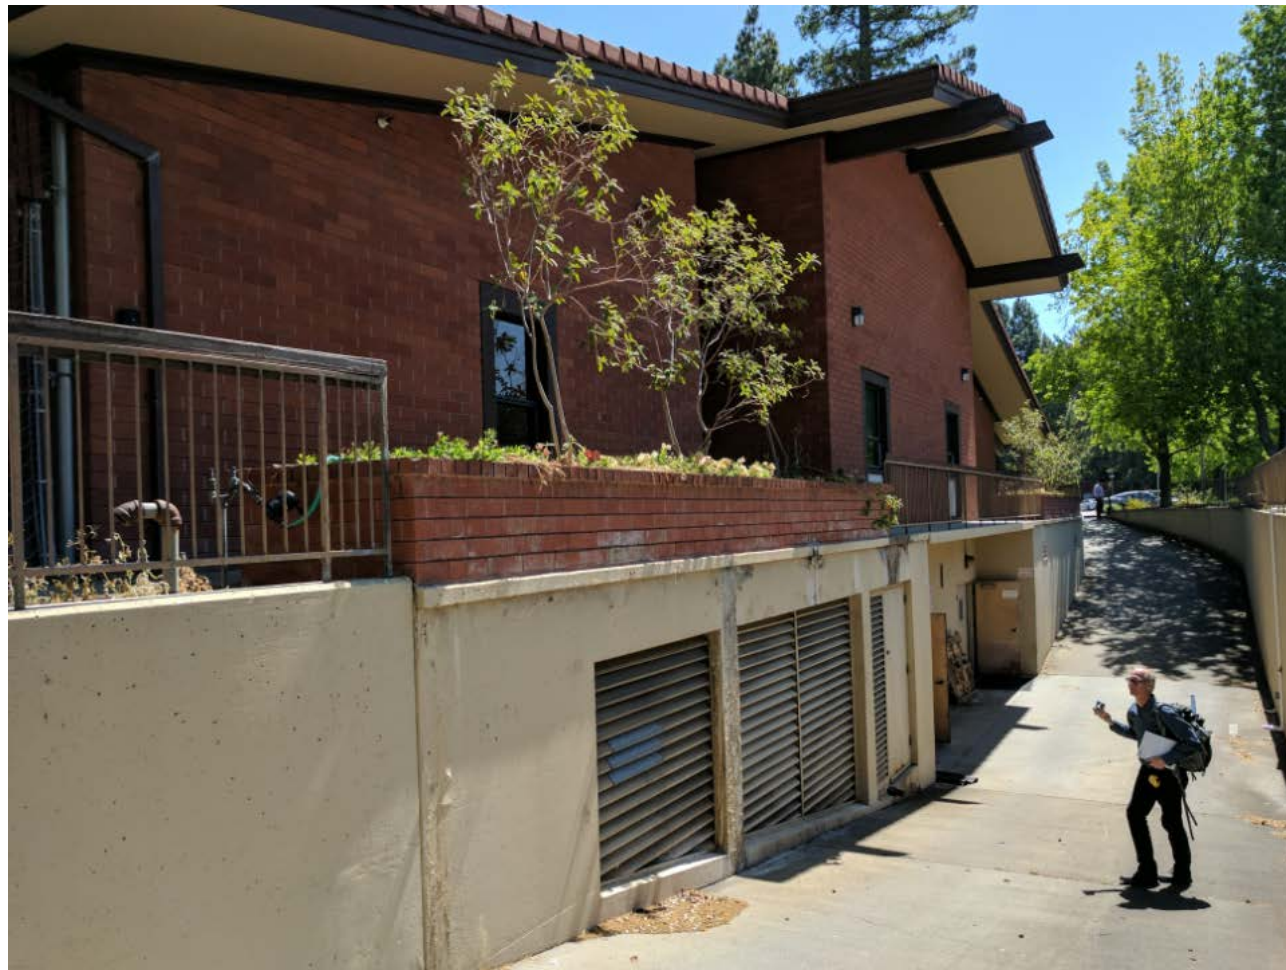
Figure 2: Annex Building

The Annex Building was built circa 1984 and has a major HVAC system renovation in 2003. The building is a two-story structure totaling approximately 25,000 SF of area. The existing building envelope elements are original as is most of the mechanical, plumbing, electrical, and fire-protection (MEP/FP) infrastructure and utility services.

The building and MEP/FP equipment have been well kept despite being their age. Based on the site walk, visual observation of the equipment, and information provided by the civic center Facilities and Engineering team, the equipment is in fair condition.

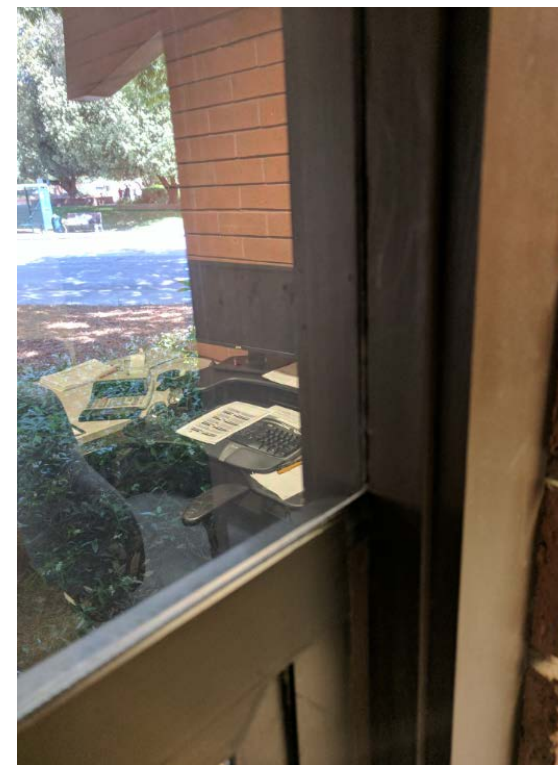
Figure 6: Single-Pane Glazing

The existing building envelope has not been renovated since original building construction and appears to be in fair condition based on visual observation. See the architectural assessment report for additional building envelope information on the existing envelope condition. This section focuses only on the thermal and energy code performance of the envelope.

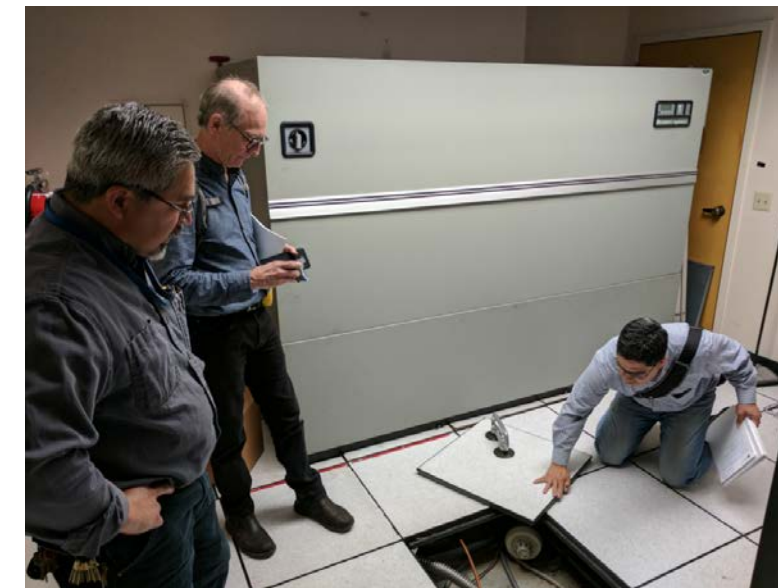
Figure 12: Liebert AC Unit Serving the Data Center

The areas on the basement level are also served by the building multi-zone AHU. The data center is also served by a floor-mounted Liebert unit via a underfloor air delivery plenum. The Liebert air-cooled condenser is located in an area way behind an external louver, which is not recommended.

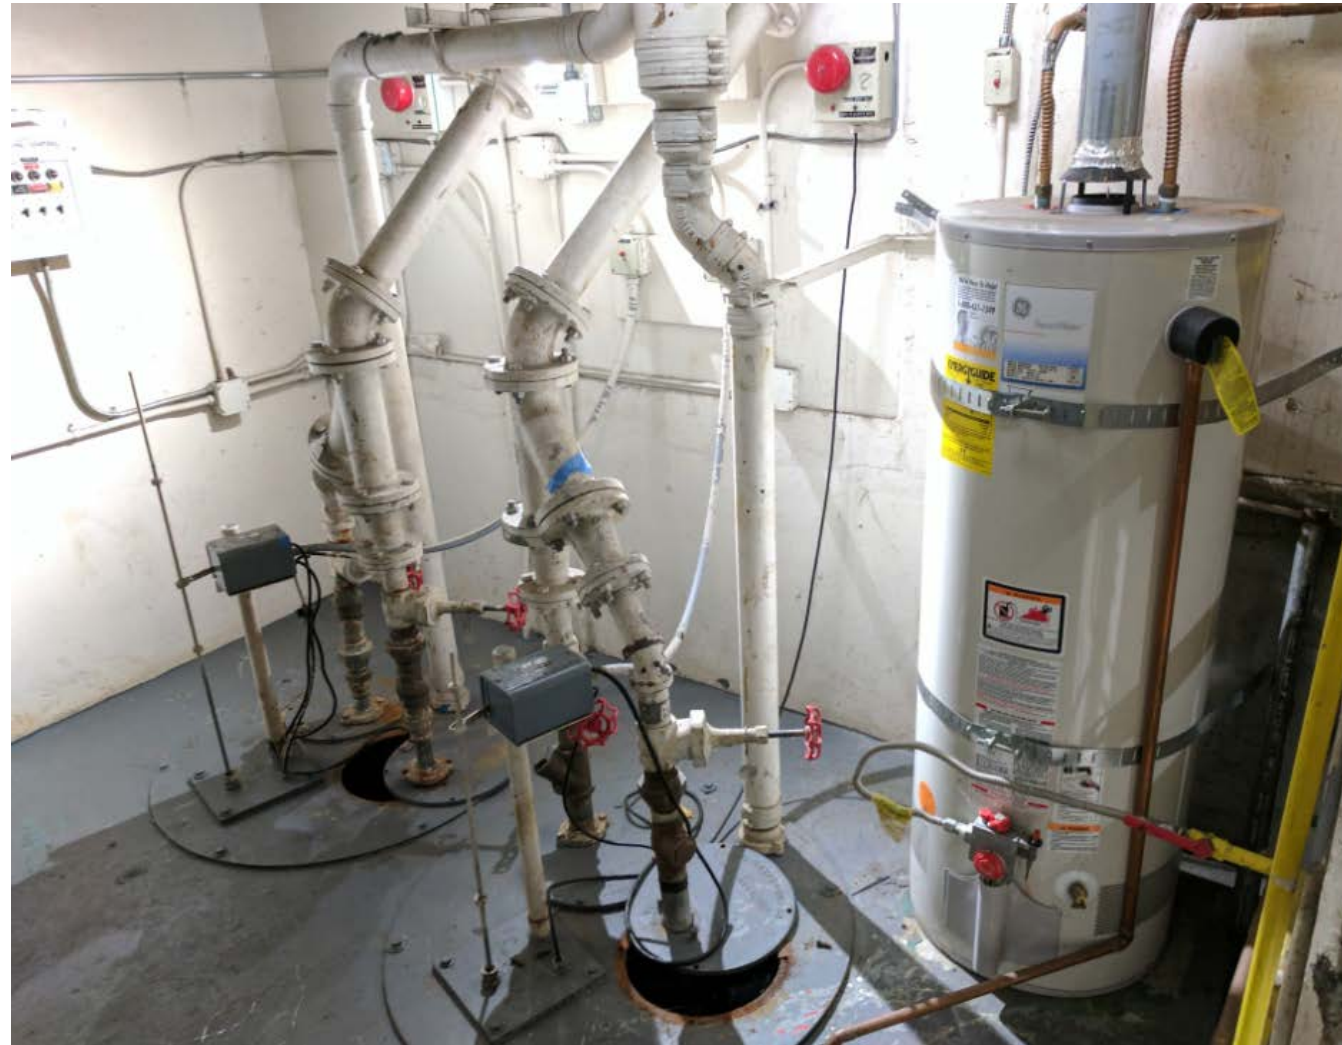
Figure 14: Domestic Hot Water Gas Fired Heater and sewer/storm ejector Pumps

The existing plumbing system was installed in the original building build out from 1980's. The building domestic water heater, thermostatic control valve, and plumbing fixtures were replaced in the 2003 renovation project and are therefore approximately 14 years old.

The existing plumbing utilities and piping infrastructure is from the original building construction and approximately 33 years old. The existing plumbing piping infrastructure (domestic cold water, sanitary sewer, storm, and gas) should be tested prior to being reused.

The building has two ejector pumps, one for sewer and another for storm, both located in the basement level of the building.

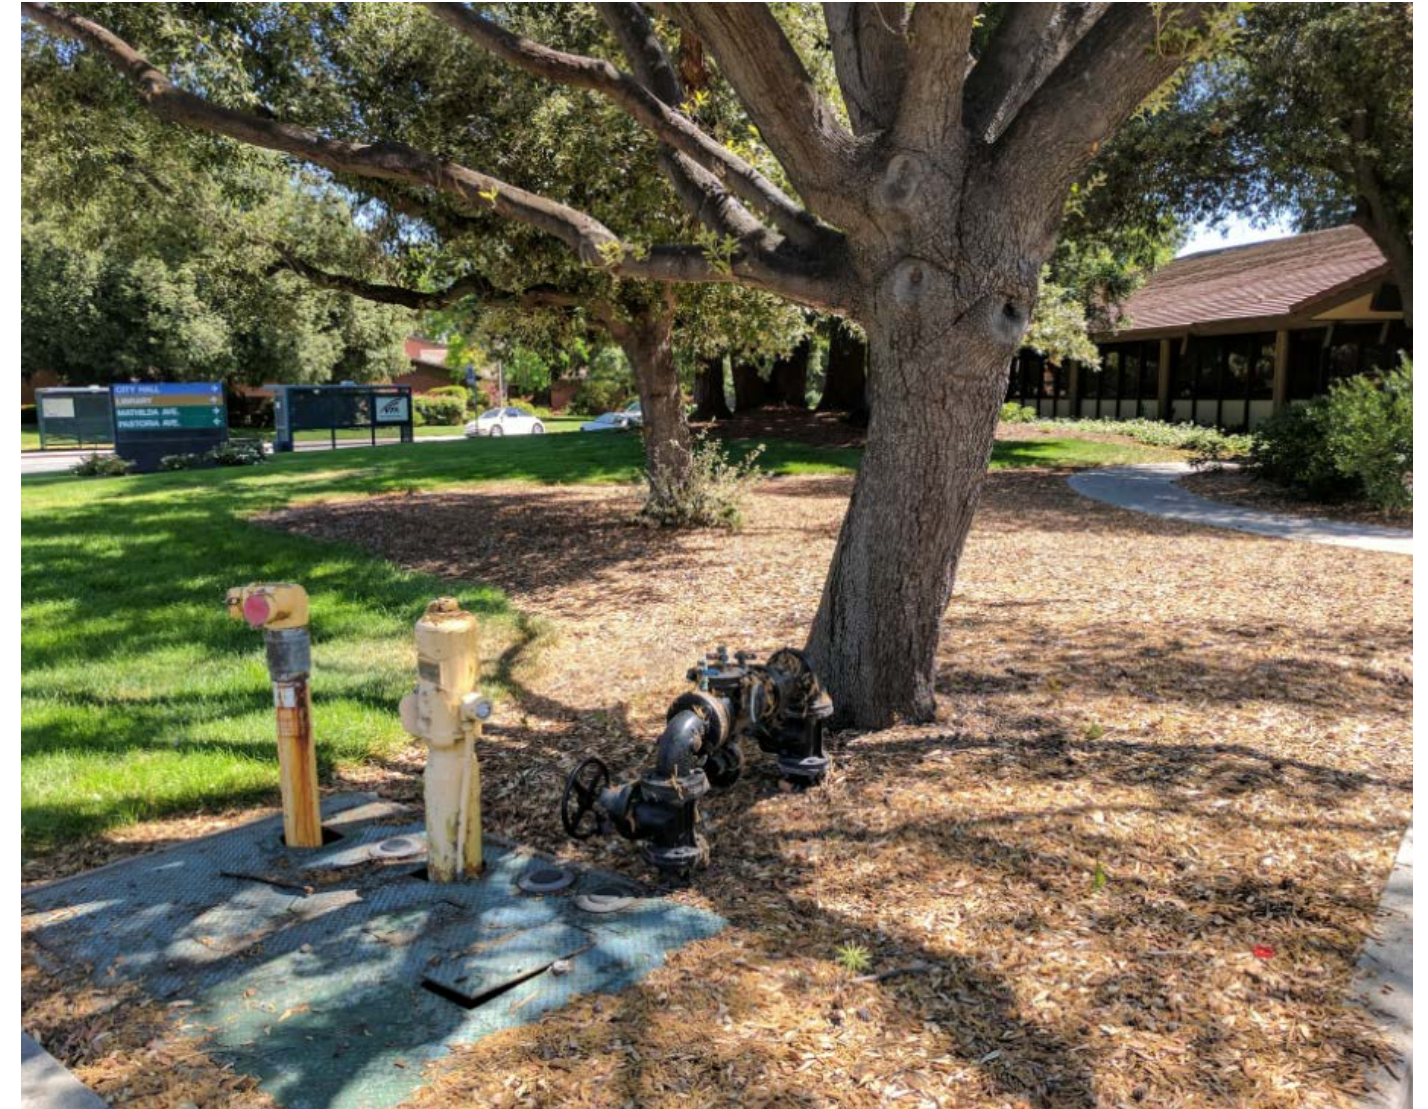
Figure 15: Fire Protection Post Indicator Valve (PIV)

The building is fully sprinklered. The wet sprinkler system service comes into the building from the site utility system and distribution. The actual location for the fire protection water entry point is by the cooling tower area as indicated by the outdoor PIV, although the fire riser and test valves were not observed.

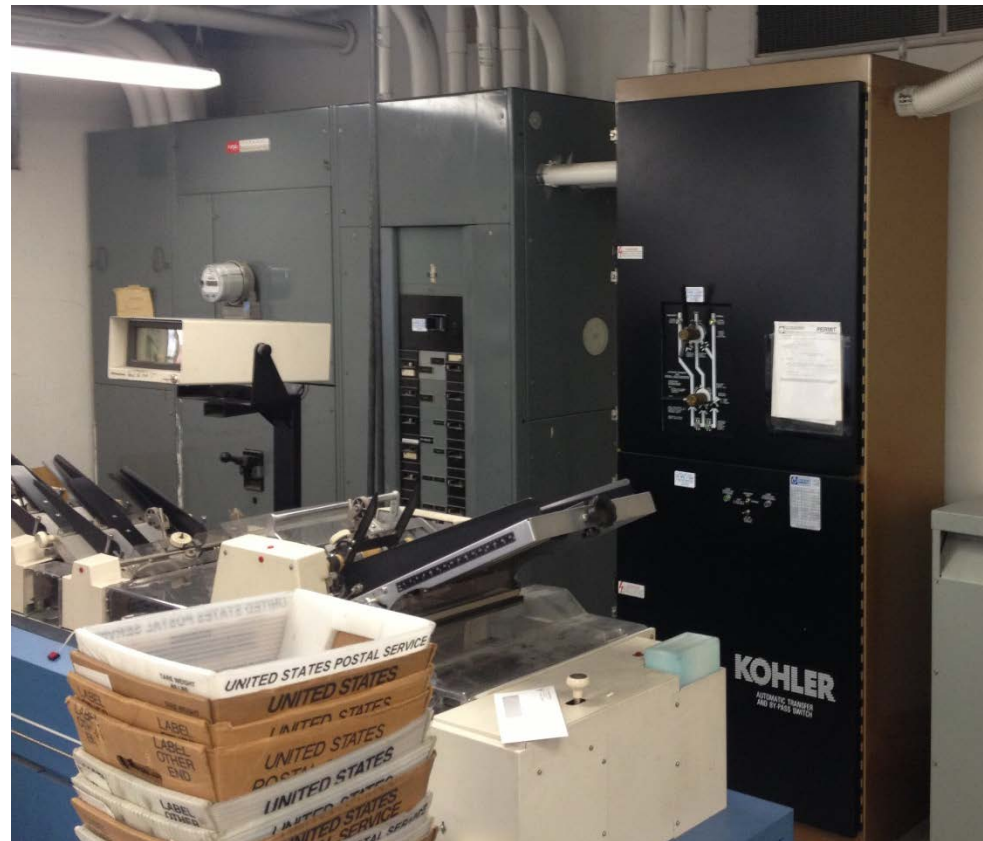
Figure 16: Main Distribution Panel

The majority of the main distribution and secondary distribution panels is in fair condition, of original vintage, and manufactured by Federal Pacific. Some equipment was replaced during a 1984 renovations.

Based upon the main panel's rating of 1600A, 208Y/120V, 3-phase, 4-wire, the existing service could serve a load density of approximately 32W/sf. The building's current estimated demand load is 11W/sf. This includes 4W/sf for plug load and lighting and 5W/sf for mechanical systems. The electric service appears to be appropriate for the building type.

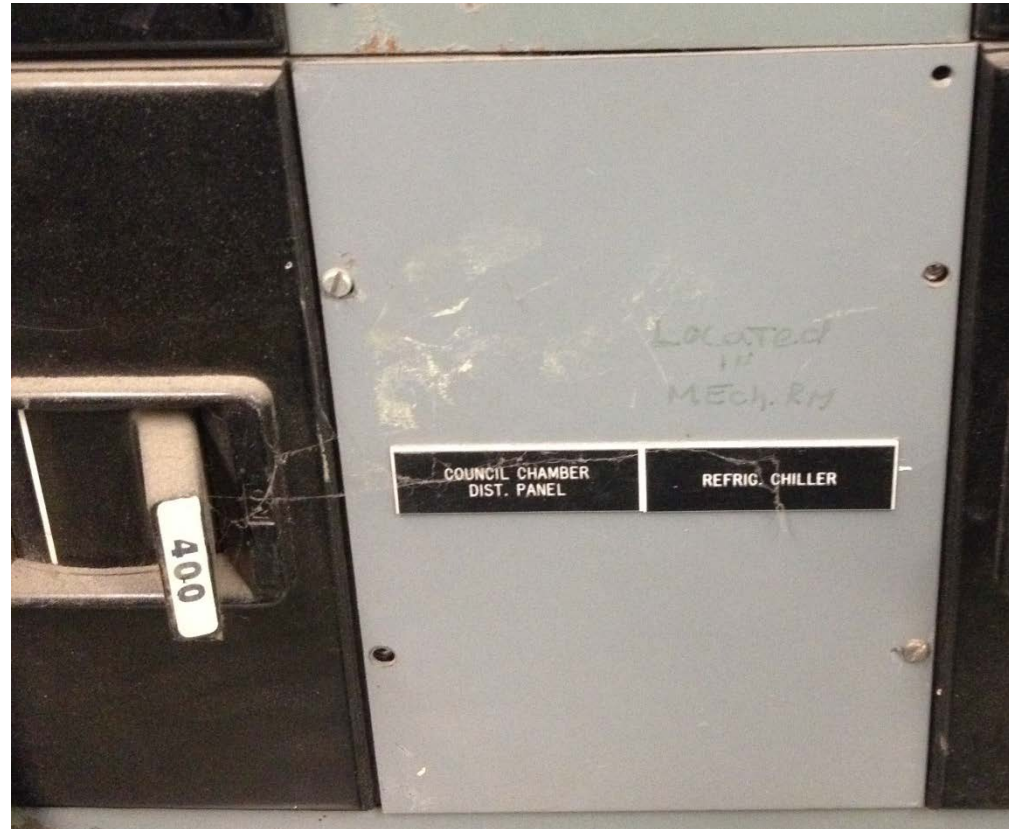
Figure 18: Council Chamber Distribution Panel Subfeed from Annex Building

The main distribution panel also contains a 400 circuit breaker labeled 'Council Chamber Dist. Panel.' Further investigation is required.

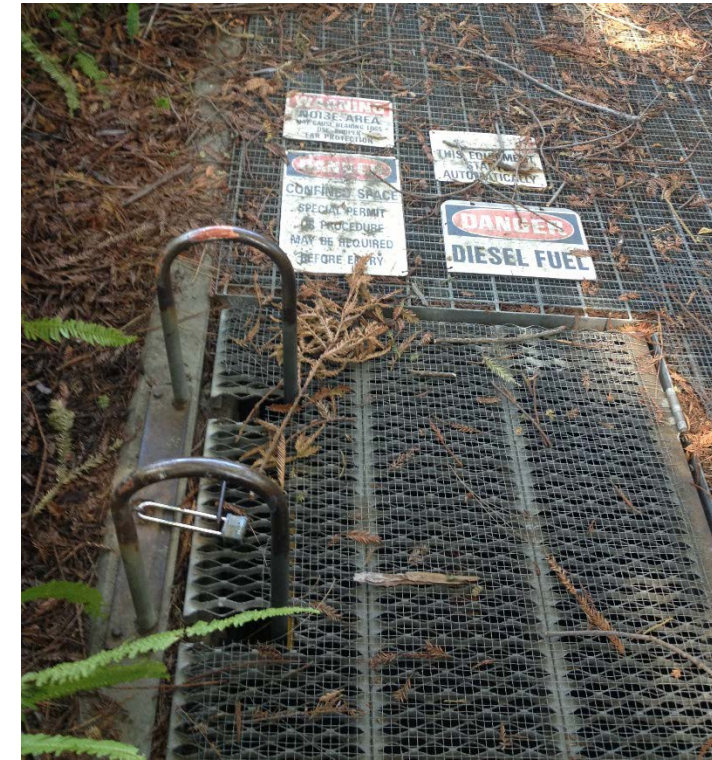
Figure 199: 150kW Generator Pit

In addition to the 1600A distribution board, there is a 150kW, diesel, 208/120V, 3-phase, 4-wire generator that provides emergency standby power to the building. The generator is located in an exterior pit and via the ATS provides power to the computer room, emergency lighting, and various mechanical and plumbing equipment loads. The emergency distribution system is not currently segregated into NEC article 700, 701, and 702 branches.

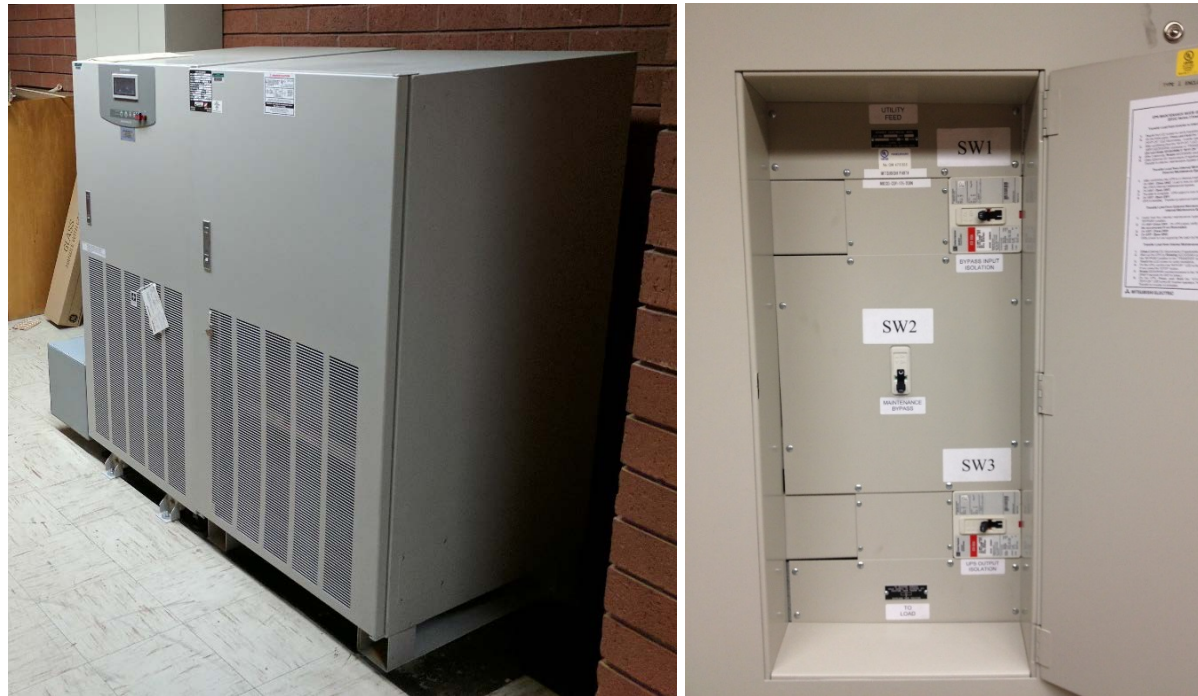
Figure 20: UPS Bypass Panel and Battery Cabinets

An additional 75kVA Uninterruptable Power Supply (UPS) located in the first floor UPS room provides backup power to certain loads in the Computer Room. The UPS is equipped with an integral input bypass which allows for manual transfer between utility and battery power. The UPS panel powers the Computer Room panels located in the basement.

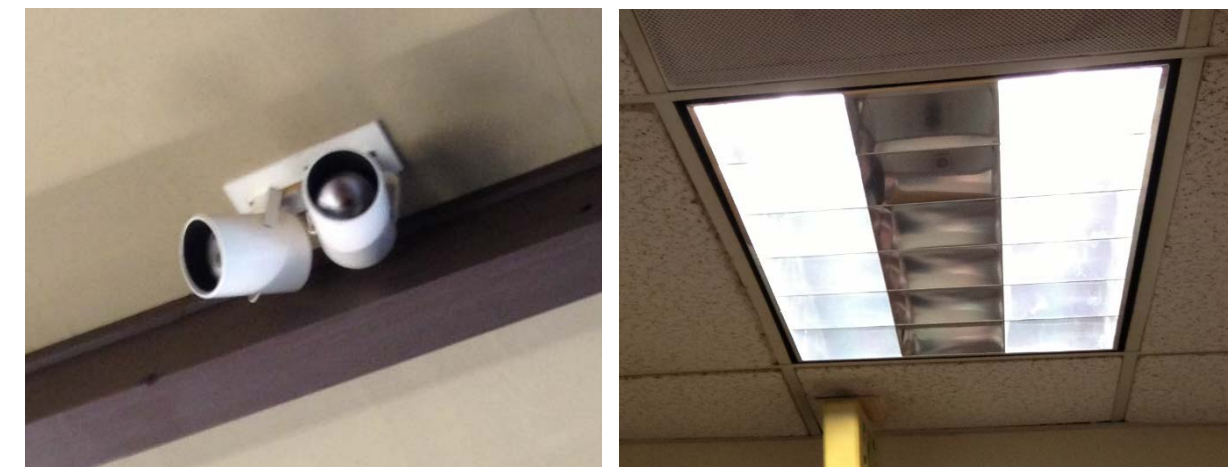
Figure 23: Typical Interior Light Fixtures

The building makes use of a combination of fixtures throughout, primarily 2'x4' recessed troffers and incandescent monopoints. Existing fixture lamp types appear to be primarily linear fluorescent. The amount of lighting provided appears to be sufficient.

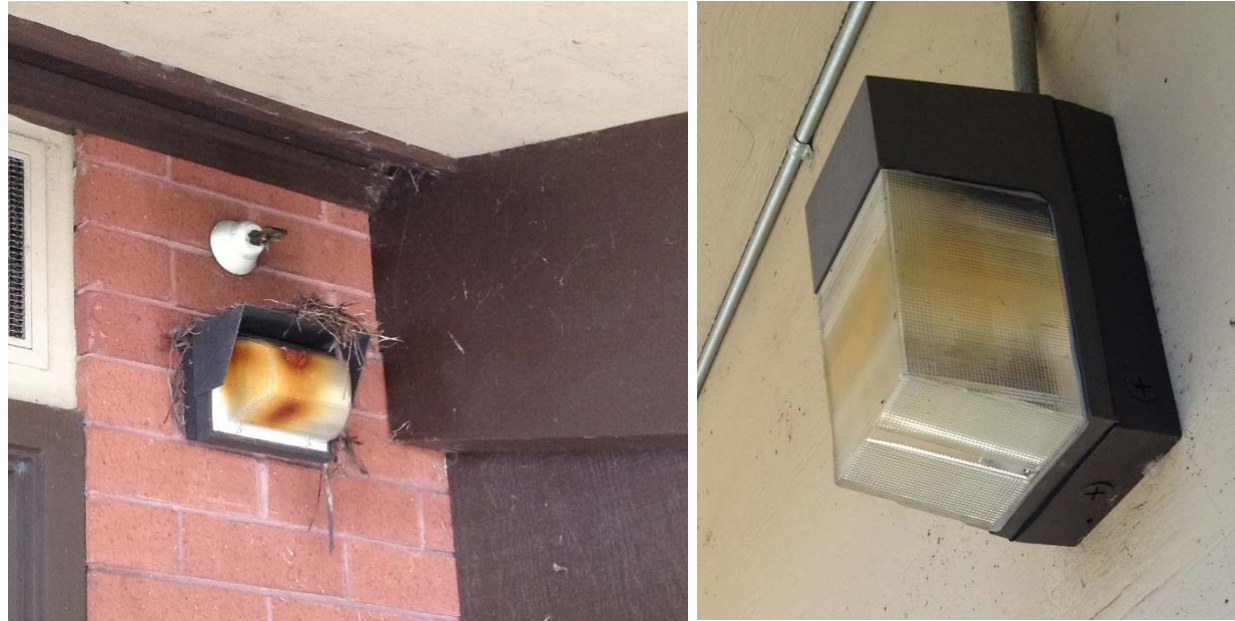
Figure 24: Typical Exterior Light Fixtures

Exterior fixtures consist of wallpacks mounted to the building façade. Many of these fixtures have not been maintained.

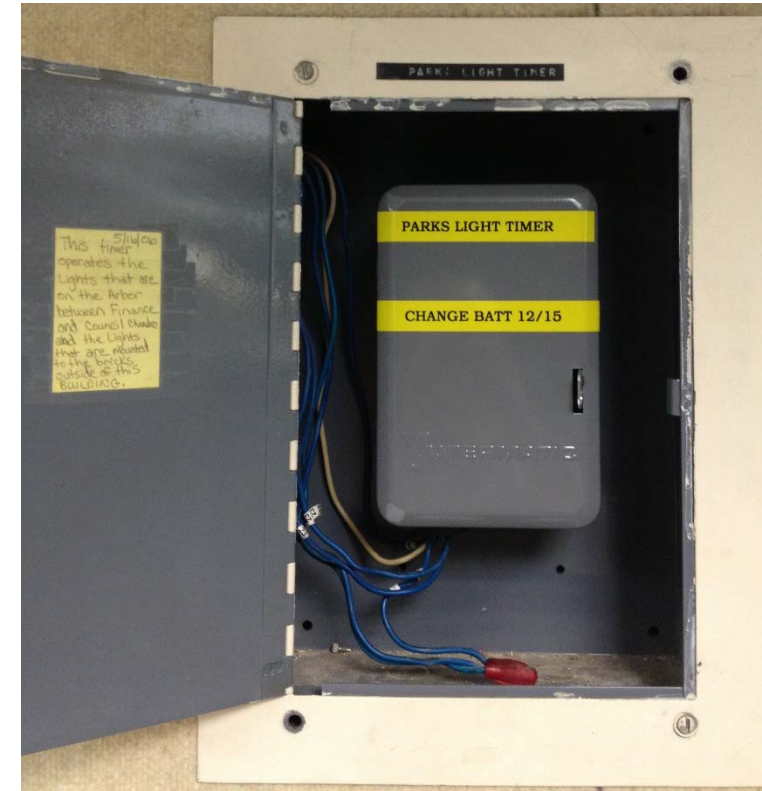
Figure 25: Exterior Lighting Timeclock

A timeclock is used for controlling exterior lighting.

It is unlikely that the lighting controls meet the latest California Title 24 requirements. For example, daylighting and dimming controls are not provided, as required per T24.

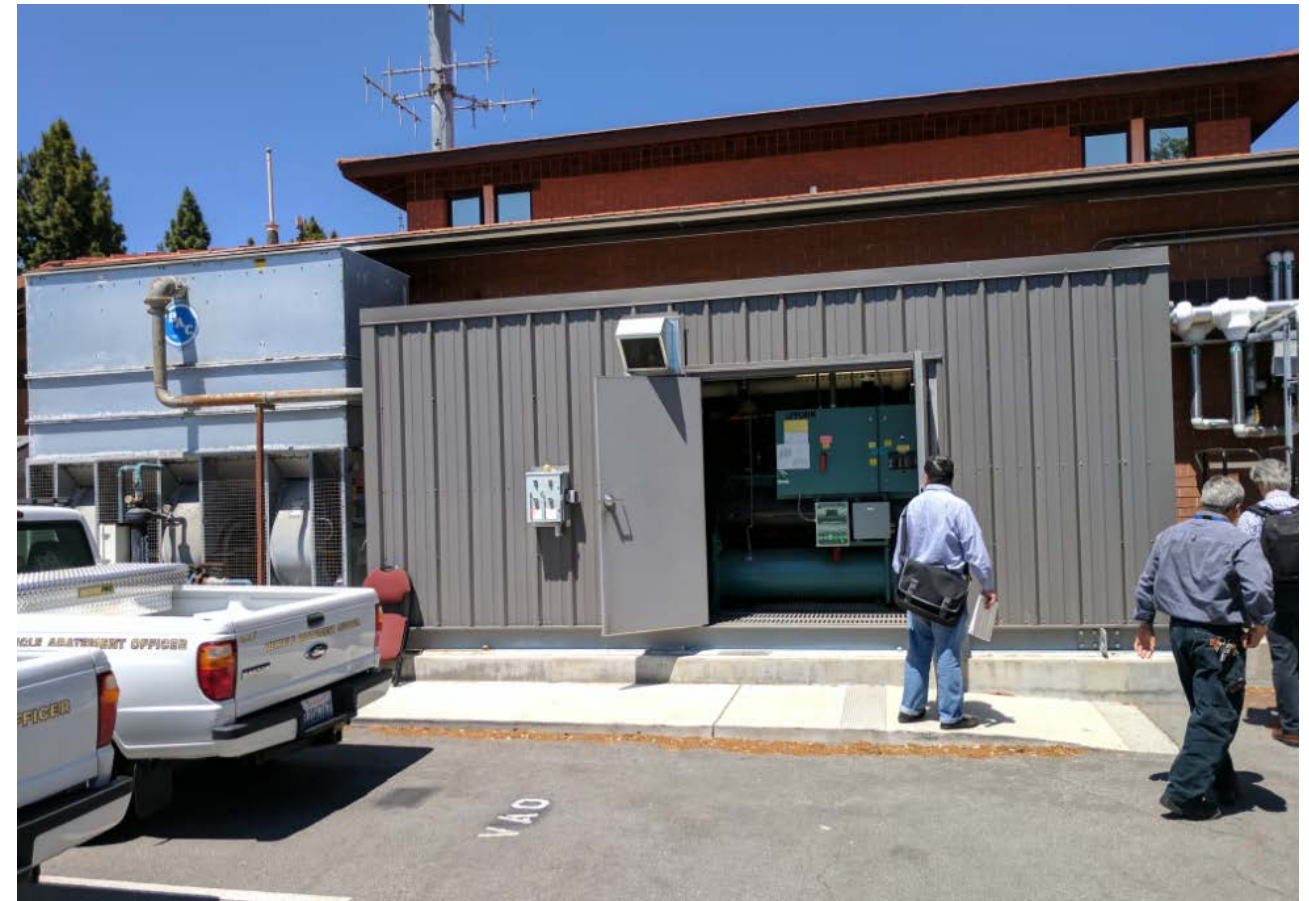
Figure 28: Public Safety Building Cooling Tower and Chiller

The existing HVAC system design is comparable to a modern HVAC system and can be reused in future renovations since it still has many years of operation left.

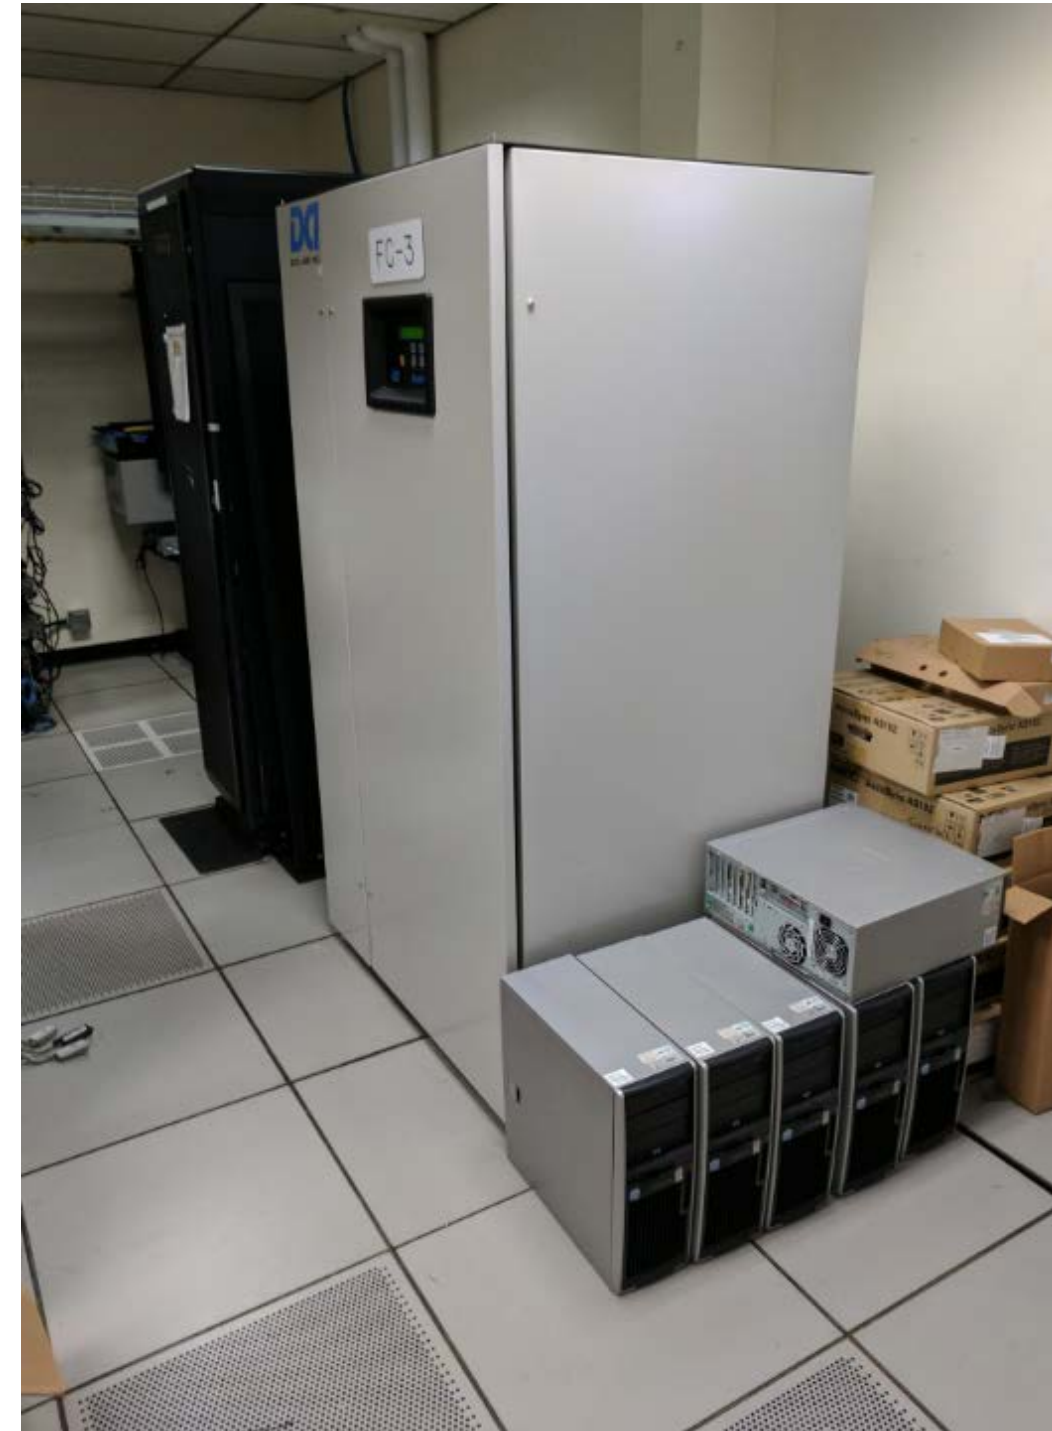
Figure 32: Liebert AC Unit Serving the Data Center

The public safety building also includes a data center, Emergency Operations Center, Crime Lab, transit monitoring room, and other PSC related program areas.

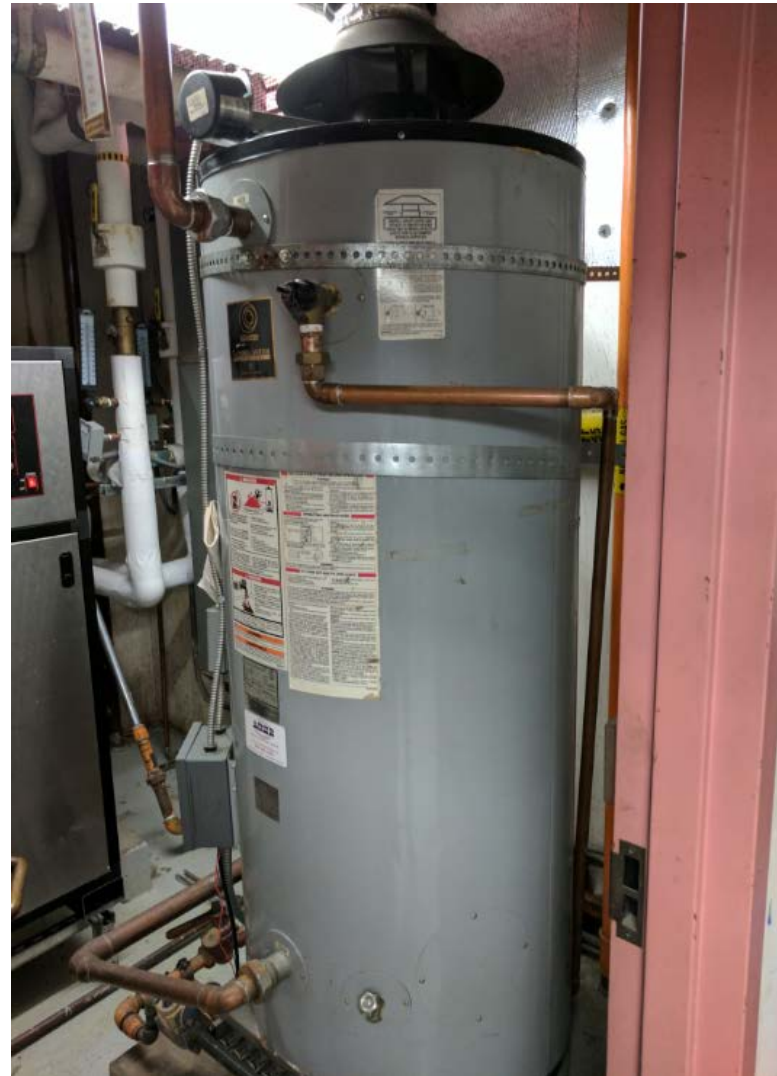
Figure 33: Domestic Hot Water Gas Fired Heater and sewer/storm ejector Pumps

The existing plumbing utilities and piping infrastructure is from the original building construction and approximately 33 years old. The existing plumbing piping infrastructure (domestic cold water, sanitary sewer, storm, and gas) should be tested prior to being reused.

The building plumbing fixtures are outdated in terms of water performance and would not meet current CALGreen code requirements, requiring that they be replaced in a renovation scenario.

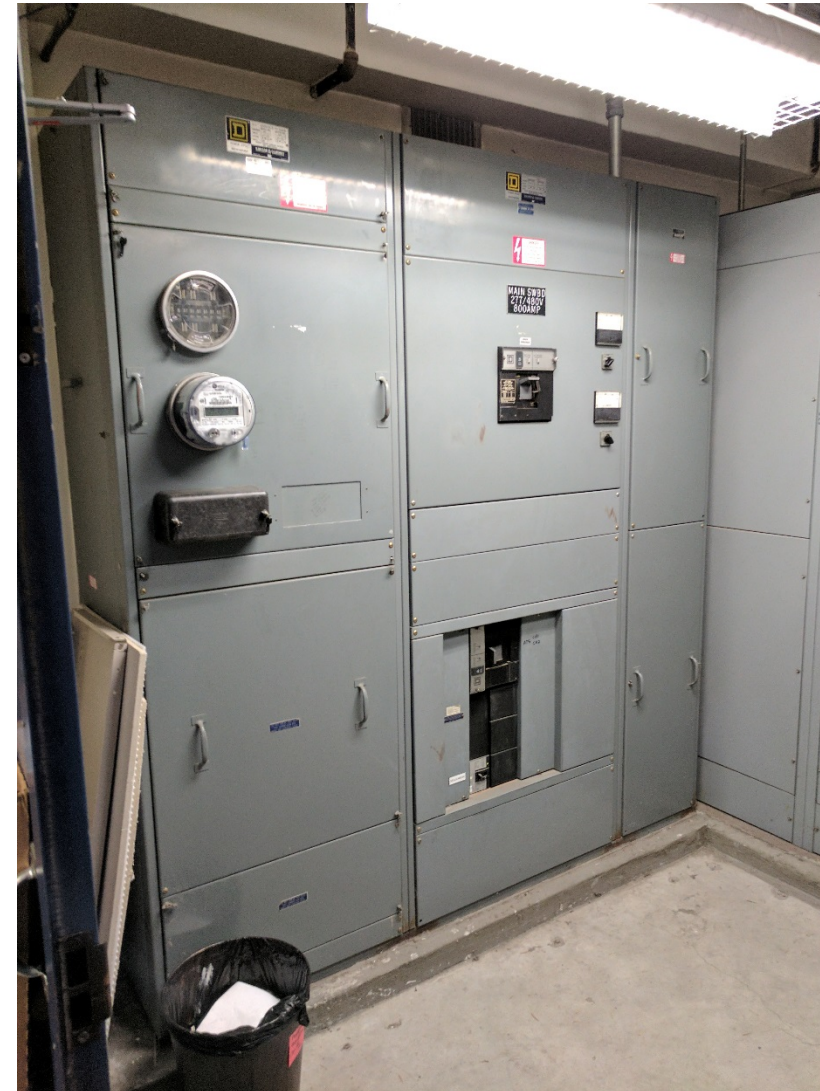
Figure 34: Main Distribution Panel

The majority of the main distribution and secondary distribution panels is in good condition, of original vintage, and manufactured by Square D.

Based upon the main panel's rating of 800A, 480Y/277V, 3-phase, 4-wire, the existing service could serve a load density of approximately 11W/sf. The electric service appears to be appropriate for the building type.

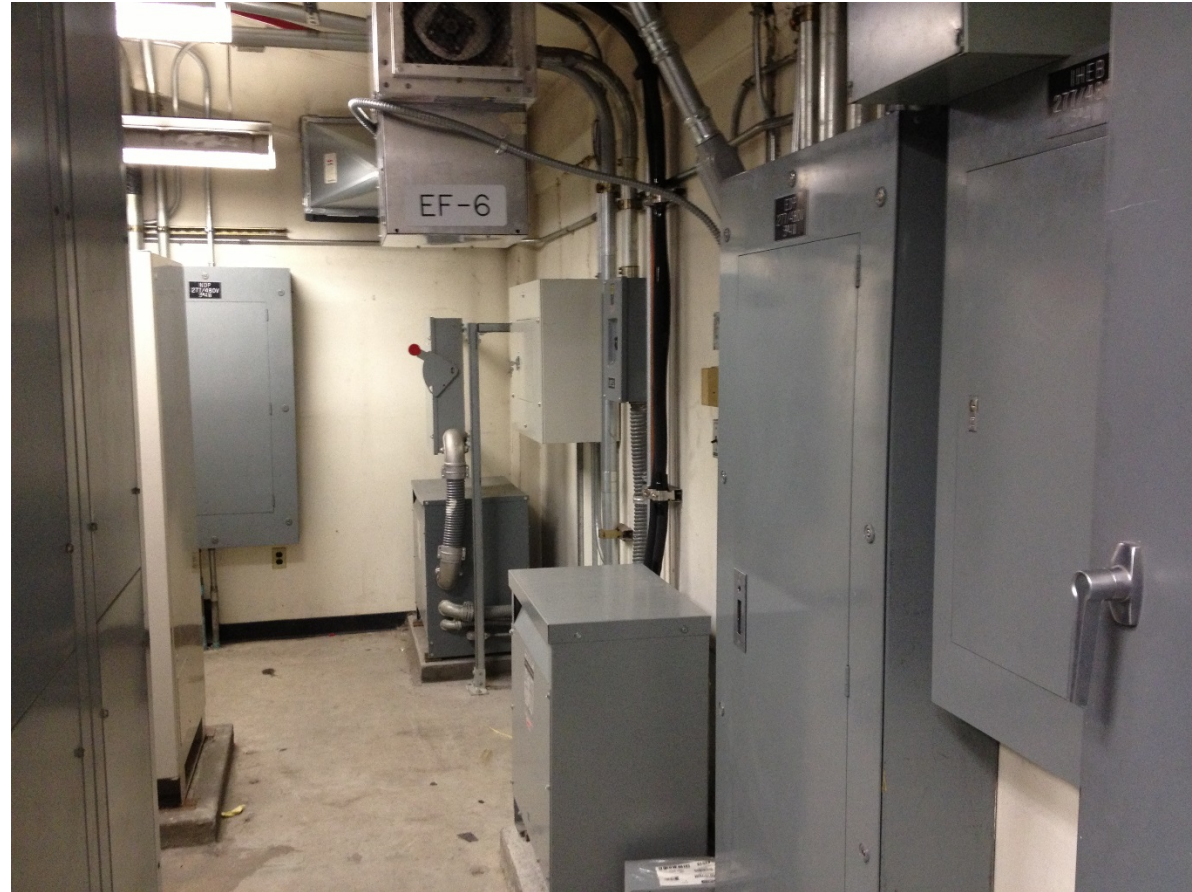
Figure 35: Branch Panels

The 800A main switchboard serves secondary distribution panels, motor control centers, and branch panels. Branch power panels are distributed throughout the facility to feed power, lighting, mechanical, elevator, and computer room loads and are rated at 100A-to-225A. Existing panels appear to be in good condition.

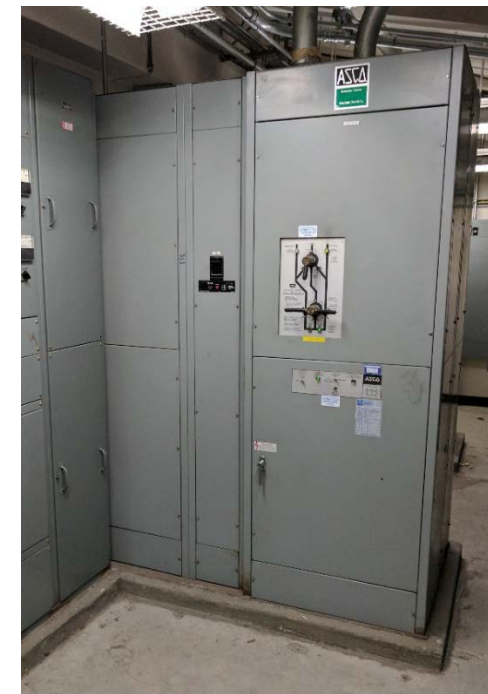
The building is also provided with two 230kW diesel, 480/277V, 3-phase, 4-wire generators. The generators are located together in an exterior enclosure and do not appear to be paralleled. Instead, the emergency power system consists of a 6-pole changeover switch accompanied by a pair of 3-pole transfer switches.

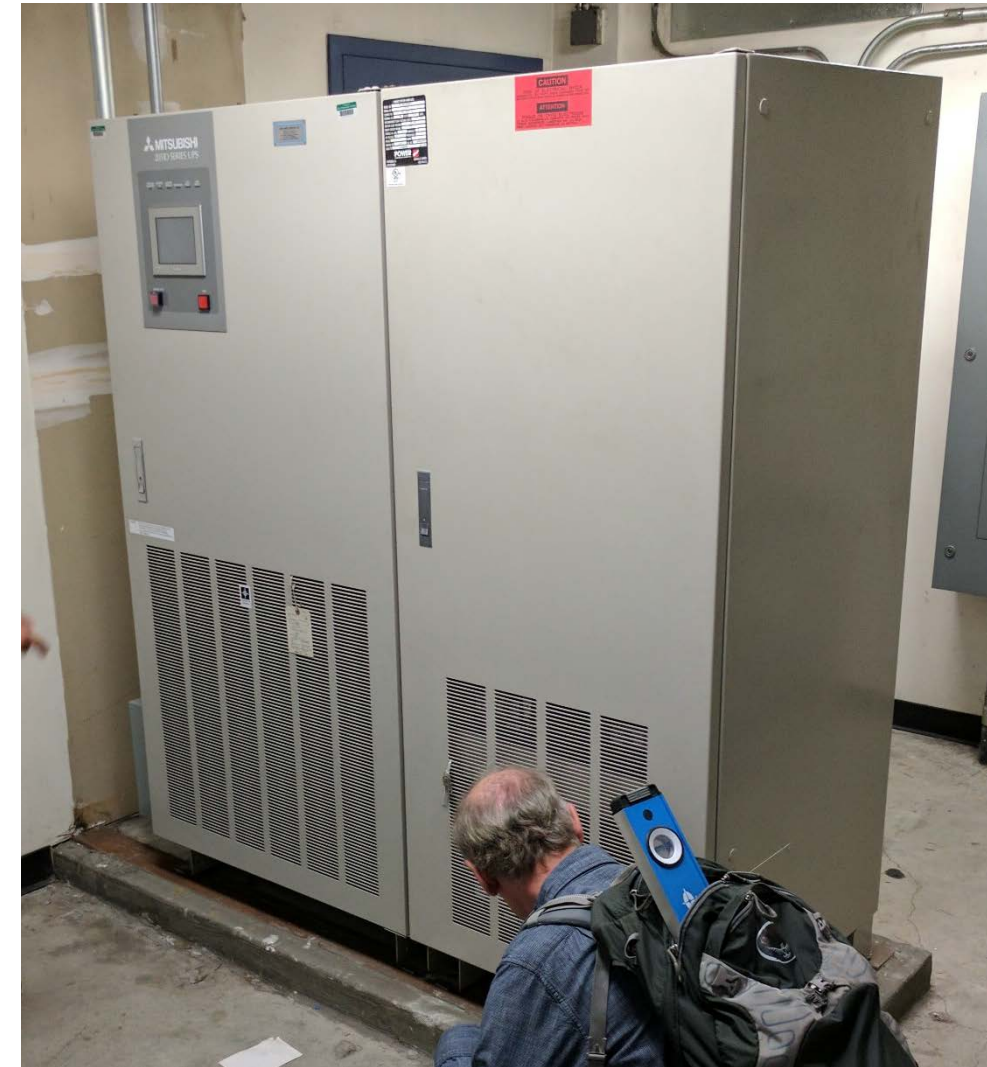
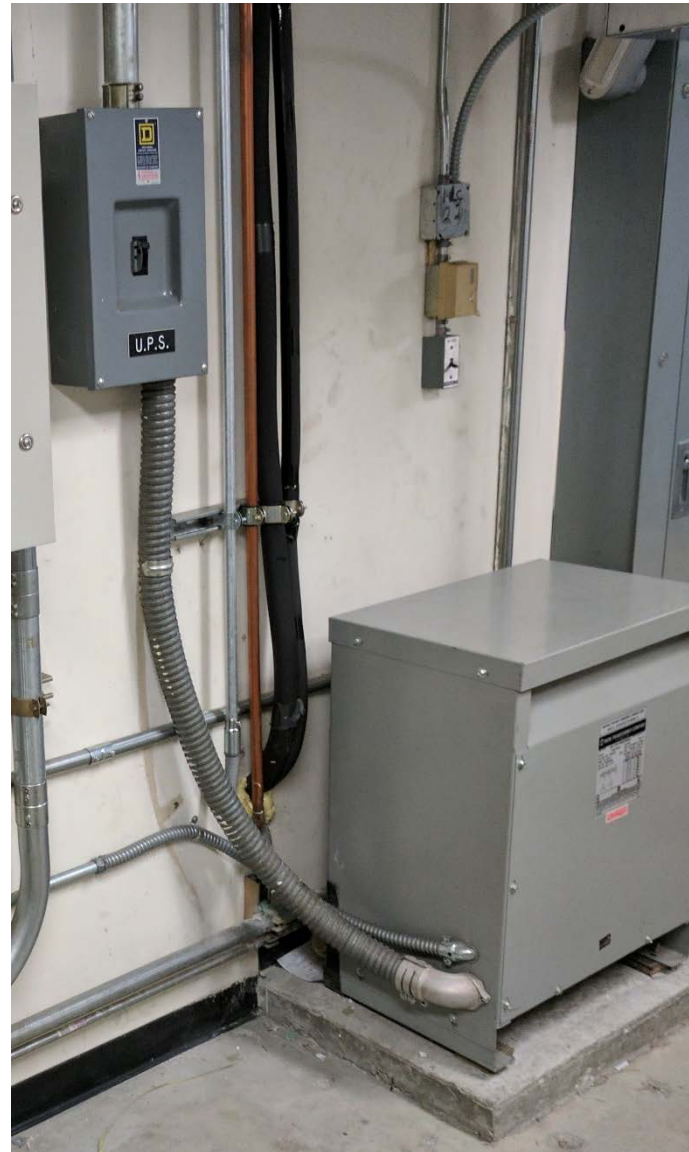
Figure 38: UPS Bypass Panel and Battery Cabinets

An additional 45kVA Uninterruptable Power Supply (UPS) located in the main electrical room provides backup power to Computer Room panels located in the room adjacent to the second floor computer room. The UPS is equipped with an integral input bypass which allows for manual transfer between utility and battery power.

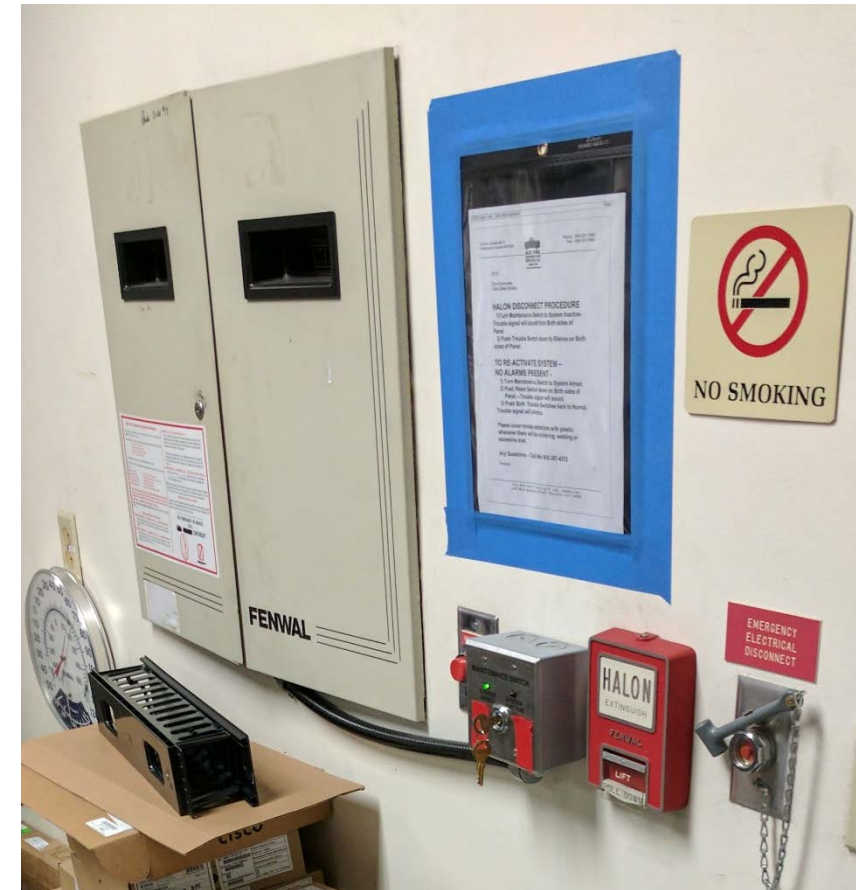
Figure 39: Computer Room Clean Agent Fire Suppression and Raised Floor

The Computer Room is provided with a Halon clean agent fire suppression system. The Computer Room is located on a raised floors with underfloor smoke detectors.

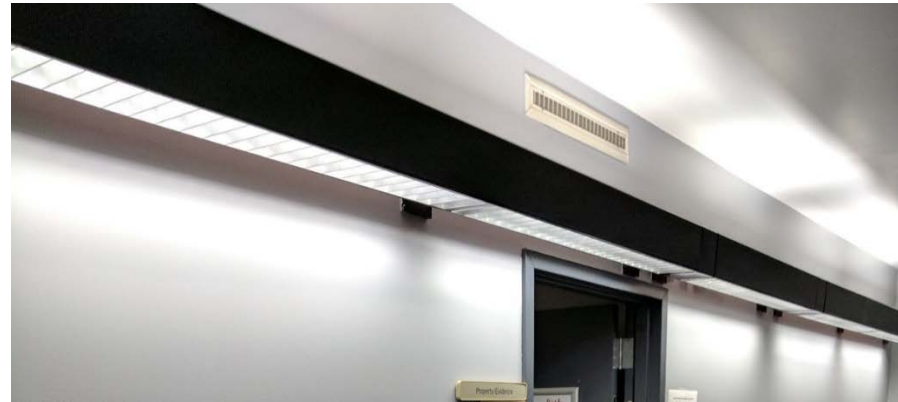
Figure 40: Typical Interior Light Fixtures

The building makes use of a combination of fixtures throughout, primarily 2'x4' recessed troffers and linear fluorescents. Existing fixture lamp types appear to be primarily linear fluorescent. The amount of lighting provided appears to be sufficient.

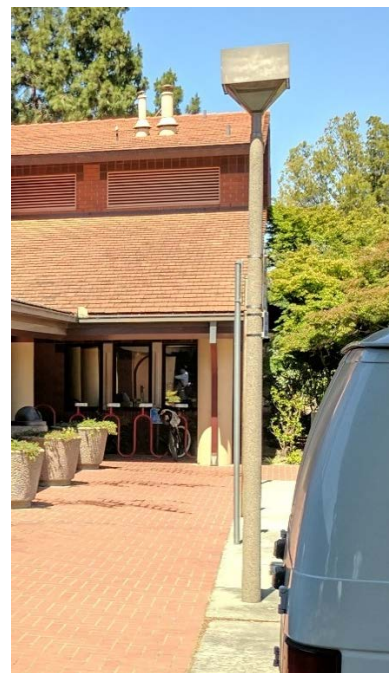
Figure 41: Typical Exterior Light Fixtures

Exterior lighting appears to consist of decorative pole fixtures located around the building perimeter.
