City of Sunnyvale

Notice and Agenda - Final Heritage Preservation Commission

DRAFT
DESIGN GUIDELINES
FOR
MURPHY STATION
HERITAGE LANDMARK
DISTRICT
April 2019 Version

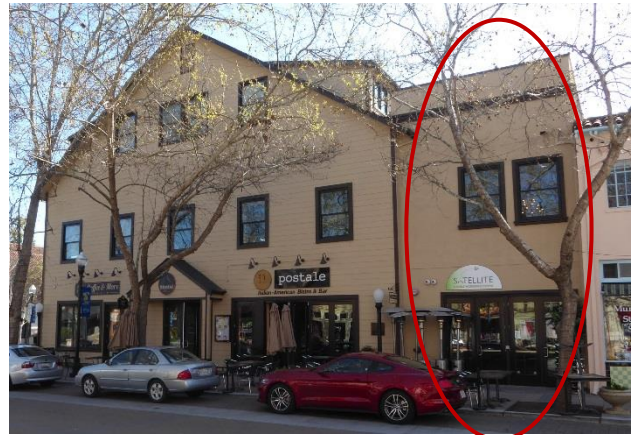
Overall building, Murphy Avenue elevation; circled area is later addition to the building.

- Extend horizontal wood siding onto two-story 1993 addition, but consider a slight variation in siding width to differentiate old from new.
- Obtain Sign Permit for existing signage (no permit history found for signage).
- Add gooseneck lights for all building signage.

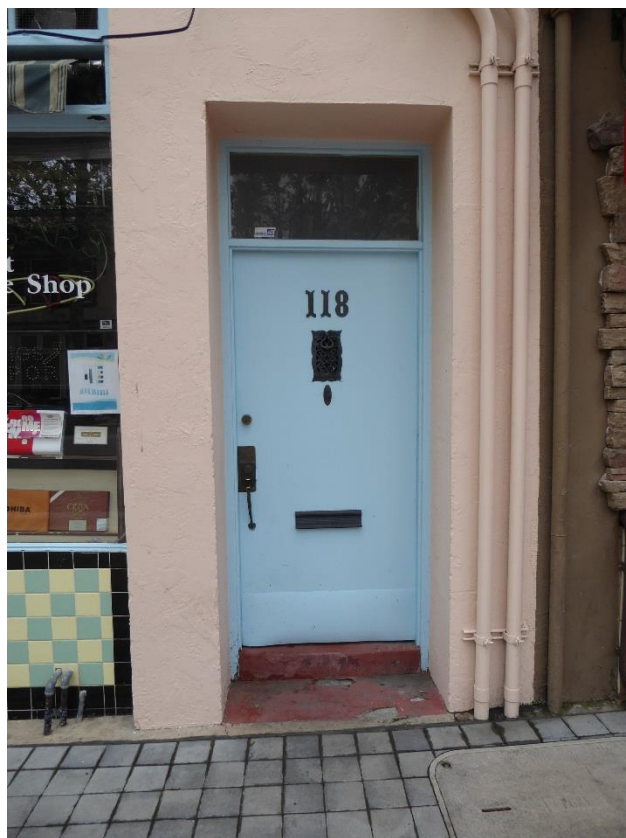
Above: Entry to upper story. Note exposed conduit.

- Conduit and meters should be minimized on the Murphy Avenue façade and priority given to relocating these (if possible).
- Remove unpermitted signage (State Farm) on the rear façade/gate of the building.
- Replace awning on front facade.

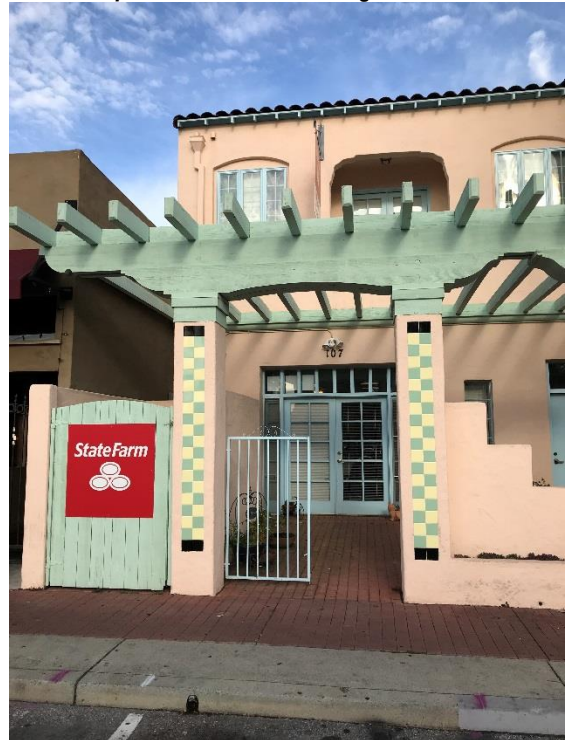
Below: Unpermitted State Farm sign on rear elevation

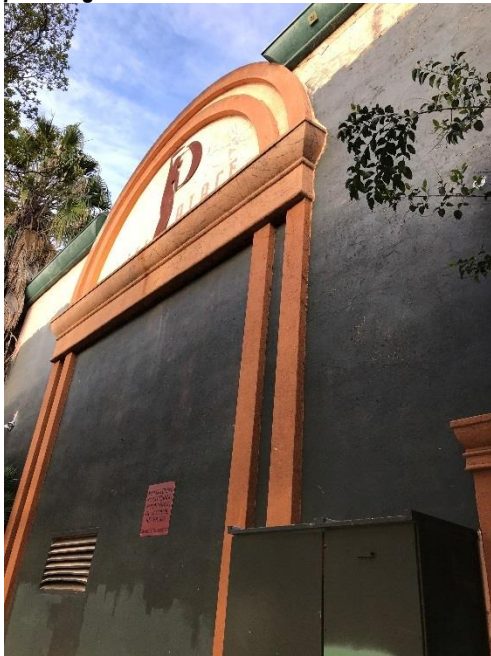
Below: Rear façade showing various paint schemes and patching.

- Expand tile base and replace with a tile color/style that is more compatible with the building/District.
- Repaint the entire building base the same color (all sides appear to be different colors) with priority given to the rear of the building where the paint line stops about three feet from roofline and is not a consistent color. Use color for trim or accent in limited locations.

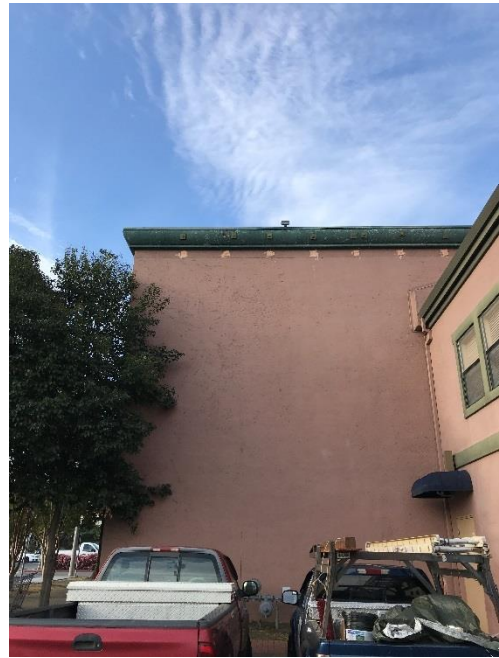
Above: Side façade showing paint colors.

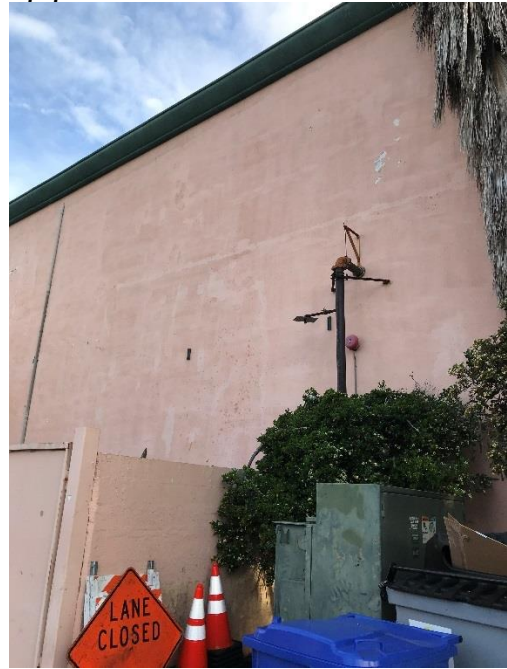
Below: Side façade with storage and mechanical equipment.

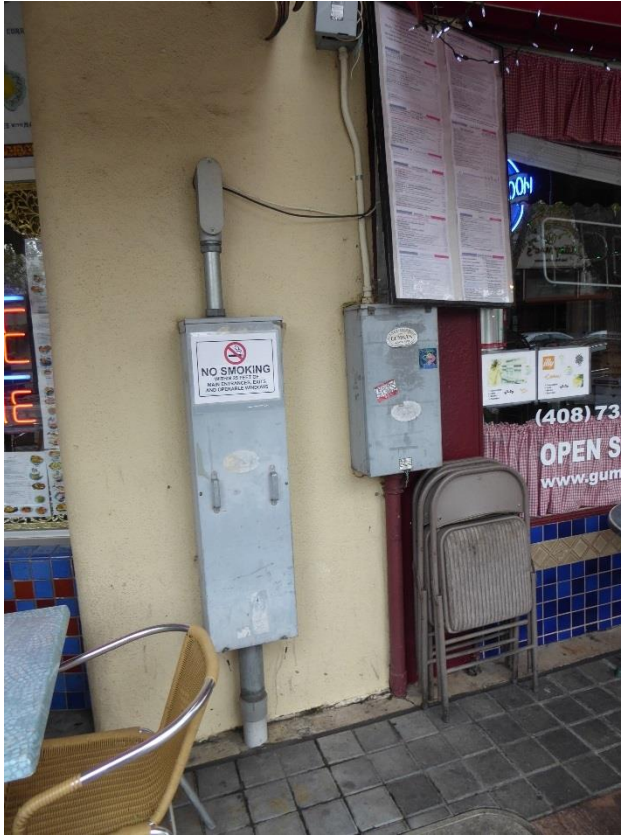
Above: Detail showing meters and conduit applied to exterior of building.

- Future modifications to the building should strive to contribute more to the character of the District.
- Replace faded awning.
- Restore transom window over doorway.
- Replace door with one that is more compatible with the District.
- Extend tile base across the entire front façade (except doorway).
- Minimize Conduit and meters on the Murphy Avenue façade and relocated (if possible).
- Per existing planning approval, remove existing rear structure and provide trash enclosure/storage that is consistent with the building and District.
- Remove potted trees on rear side of building, currently in plastic buckets from the nursery.

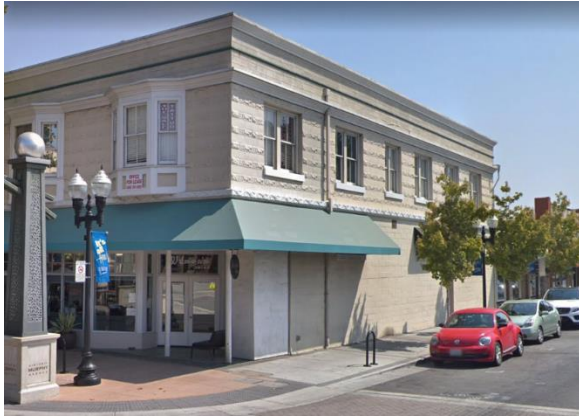
Above: View showing corner alteration

- Remove storage area next to salon on Murphy Avenue façade or incorporate it architecturally into the building, origin is unknown, but not original and no permits are found.
- Carry masonry exterior with smooth, and rough textured facing across entire building (modified around Salon tenant space).
- Minimize conduit and meters on the Murphy Avenue façade and relocate these elements (if possible).
- Remove the infill storage area at the corner where the second story overhangs the first creating a canted corner entry. This infill is not compatible with the historic character of the building and changes the corner entry. It is not of high quality material and is a highly visible, incompatible alteration.

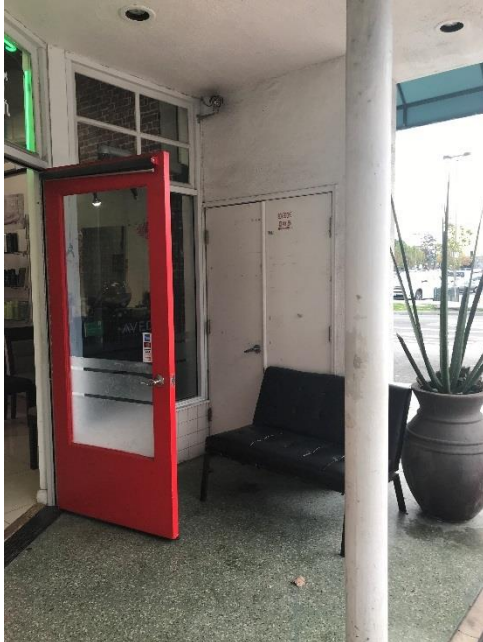
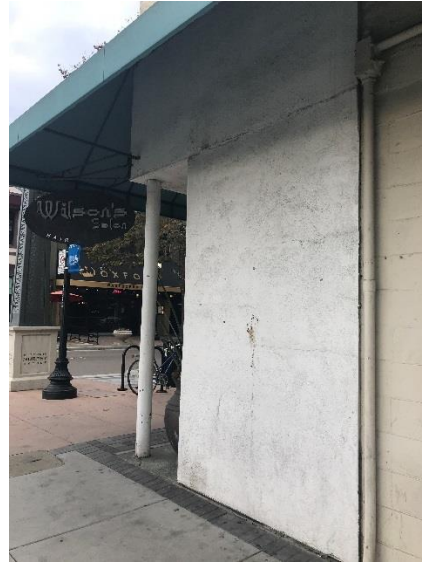
Below: Detail showing corner alteration

Above: Detail showing corner alteration and incompatible materials and placement.

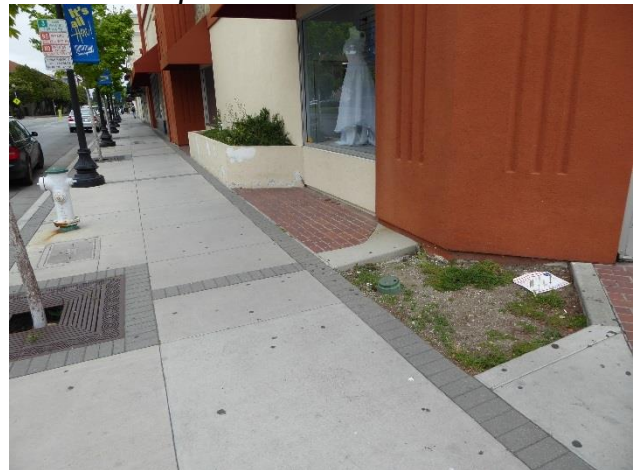
Below: Detail of planters.

- Landscape planters should be maintained or removed.
- Maintain planted area along S. Sunnyvale.
- Low wall along Washington Avenue is in need of repair.
- Update rear gate/fence with a style that is more compatible with the building and the District.
- Keep stored items within fenced area at rear of building.
- Exposed conduit and pipes should be minimized and priority given to relocating these (if possible).

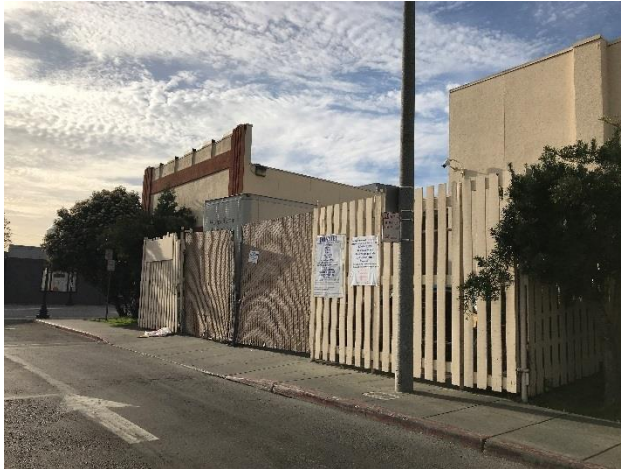
Above: Rear of building and parking lot.

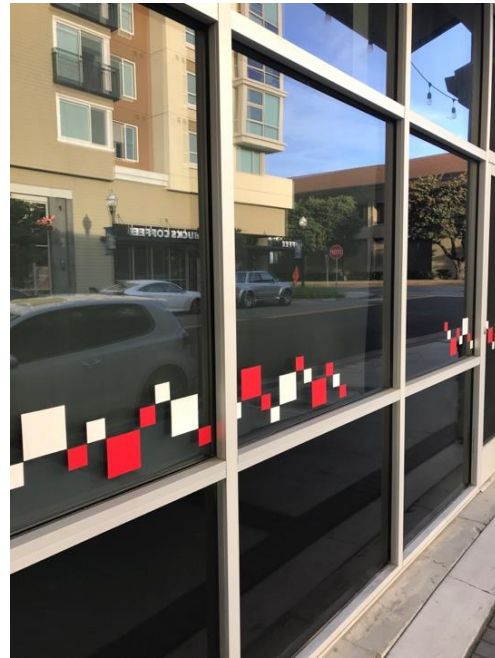
Above: A detail of the tinted windows on Frances Street.

- Conduit and meters should be minimized at Murphy Avenue façade and priority given to relocating these (if possible).
- Replace tinted windows at storefront with clear glass.

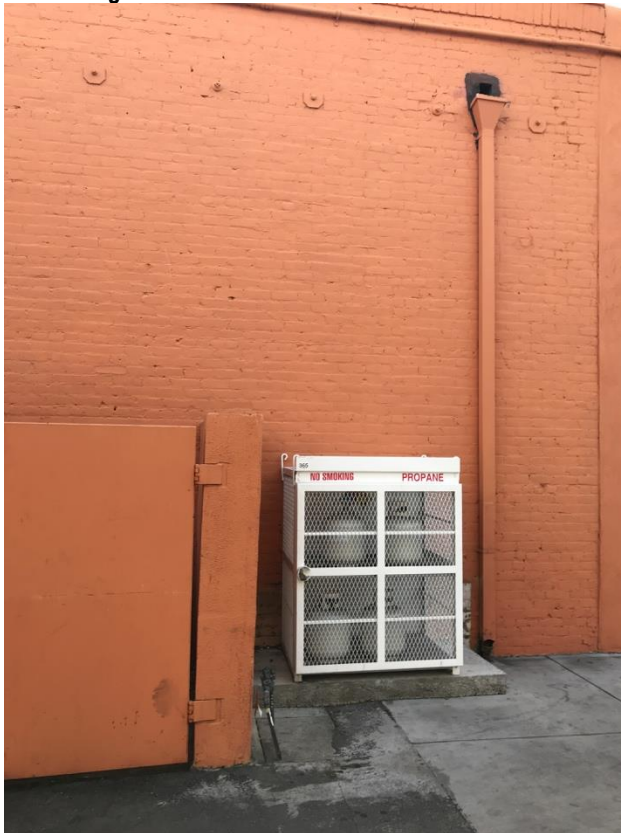
Below: The side elevation at the alley. Note the propane tank storage which is not recommended to continue.

- Maintain paint coatings at the upper story window surrounds and sills.
- Remove propane tank storage from alleyway off Washington Avenue.
- Replace windows on one-story Washington tenant space to a style that is more compatible with the District/building. The current windows are too contemporary.
- Remove gateway structure at rear of building.

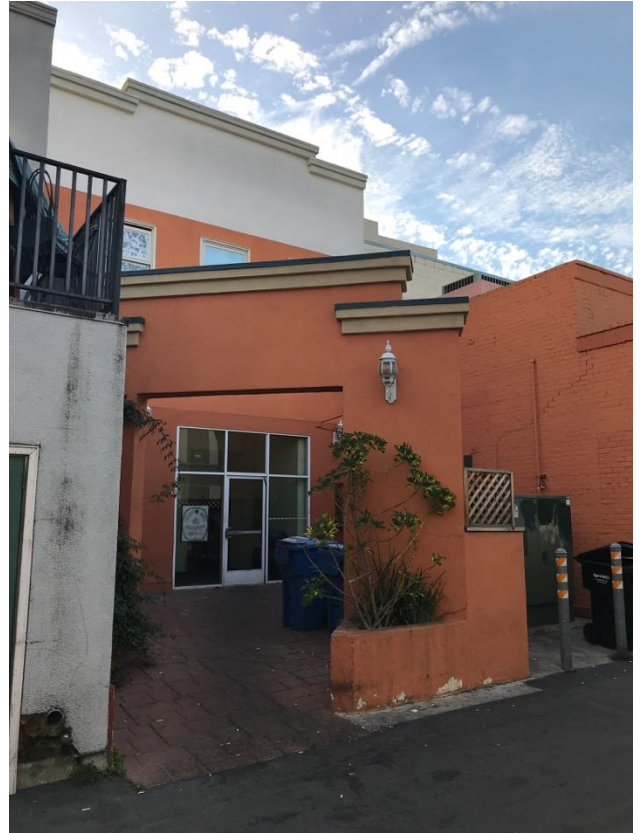
Above: Gateway to rear entrance.

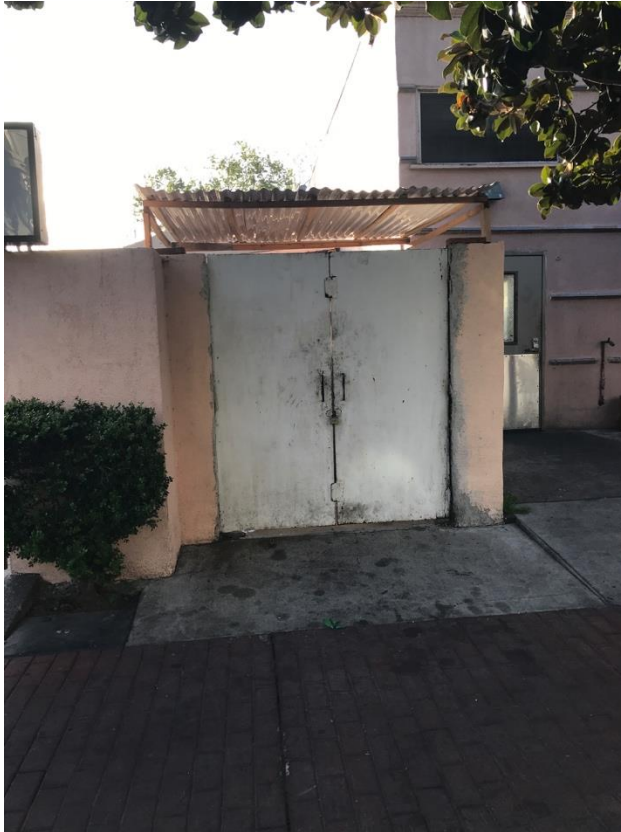
Below: Current trash enclosure.

- Future modifications to the building should strive to contribute to the character of the overall District.
- Replace opaque storefront glazing with transparent glass.
- Replace glass awning on front façade with something more compatible with the District.
- Remove horizontal banding on front façade.
- Recess entry doors and replace door style.
- Replace stone base with something more compatible (e.g. ceramic tile).
- Trellis structure at rear should be removed.
- Series of doors at south end of rear facade are unsightly and it is not clear why they are required. Remove if possible.
- Trash enclosure should be replaced with one that meets current regulations and is consistent with the building architecture (e.g. trash enclosure roof).

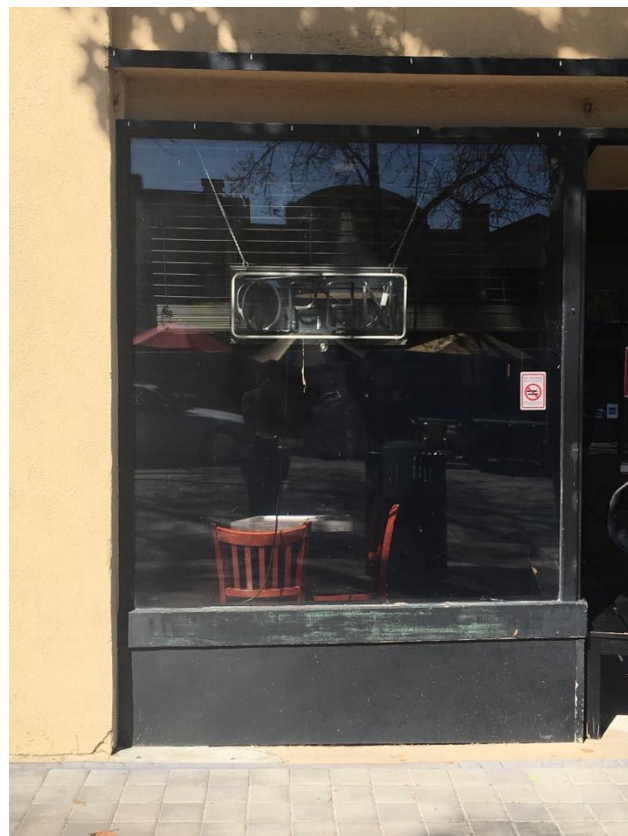
Above: The storefront glazing; note that this building does not have a tile base.

- Conduit and meters should be minimized at Murphy Avenue façade and priority given to relocating these (if possible).
- Install tile or brick on the base of the Murphy facade to further contribute to the District character.
- Consider exterior lighting (e.g. gooseneck lamp) on indented band above storefront windows.
- Make improvements to front façade above storefront windows; area appears unfinished with visible nails and fasteners apparent.
- Modify the trash enclosure “roof” to make it more compatible with the building.
- Replace rear cabinet sign with a sign style that is compatible with the District; ensure current signage is property permitted.
- Opportunities exist for use of rear patio area to enhance the rear façade and engage uses at this side of the building.

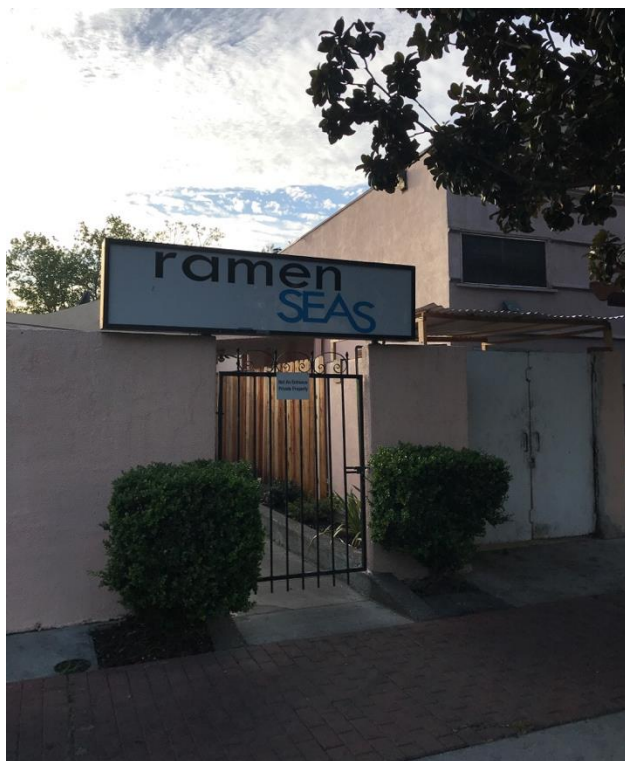
Above: At the rear of this building there is area for an outdoor patio space; the trash enclosure needs to be improved.

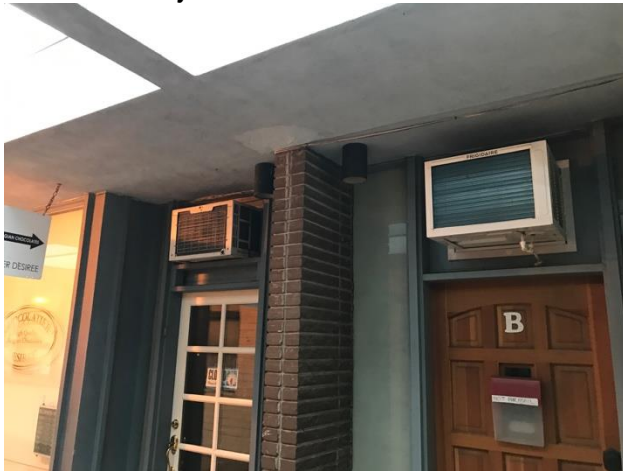
Below: Rear entry doors with air units above.

- Replace awnings on rear façade.

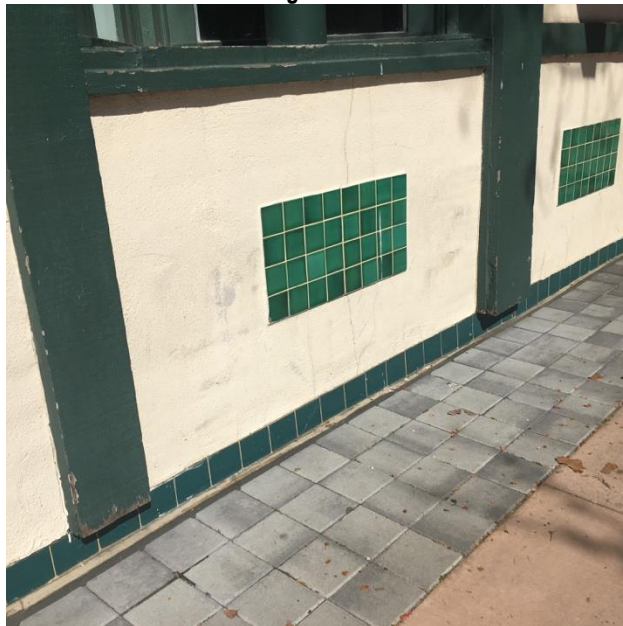
Below: Detail of the building base.

- Replace tile base so that is more compatible with tile in the District.
- Create more openings along the facades of the building, to create a more open, glazed storefront.
- Replace the entry door with one that is more compatible with the District.
- Remove tile from roof over the main entrance.
- Make modifications to the rear façade, consolidate multiple trash/equipment enclosures.
- Open up and repair windows that are covered in the breezeway and enhance the pedestrian experience in the breezeway.
- Replace roof awning in rear of building, or remove all together.

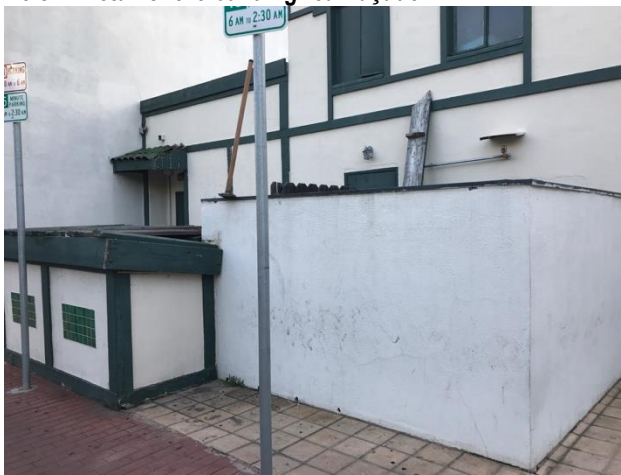
Below: Detail of the building rear façade.

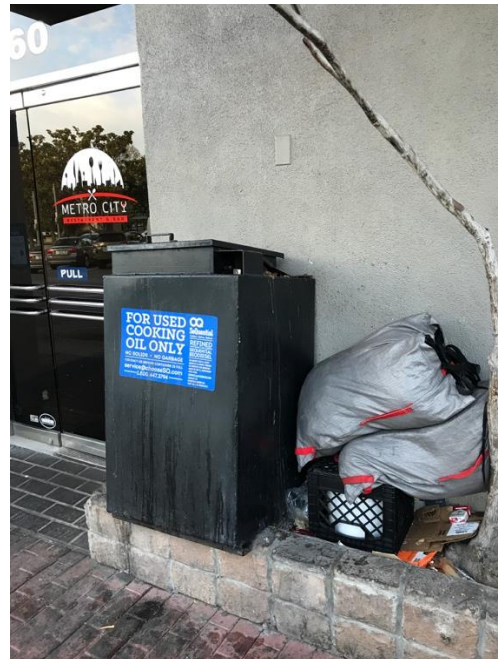
Below: Rear area showing oil storage that should be enclosed.

- Conduit and meters should be minimized at Murphy Avenue façade and priority given to relocating these (if possible).
- Consider variation in the form of the parapet, similar to other buildings in the District.
- Replace trash enclosure door (missing one door) in rear of building.
- No materials should be stored at outside area in rear of building. Storage of items related to restaurant use should be located inside the tenant space or within an existing screened storage area.

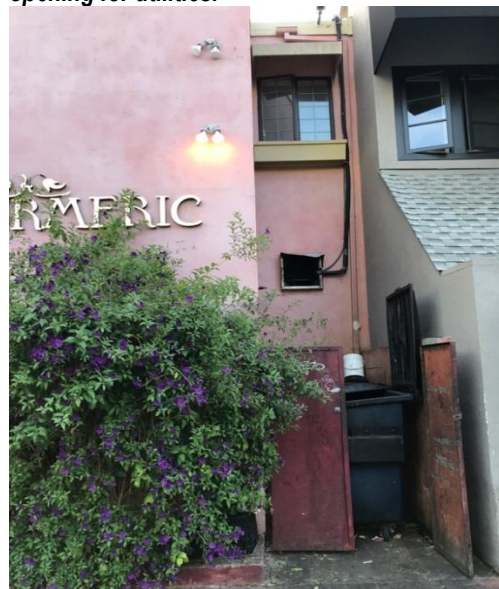
Below: Detail of rear showing trash enclosure and opening for utilities.

- Future modifications to the building should strive to make the building more compatible with the character of the District.
- Conduit and meters should be minimized at the Murphy Avenue façade and priority given to relocating these (if possible).
- Replace front awning with one that spans across the building.
- Re-paint building with a lighter color base with darker color(s) for trim and accent.
- Open up the front façade with additional windows or openings.
- Replace second story windows with a window design that is more compatible with the District
- Replace rear awnings.
- Cover the large utility opening at rear façade.
- Re-paint rear trash enclosure to remove graffiti and replace the roof of the structure.
- Power wash pavement at rear of building (adjacent to trash enclosure) regularly to ensure the area remains clean.

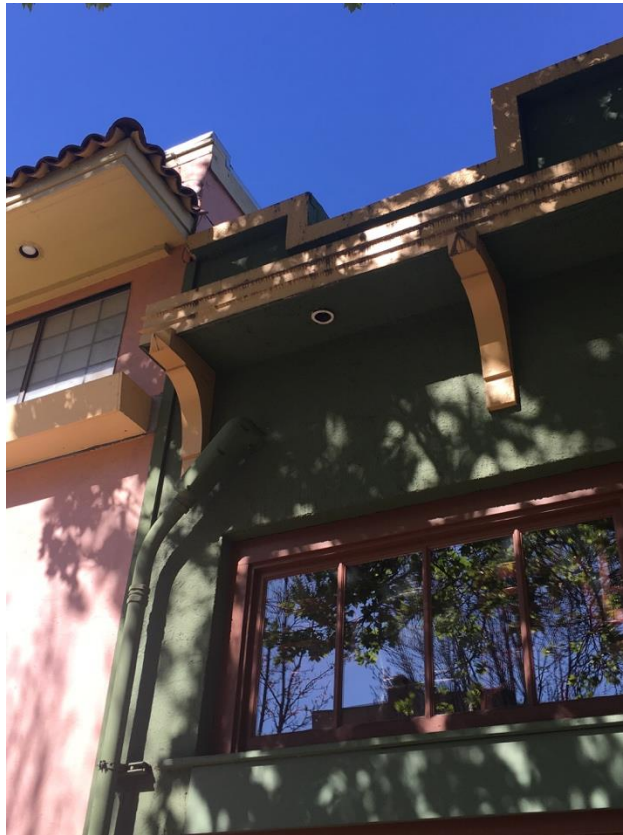
Above: Front transom detail and conduit on façade.

- Conduit and meters should be minimized at Murphy Avenue façade and priority given to relocating these, if possible.
- Retain tile base, but replace existing tiles with a tile/style that is more appropriate to the building design and District.
- Rear elevation is in good condition; however, future modifications should strive to make it more compatible with the District by employing fewer materials and providing consistent door openings.

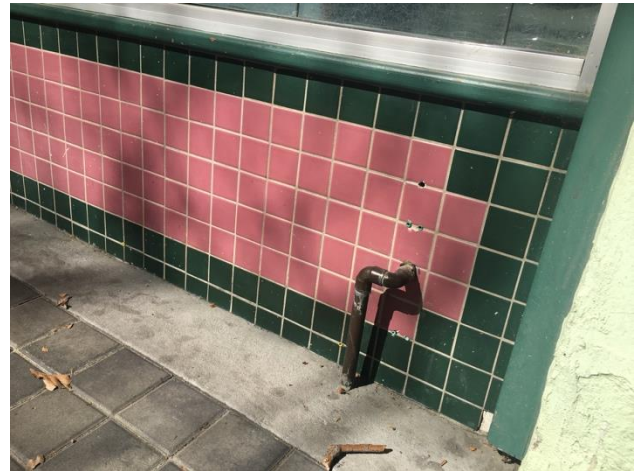
Above: Detail of tile base with utility line at front façade.

- Conduit and meters should be minimized at Murphy Avenue façade and priority given to relocating these, if possible.
- Consider use of a smaller-scaled awning to enhance the storefront.
- Replace missing tiles from ceramic tile base.
- Consider re-painting in a lighter, creamier color, with dark accents.
- Maintain the tile base along Murphy Avenue, but consider use of different colored tiles to better enhance the building character.
