RESOLUTION NO. _____

A RESOLUTION OF THE CITY COUNCIL OF THE CITY OF SUNNYVALE UPDATING THE MURPHY AVENUE DESIGN GUIDELINES, NOW TO BE KNOWN AS THE DESIGN GUIDELINES FOR THE MURPHY STATION HERITAGE LANDMARK DISTRICT, AND FIND THAT THE ACTION IS EXEMPT FROM CEQA

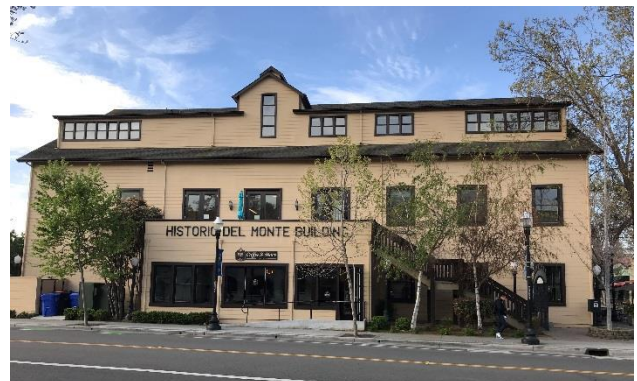
Overall building, Murphy Avenue elevation; circled area is later addition to the building.

- Extend horizontal wood siding onto two-story 1993 addition, but consider a slight variation in siding width to differentiate old from new.
- Obtain Sign Permit for existing signage (no permit history found for signage).
- Add gooseneck lights for all building signage.

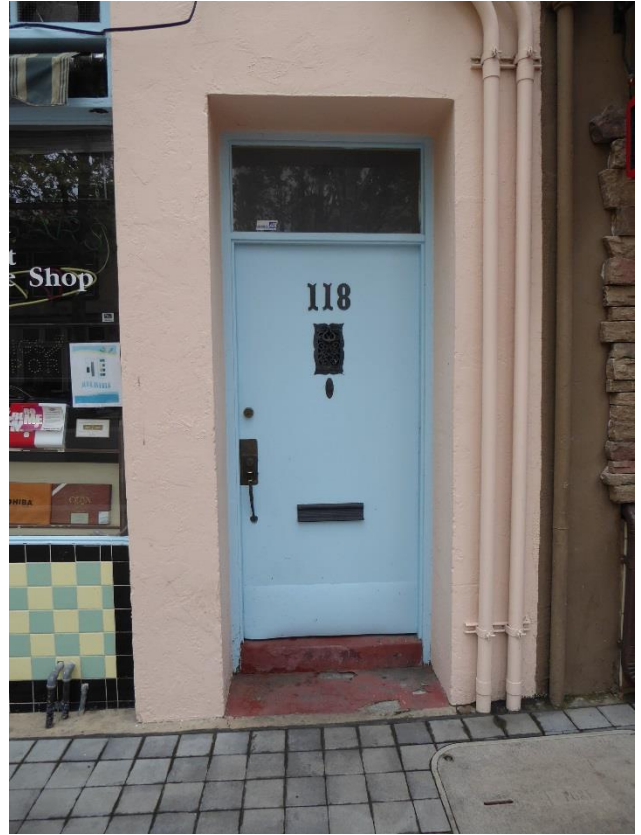
Above: Entry to upper story. Note exposed conduit.

- Conduit and meters should be minimized on the Murphy Avenue façade and priority given to relocating these (if possible).
- Remove unpermitted signage (State Farm) on the rear façade/gate of the building.
- Replace awning on front facade.

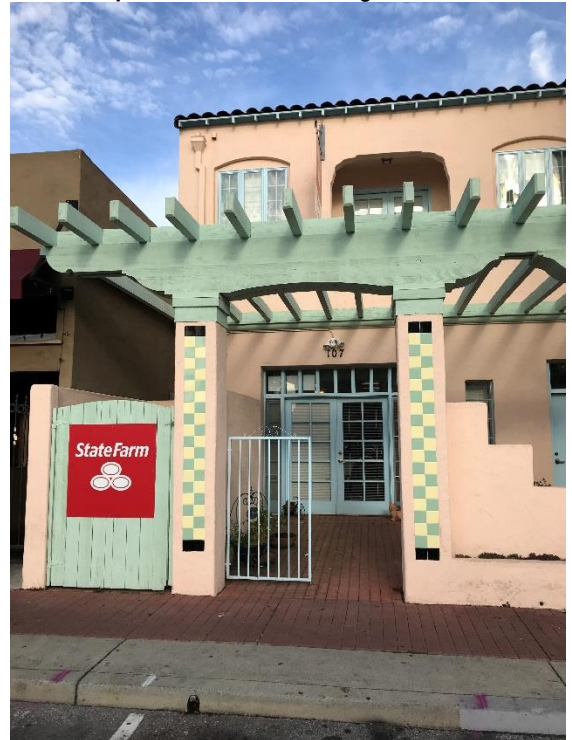
Below: Unpermitted State Farm sign on rear elevation

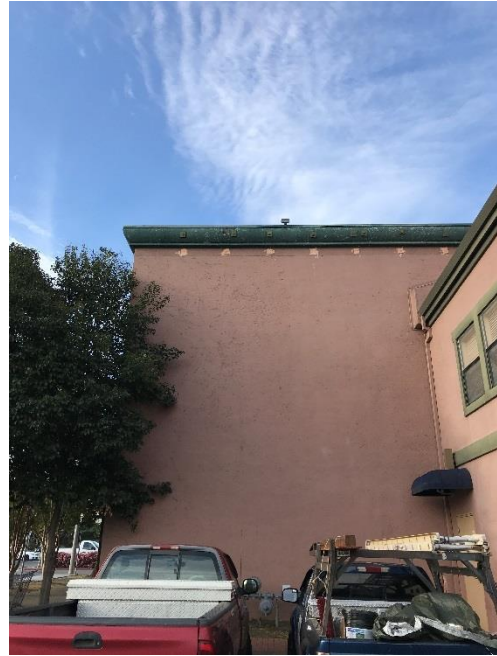
Below: Rear façade showing various paint schemes and patching.

- Expand tile base and replace with a tile color/style that is more compatible with the building/District.
- Repaint the entire building base the same color (all sides appear to be different colors) with priority given to the rear of the building where the paint line stops about three feet from roofline and is not a consistent color. Use color for trim or accent in limited locations.

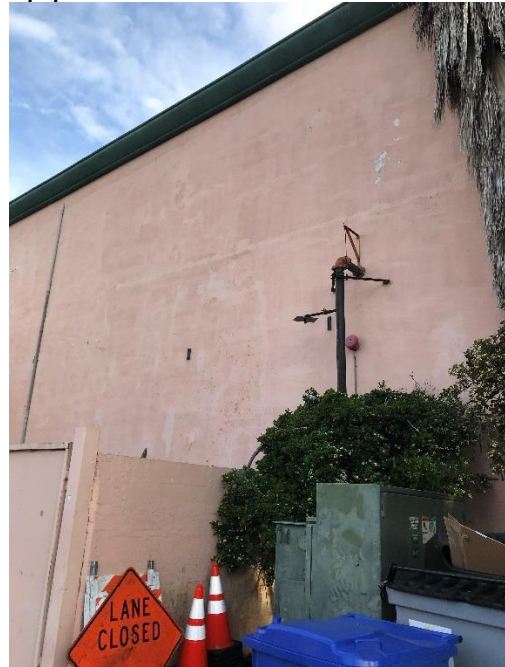
Below: Side façade with storage and mechanical equipment.

- If not already existing, construct a trash enclosure for the dumpster. It is often left out, adjacent to the parking lot.

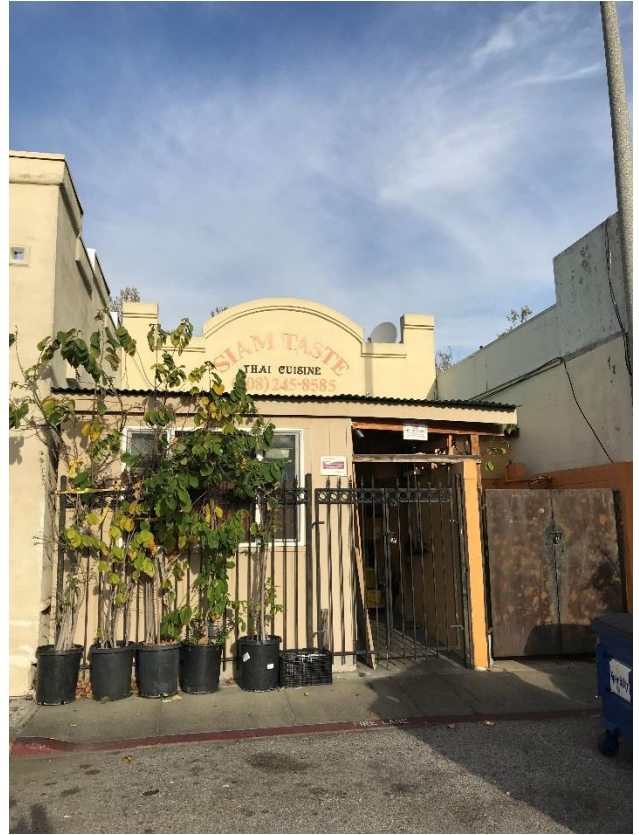
Above: Rear façade of storefront.

- Future modifications to the building should strive to contribute more to the character of the District.
- Replace faded awning.
- Restore transom window over doorway.
- Replace door with one that is more compatible with the District.
- Extend tile base across the entire front façade (except doorway).
- Minimize Conduit and meters on the Murphy Avenue façade and relocated (if possible).
- Per existing planning approval, remove existing rear structure and provide trash enclosure/storage that is consistent with the building and District.
- Remove potted trees on rear side of building, currently in plastic buckets from the nursery.

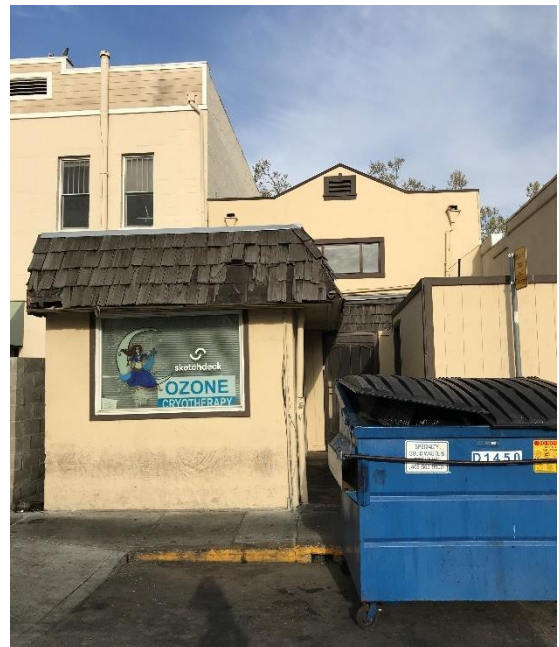
Above: Rear of storefront showing outbuildings and garbage dumpster.

- Remove tile from side walls and extend wood pilasters to ground.
- Minimize Conduit and meters at the Murphy Avenue façade and relocate these elements (if possible).
- Update tile color/style to be more compatible with the building/District.
- Consider bringing the upper level door closer to the sidewalk, but still maintain some set back. The entry door is more recessed than necessary.
- Rear structures should either be removed or updated so that they more readily fit the character of the District.

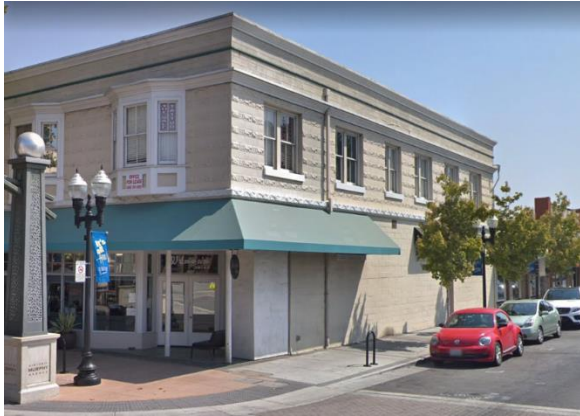
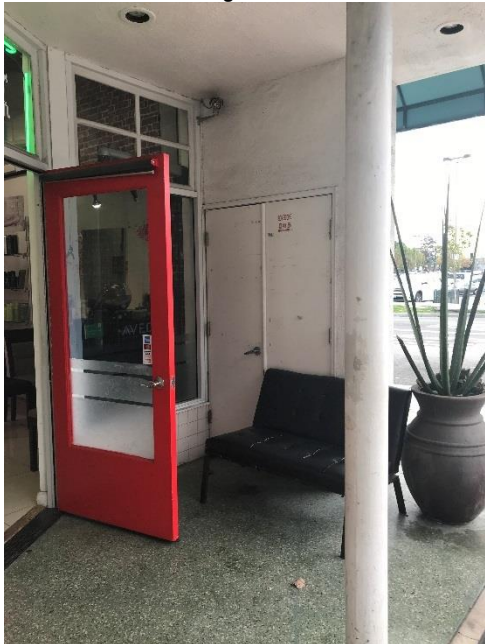
- Remove storage area next to salon on Murphy Avenue façade or incorporate it architecturally into the building, origin is unknown, but not original and no permits are found.
- Carry masonry exterior with smooth, and rough textured facing across entire building (modified around Salon tenant space).
- Minimize conduit and meters on the Murphy Avenue façade and relocate these elements (if possible).
- Remove the infill storage area at the corner where the second story overhangs the first creating a canted corner entry. This infill is not compatible with the historic character of the building and changes the corner entry. It is not of high quality material and is a highly visible, incompatible alteration.

Above: View showing corner alteration

Below: Detail showing corner alteration

Above: Detail showing corner alteration and incompatible materials and placement.

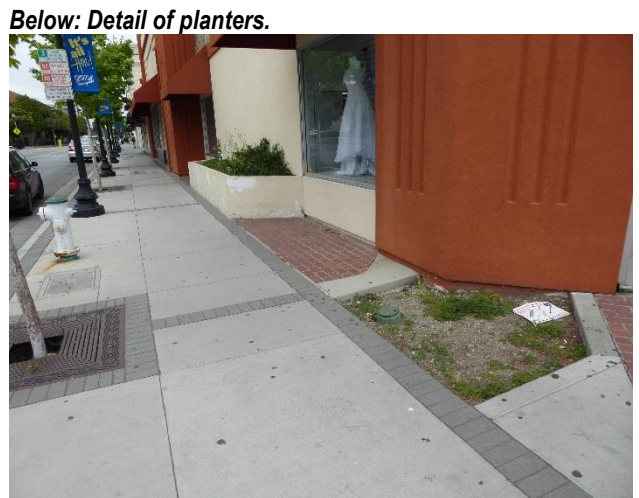
Below: Detail of planters.

- Landscape planters should be maintained or removed.
- Maintain planted area along S. Sunnyvale.
- Low wall along Washington Avenue is in need of repair.
- Update rear gate/fence with a style that is more compatible with the building and the District.
- Keep stored items within fenced area at rear of building.
- Exposed conduit and pipes should be minimized and priority given to relocating these (if possible).

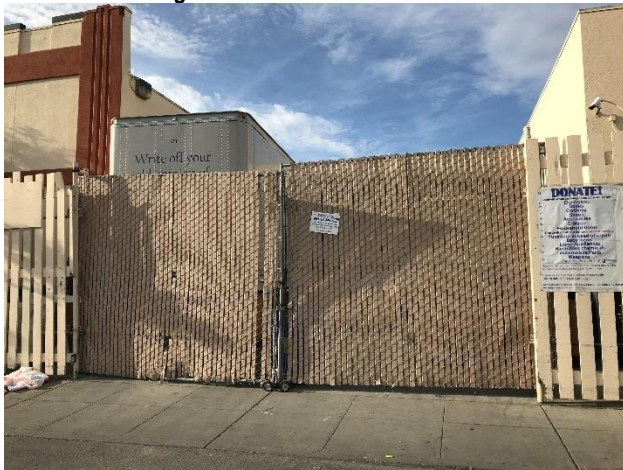
Below: Detail of gates.

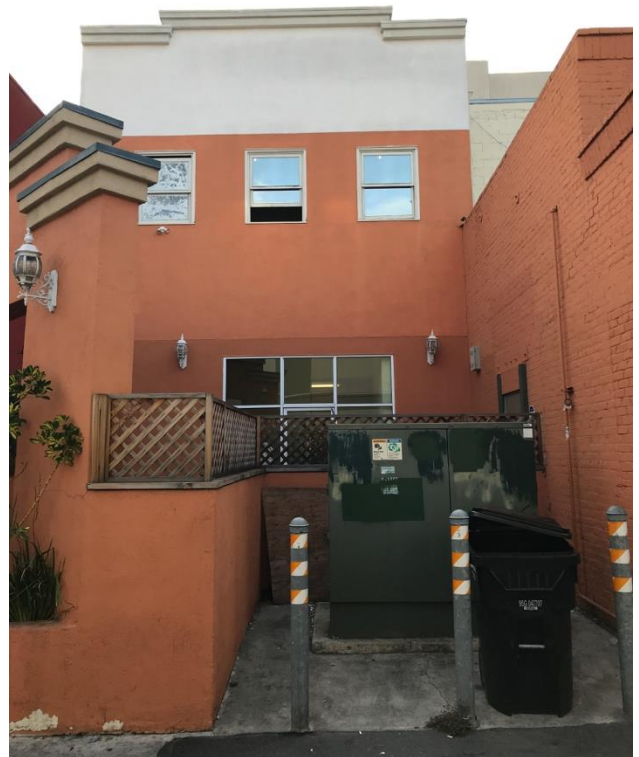
Above: Rear façade of building from alley

- Maintain paint coatings at the upper story window surrounds and sills.
- Remove propane tank storage from alleyway off Washington Avenue.
- Replace windows on one-story Washington tenant space to a style that is more compatible with the District/building. The current windows are too contemporary.
- Remove gateway structure at rear of building.

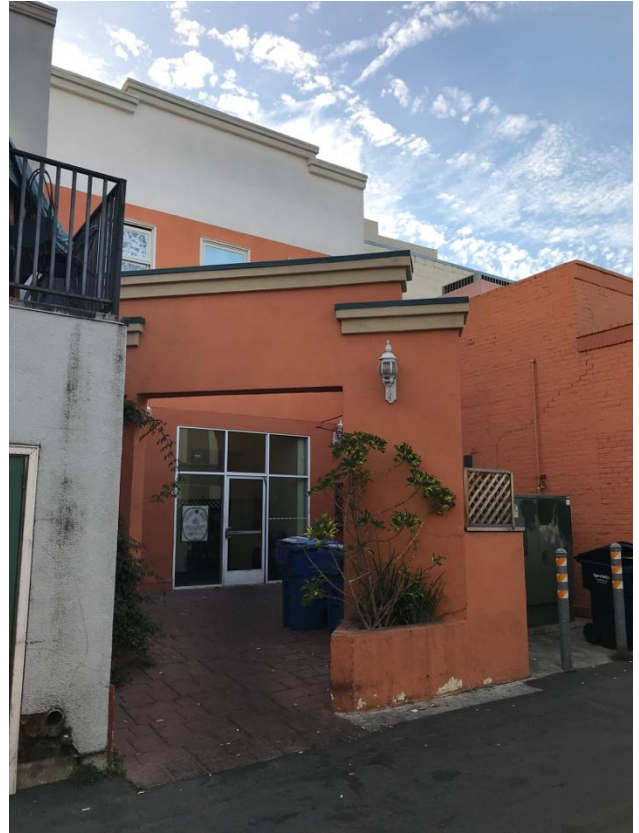
Above: Gateway to rear entrance.

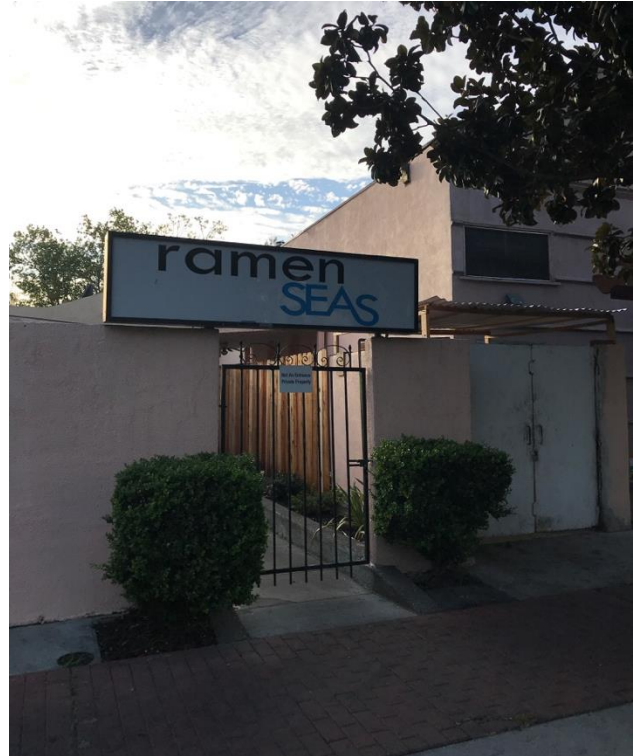
Above: At the rear of this building there is area for an outdoor patio space; the trash enclosure needs to be improved.

- Conduit and meters should be minimized at Murphy Avenue façade and priority given to relocating these (if possible).
- Install tile or brick on the base of the Murphy facade to further contribute to the District character.
- Consider exterior lighting (e.g. gooseneck lamp) on indented band above storefront windows.
- Make improvements to front façade above storefront windows; area appears unfinished with visible nails and fasteners apparent.
- Modify the trash enclosure “roof” to make it more compatible with the building.
- Replace rear cabinet sign with a sign style that is compatible with the District; ensure current signage is property permitted.
- Opportunities exist for use of rear patio area to enhance the rear façade and engage uses at this side of the building.

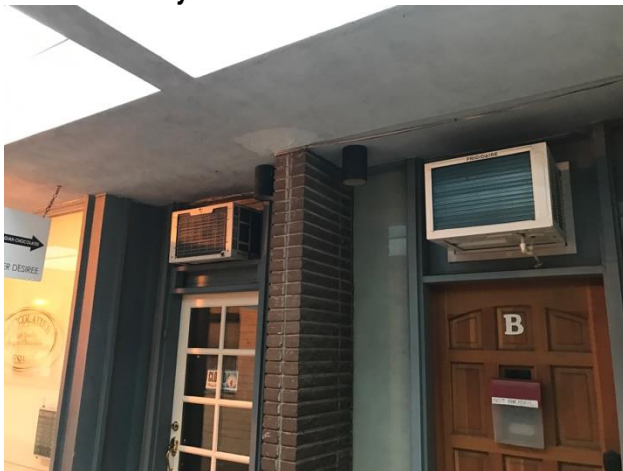
Below: Rear entry doors with air units above.

- Replace awnings on rear façade.

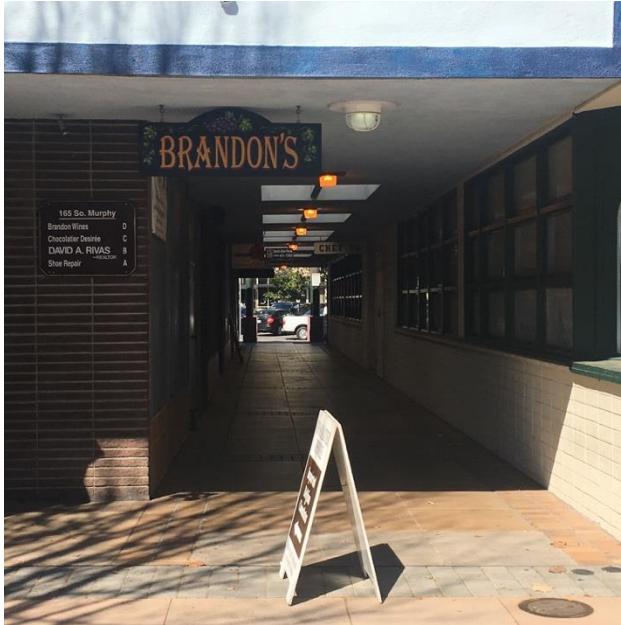
Below: Detail of the building rear façade.

- Replace tile base so that is more compatible with tile in the District.
- Create more openings along the facades of the building, to create a more open, glazed storefront.
- Replace the entry door with one that is more compatible with the District.
- Remove tile from roof over the main entrance.
- Make modifications to the rear façade, consolidate multiple trash/equipment enclosures.
- Open up and repair windows that are covered in the breezeway and enhance the pedestrian experience in the breezeway.
- Replace roof awning in rear of building, or remove all together.

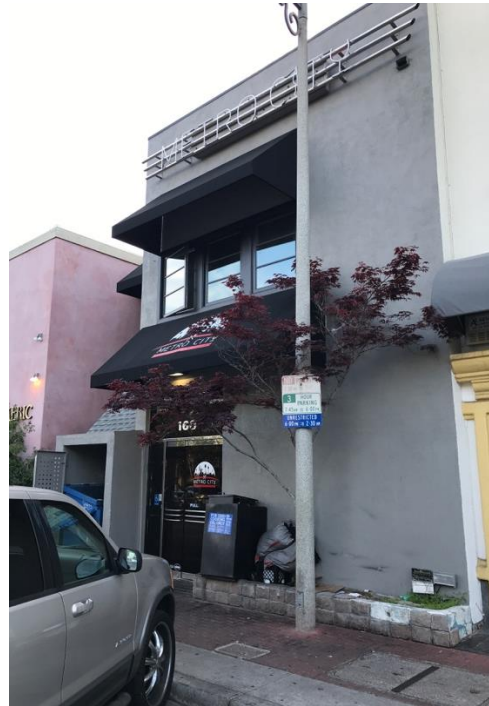
Above: Rear façade showing two stories.

- Conduit and meters should be minimized at Murphy Avenue façade and priority given to relocating these (if possible).
- Consider variation in the form of the parapet, similar to other buildings in the District.
- Replace trash enclosure door (missing one door) in rear of building.
- No materials should be stored at outside area in rear of building. Storage of items related to restaurant use should be located inside the tenant space or within an existing screened storage area.

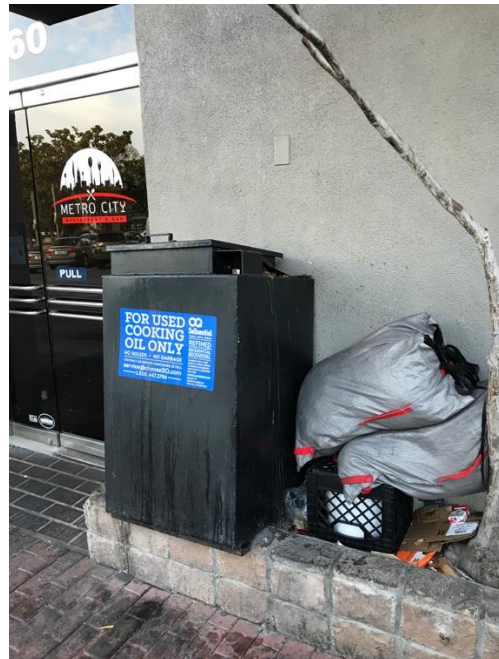
Below: Rear area showing oil storage that should be enclosed.

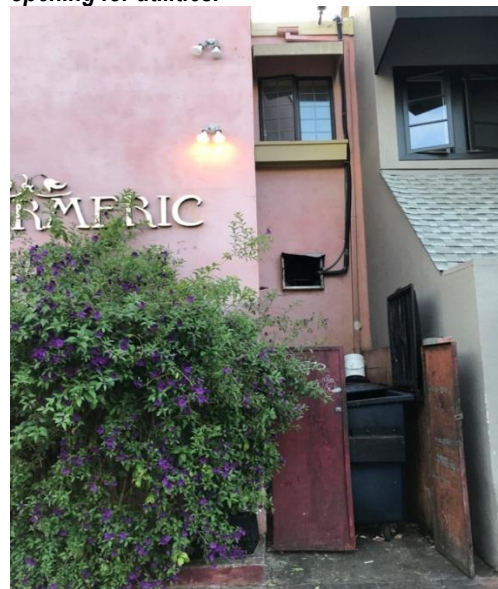
Below: Detail of rear showing trash enclosure and opening for utilities.

- Future modifications to the building should strive to make the building more compatible with the character of the District.
- Conduit and meters should be minimized at the Murphy Avenue façade and priority given to relocating these (if possible).
- Replace front awning with one that spans across the building.
- Re-paint building with a lighter color base with darker color(s) for trim and accent.
- Open up the front façade with additional windows or openings.
- Replace second story windows with a window design that is more compatible with the District
- Replace rear awnings.
- Cover the large utility opening at rear façade.
- Re-paint rear trash enclosure to remove graffiti and replace the roof of the structure.
- Power wash pavement at rear of building (adjacent to trash enclosure) regularly to ensure the area remains clean.

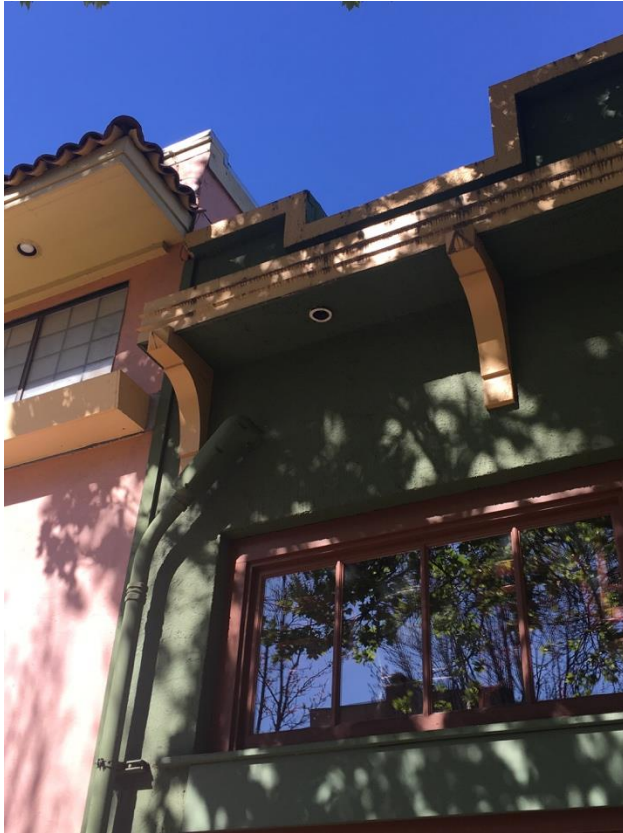
Above: Front transom detail and conduit on façade.

- Conduit and meters should be minimized at Murphy Avenue façade and priority given to relocating these, if possible.
- Retain tile base, but replace existing tiles with a tile/style that is more appropriate to the building design and District.
- Rear elevation is in good condition; however, future modifications should strive to make it more compatible with the District by employing fewer materials and providing consistent door openings.

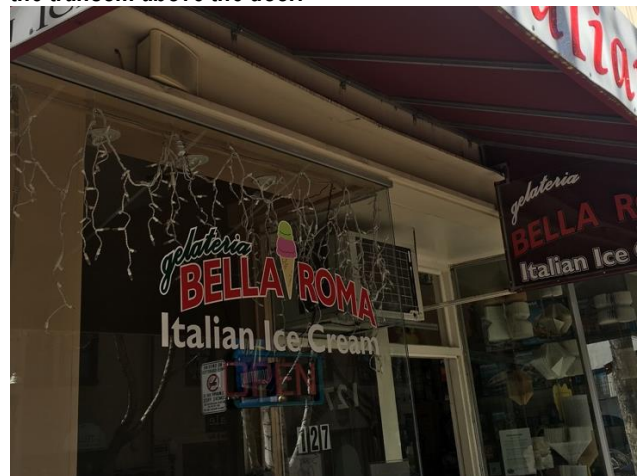
Below: This storefront has a window air conditioning unit in the transom above the door.

- Retain recessed store entries in historic configuration.
- Retain storefront doors and over door transom windows. Eliminate air conditioning units above storefront doors and find other solutions to cooling interior spaces.

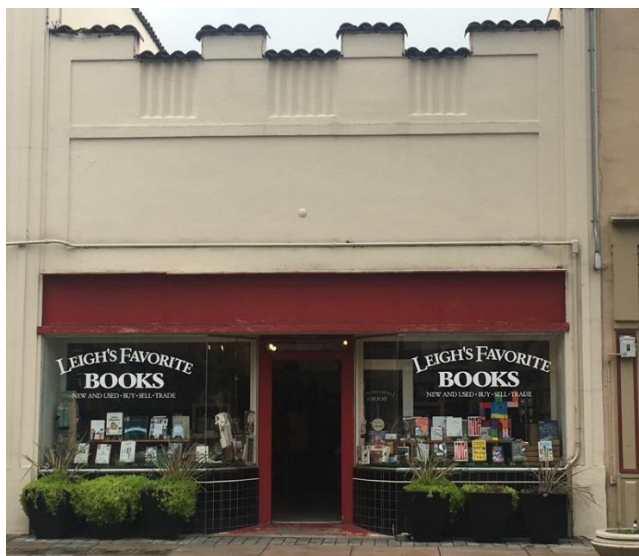
Below: These planters distract from the historic tile at the base of the storefront.

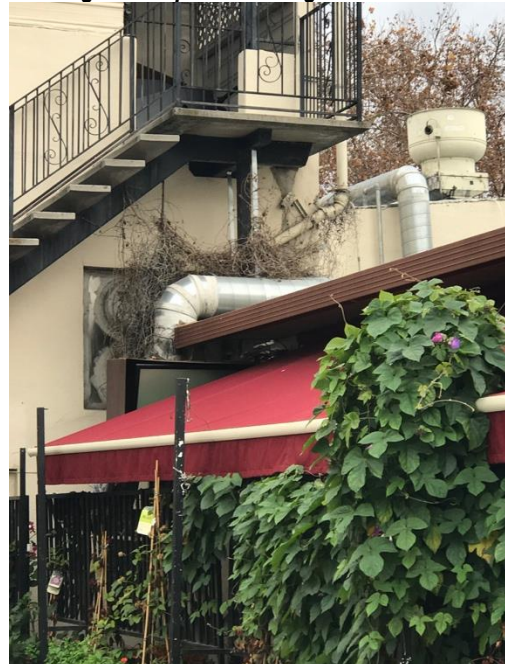
Below: The large, unsightly air ducts and venting at the building rear requires redesign.

- Replace the air duct at rear with a smaller duct and paint the new duct to match the existing building color, or relocate to an area that is out of the public view.
