**Date: 4/29/2019**  
**To: All Interested Parties**  
**From: Amber Blizinski, Principal Planner, Community Development Dept.**  
**Subject: Public Draft of the Design Guidelines for the Murphy Station Heritage Landmark District**

*DRAFT*  
DESIGN GUIDELINES  
FOR  
MURPHY STATION  
HERITAGE LANDMARK  
DISTRICT  
April 2019 Version

# MURPHY STATION HERITAGE LANDMARK DISTRICT

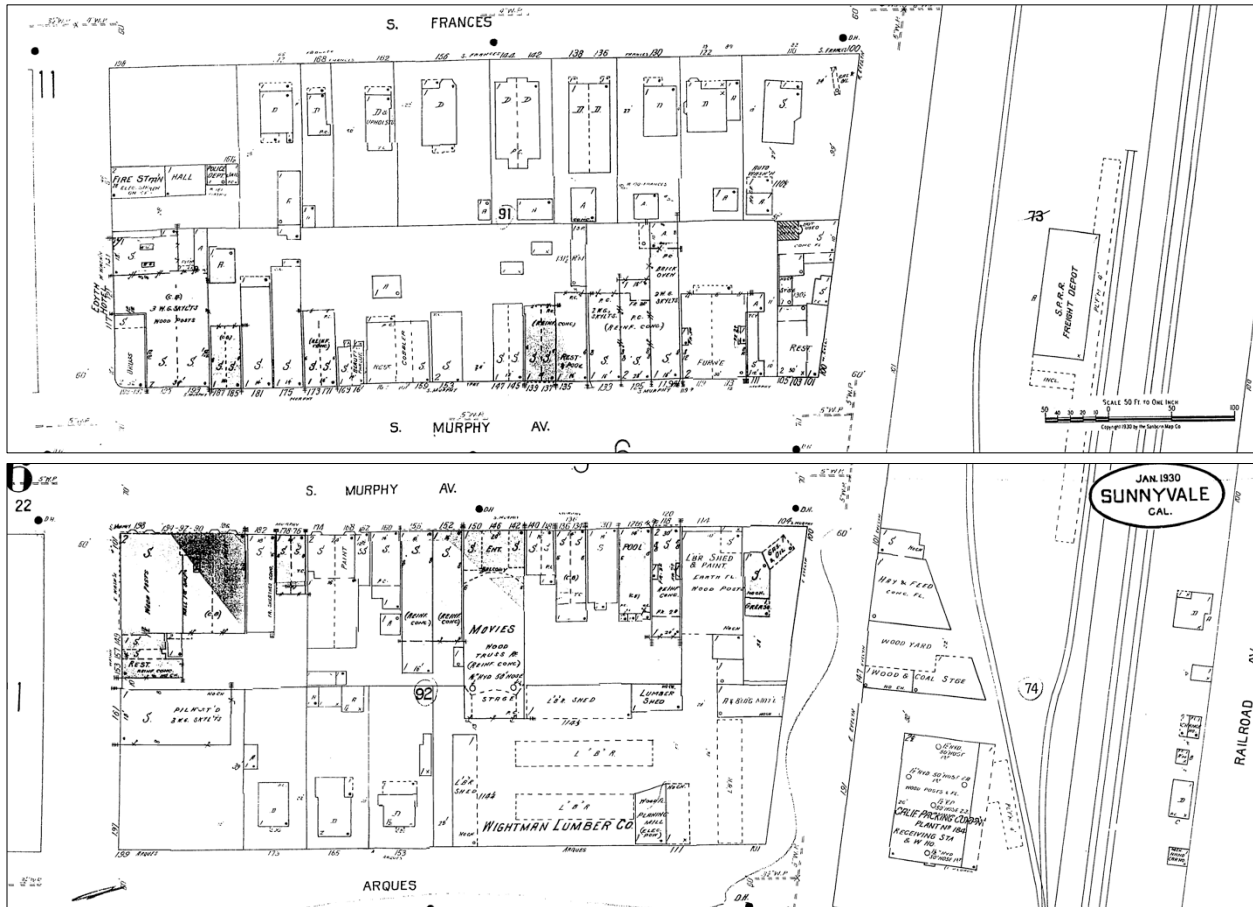
1943 Sanborn Maps of S. Murphy Avenue showing the former configuration of the rear lots, prior to parking areas being inserted where S. Francis and Arques Streets once aligned.

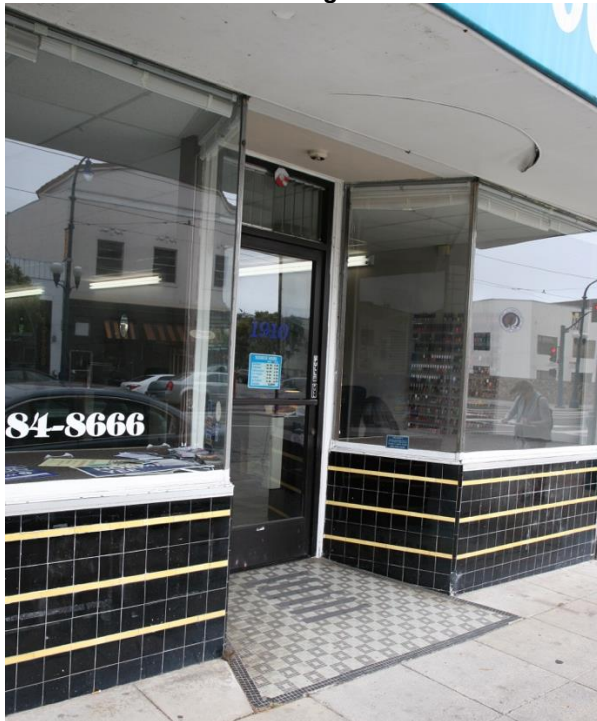
**Above: An intact, recessed storefront from the late 1920s.**

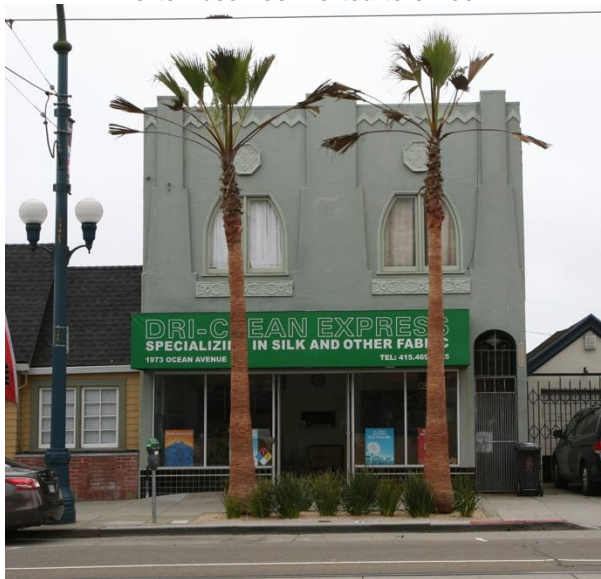
**Below: A strong example of a two-story, commercial building with a storefront at the first floor and a pedestrian entry to the upper story unit. Historically, these would have housed a business below, such as a small grocery with the grocer living above. Today, the upper story spaces have often been converted to office.**

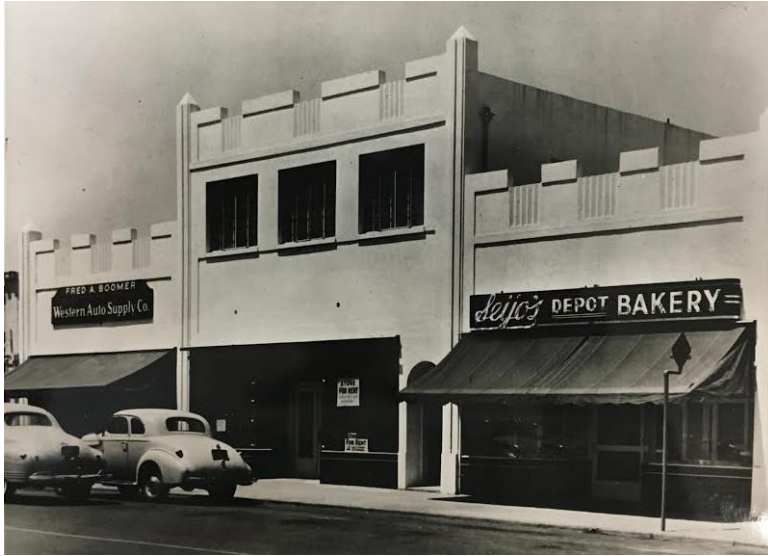
*Above: Note the tile work at the storefront base, the stepped parapet, the signage area, and stucco finish at 121-133 S. Murphy Ave.*

Sanborn Maps of the 100 block of S. Murphy Avenue indicate that historically this collection of buildings was wood frame, often with a stucco finish. Photographic evidence indicates windows were either wood frame or steel sash and were frequently framed in wood. A solid, permanent material was often employed at the storefront base, also referred to as a bulkhead, such as tile, stone or brick. Storefront entries sometimes had special flooring, such as terrazzo or colorful tile.

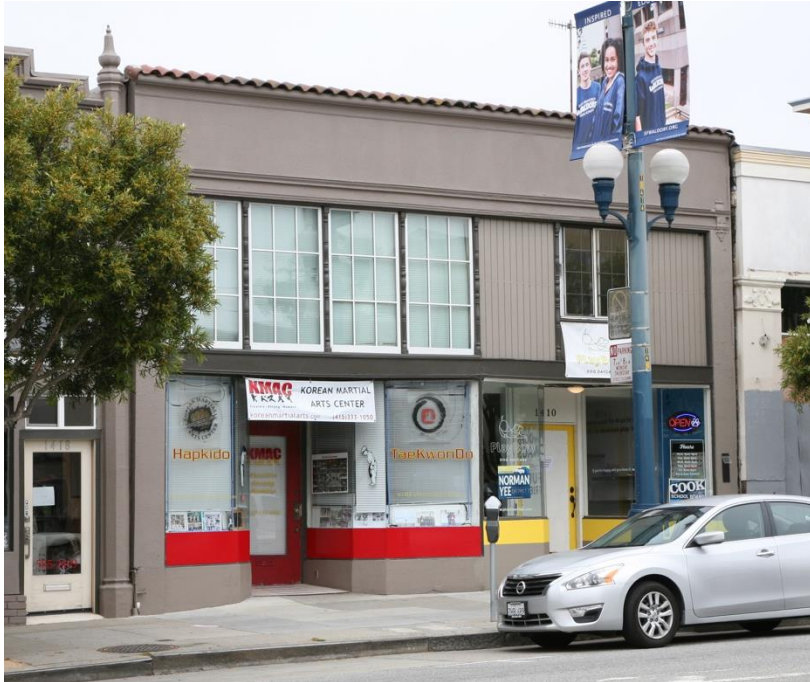
***This one-story commercial building has many intact features including its two recessed storefront entries and the detailing enframing the storefront including the large openings for the transom windows. Some transom windows have been lost and the base materials have been changed but the shape, form, massing and major features of this storefront remain.***

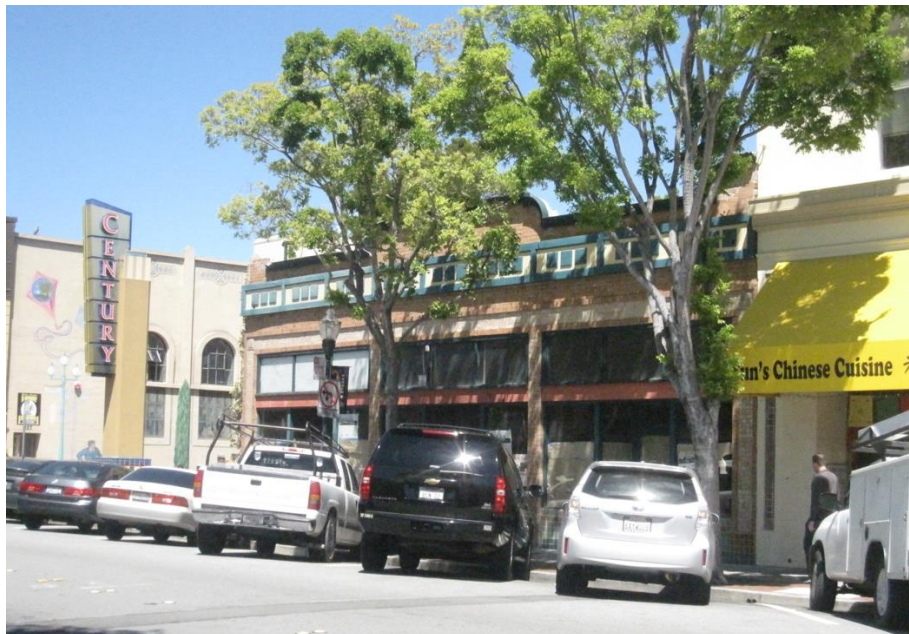
***Below: The storefront before it was altered; the clerestory windows were retained behind the wood slats shown above.***

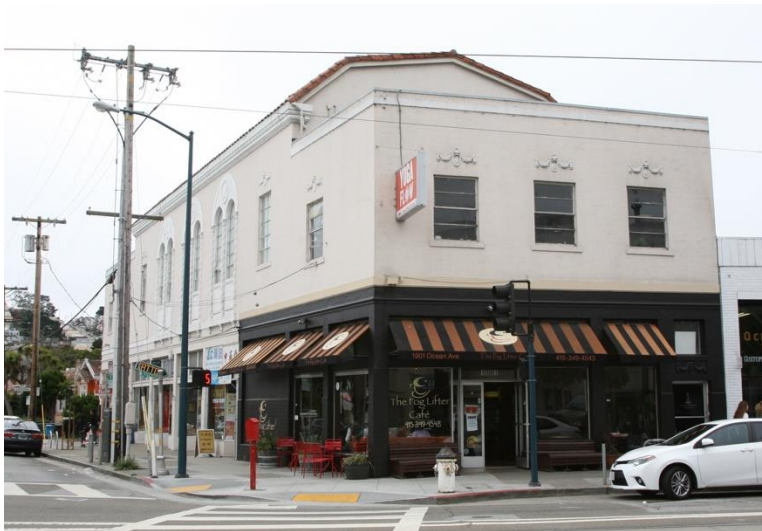
***Above: This is a good example of using several awnings of the same size and character along a corner storefront to break up the awning plane and highlight the individual elements of the building.***

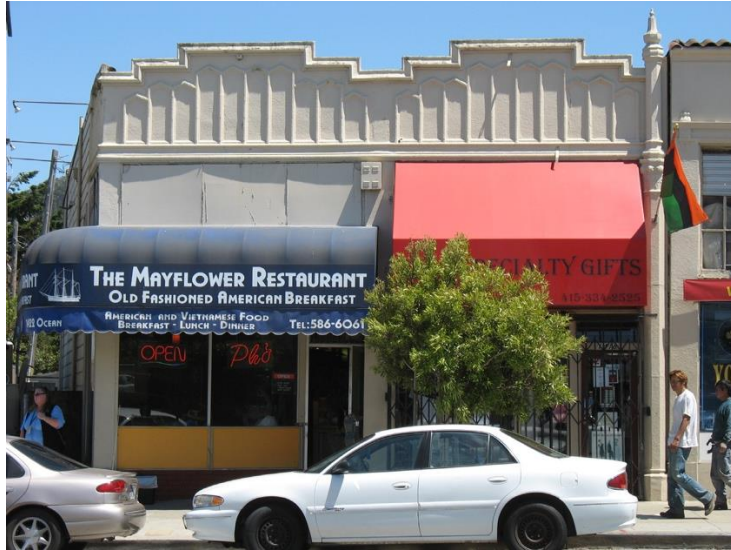
***Above: This small-scale, two-storefront corner building would benefit from restoration of the clerestory windows and consistently placed and sized awnings below the clerestory. Varying color of these awnings differentiates the two merchants which can be okay if done well.***

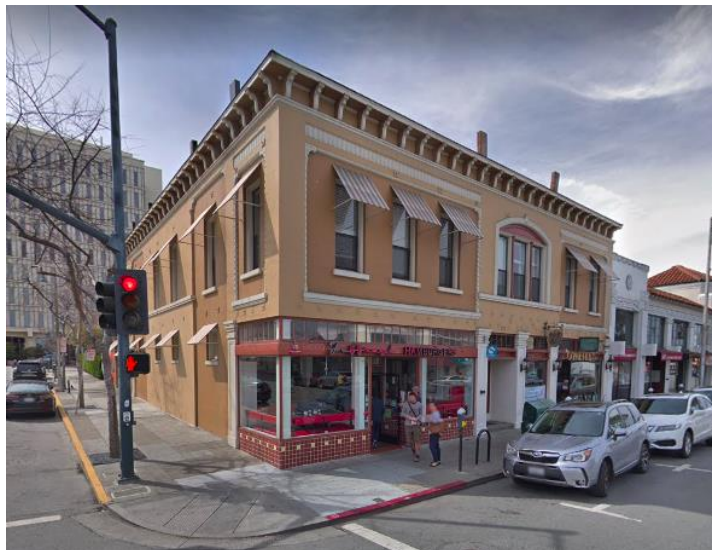
***Below: Using awnings at secondary elevations and at second story windows can further highlight the building features, while providing necessary sun shade for building users.***

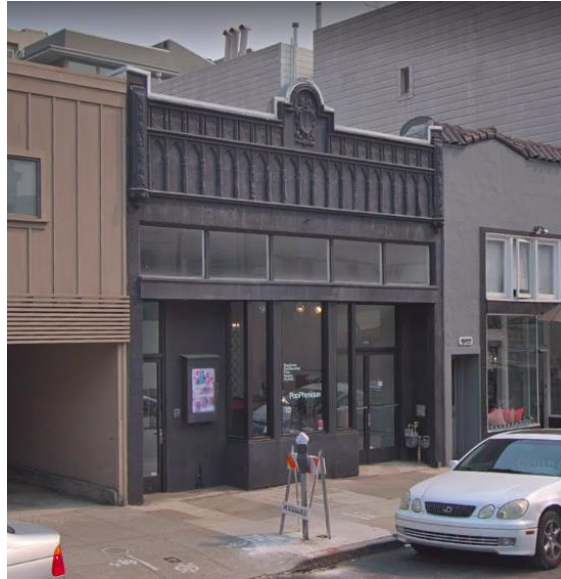
***Above: This storefront, which is very intact at the upper level, would benefit from differing colors for trim and at the highly decorative cornice.***

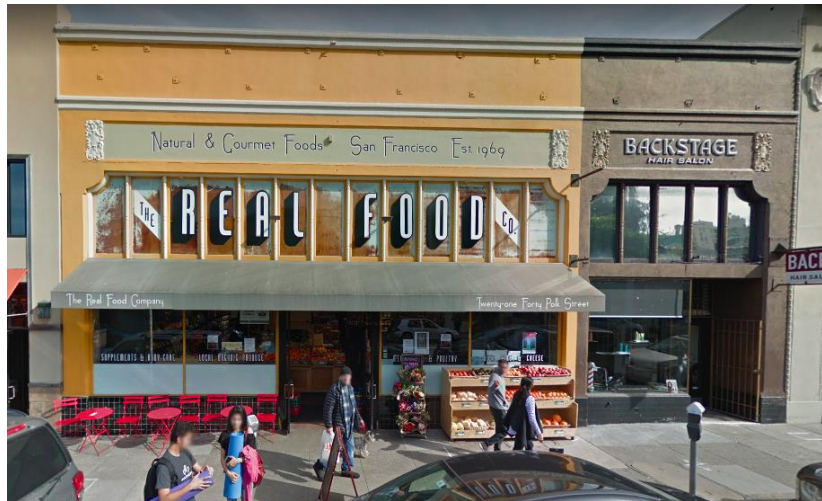
***Above: This single building houses two storefronts. Different body paint colors, varying signage and use of awnings creates two distinct facades.***

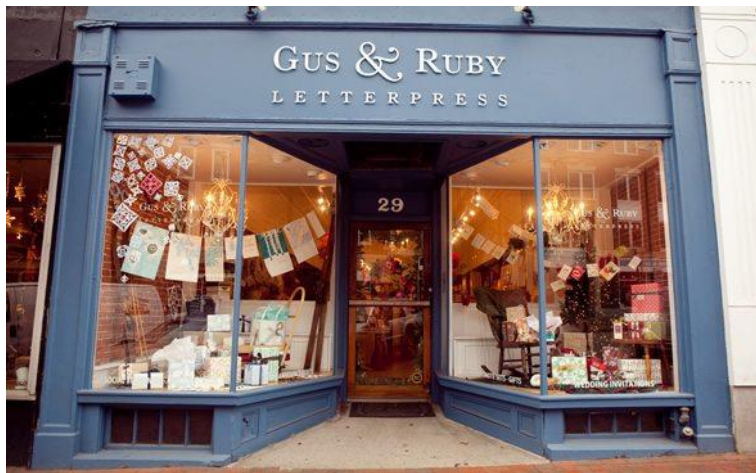
***Above: Using one color for the storefront works here as the raised, simple letter signage at the sign band and the creative use of the window display area provides plenty of color and variation.***

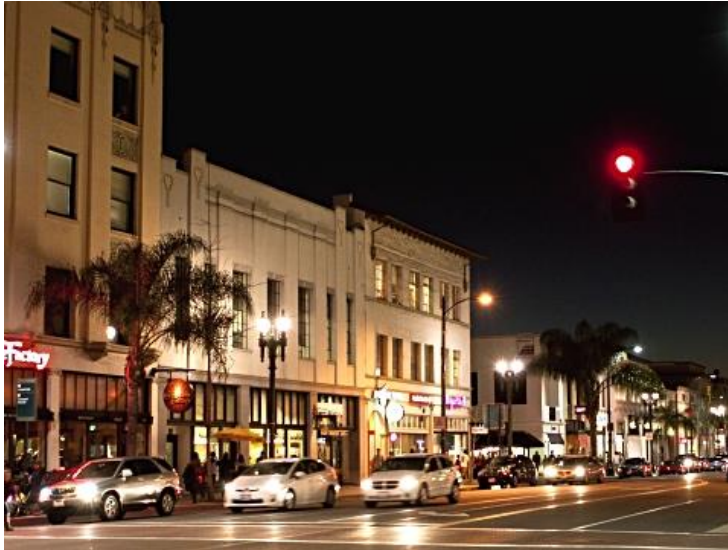
***Above: This commercial street has varying street lights, building lighting, storefront lighting and neon signage all of which contributes to the nighttime character and sense of safety.***

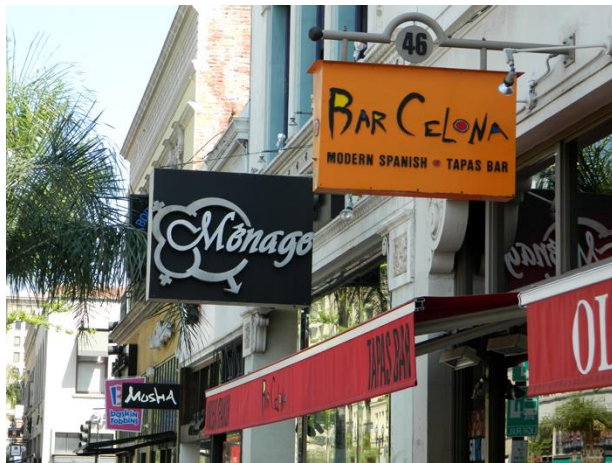
*A variety of signage including Projecting, hanging signs, lettering on awnings and affixed letter signs to sign bands add to the vibrancy of the streetscape.*

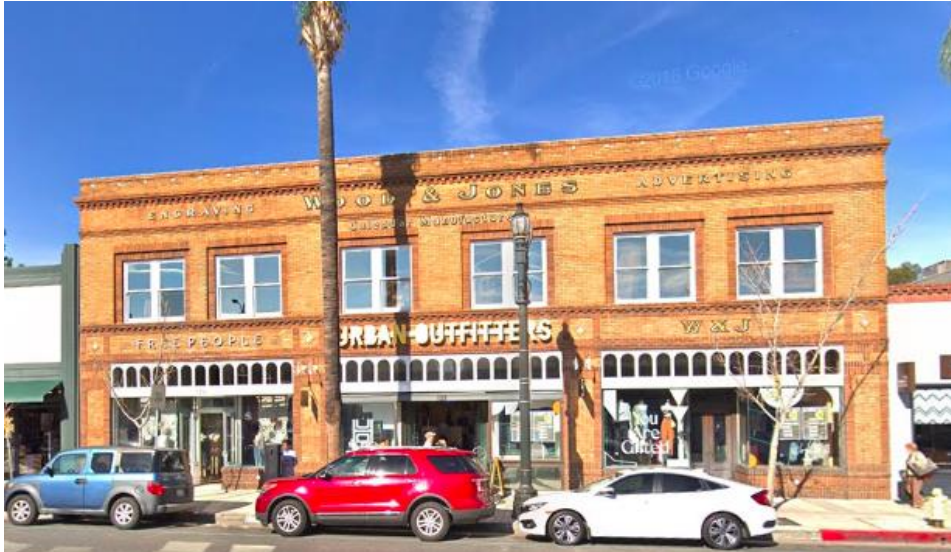
***This chain store used simple applied letters as signage, respecting the established sign band and clerestory windows.***

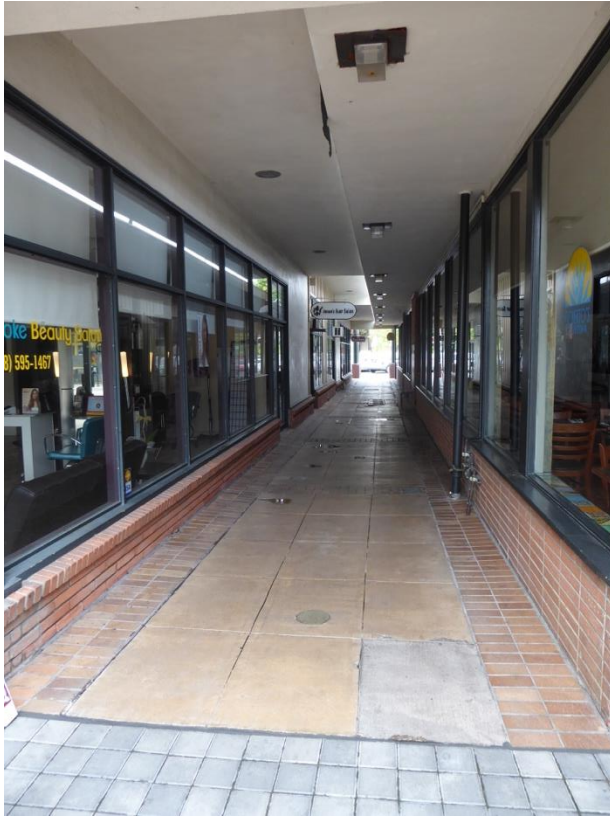
**Above: The east side breezeway.**

**Below: The west side breezeway.**

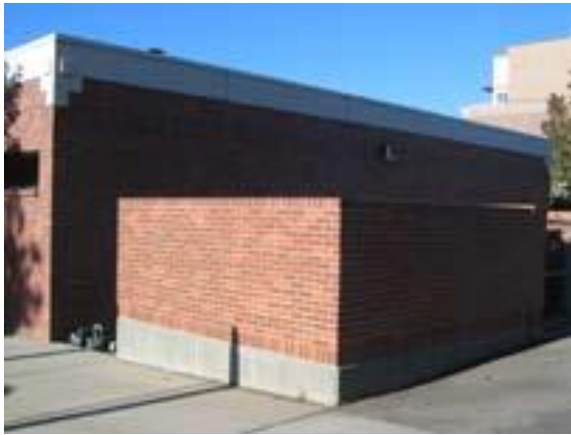
*This trash enclosure in another commercial area was designed to blend with the existing architecture.*

- Adequately separate outdoor seating / dining from storage and trash enclosures.
- Design trash enclosures to be compatible with the buildings they serve and blend with the existing architecture.
- Employ trash enclosures to screen trash receptacles.
- Ensure rear uses are safe in relation to adjacent parking; make sure uses do not spill into parking areas.

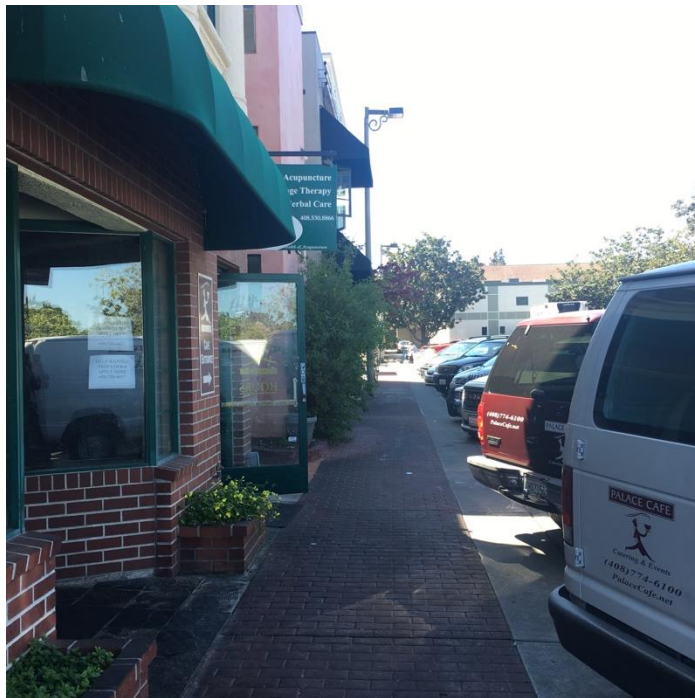
***These rear facades of the west side Murphy Avenue buildings have a sidewalk, which helps with pedestrian safety. They also do not have any trash storage at the rear.***

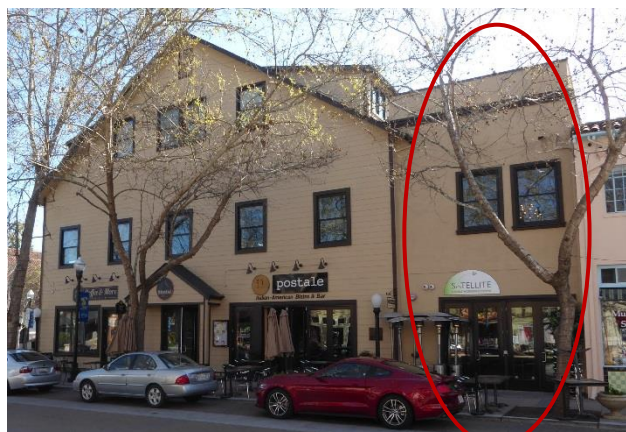
**Overall building, Murphy Avenue elevation; circled area is later addition to the building.**

- Extend horizontal wood siding onto two-story 1993 addition, but consider a slight variation in siding width to differentiate old from new.
- Obtain Sign Permit for existing signage (no permit history found for signage).
- Add gooseneck lights for all building signage.

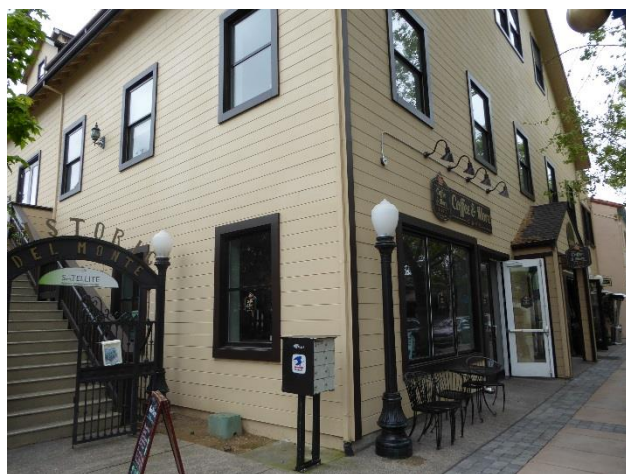
**Corner of building, with double hung windows.**

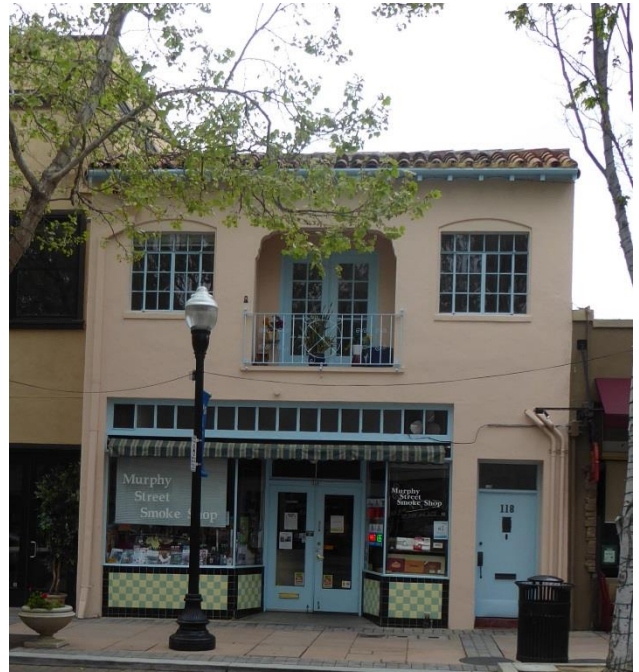
***Two-story commercial building with tiled storefront.***

- Two-story commercial building with lower level storefront.
- Smooth stucco finish with light paint color.
- Recessed store entry.
- Multi-colored ceramic tile base.
- Original angled glass and metal storefront windows with ribbon of wood transom windows above.
- Single panel, glazed, wood double entry doors with transom above.
- Rectangular opening, wood door, and transom window at entry to upper story space.
- Red tile roof with gutter and exposed rafter ends at parapet.
- Recessed balcony at upper story with decorative metal railing.
- Multi-lite, glazed, wood double doors at balcony.
- Multi-lite, industrial sash, steel windows at upper story.
- Retractable awning.
- Rear entry door and transom at lower level.
- Rear windows and upper story cut out balcony.
- Rear parapet similar to front with roofing tile

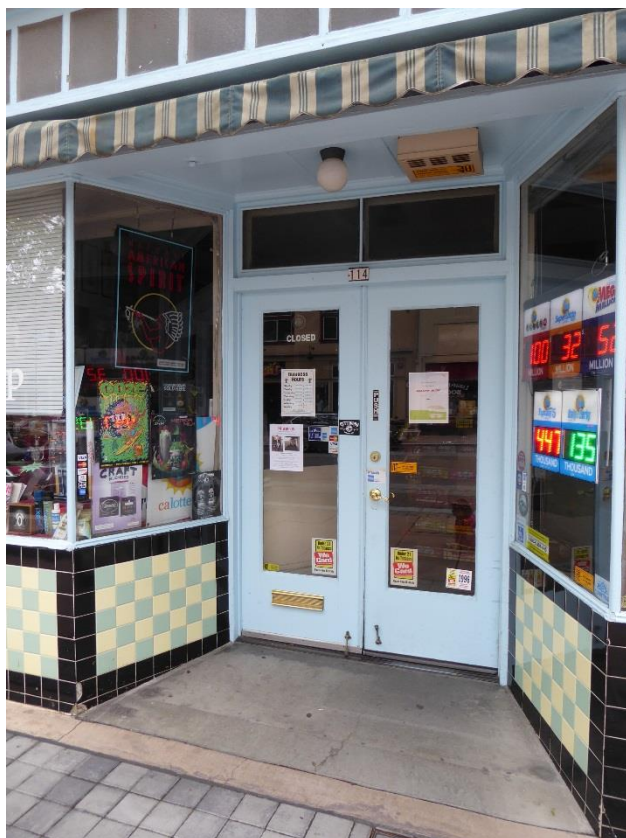
**Above: Recessed store entry with original metal storefront windows, multi-colored tile base, and single-panel, glazed, wood double-entry doors with transom above.**

- Repair stucco, when needed, to match in texture and composition, spray stucco is not appropriate.
- Maintain light color of stucco.
- Retain recessed store entries in historic configuration.

- Retain storefront doors and over door transom windows.
- Do not apply paint or coating over original base tile. Match broken or missing tiles in size and color. Match grout in color and composition.

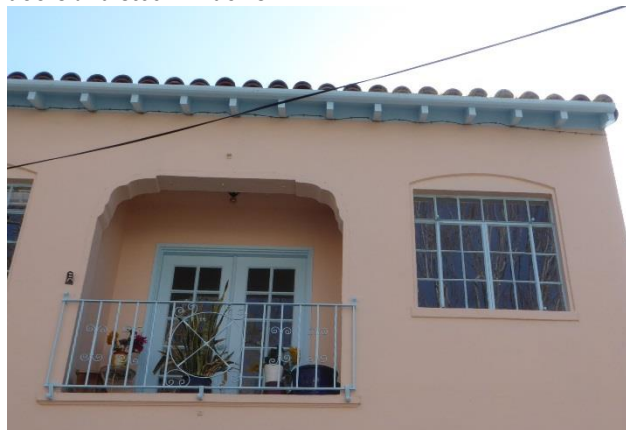
**Below: Upper level balcony with railing and wood double doors and steel windows.**

- Retain upper level balcony with railing and wood double doors.
- Clean and repair multi-paned steel windows at second floor. Maintain the paint coatings and repair glazing to match when needed.

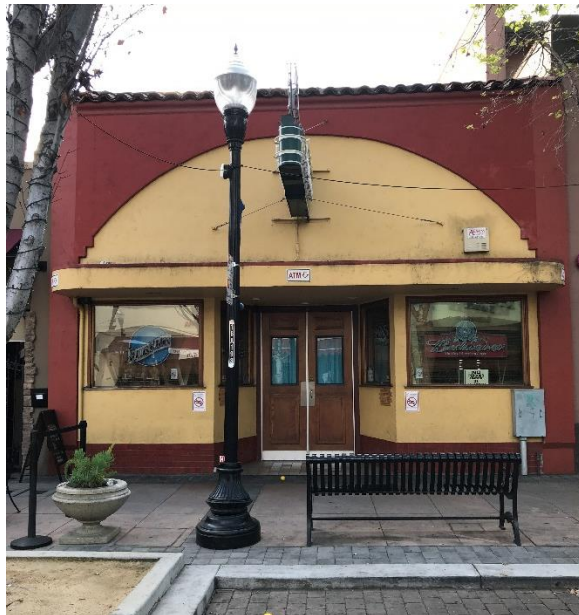
***Above: One-story commercial building with Streamline Modern detailing at storefront***

- One-story commercial building.
- Smooth stucco finish.
- Location, angle, size and configuration of recessed store entry.
- Location, size and shape of ceramic tile base.
- Red tile capping at parapet.
- Recessed arch in stucco above awning.
- Stucco clad awning with curved corners
- Projecting wall sign

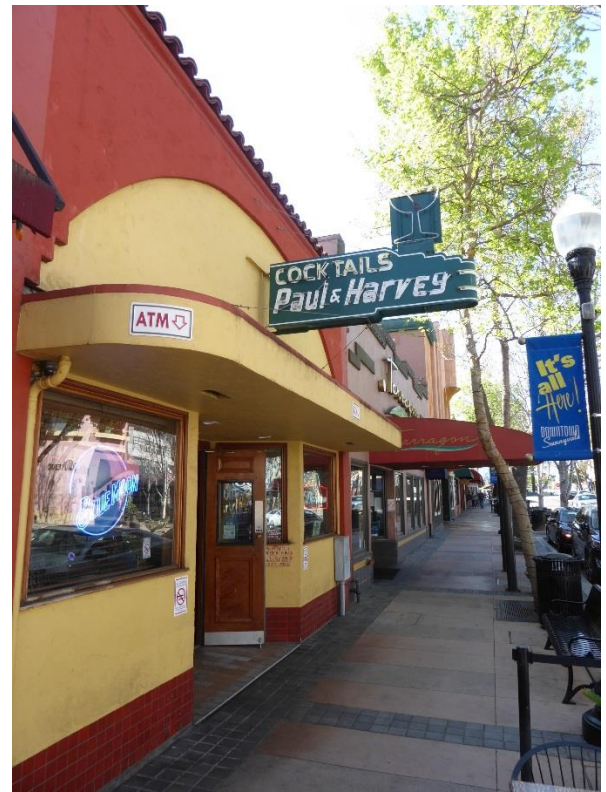
***Above: Detail of stucco-clad fixed awning with curved corners and historic neon sign.***

- Avoid changes to character-defining features in future upgrades or renovation or rehabilitation projects.
- Avoid roof top additions, as this would alter the overall character of the structure and its contribution to the District.
- Repair stucco, when needed, to match in texture and composition, spray stucco is not appropriate.
- Retain location, angle, size and configuration of recessed store entry, not including the style of the existing doors.
- Avoid painting on true masonry surfaces such as terra cotta, ceramic tile or roofing tiles.
- Avoid application of paint or coating over base tile. Match broken or missing tiles in size and color. Match grout in color and composition.
- Retain tile capping at parapet.
- Retain recessed arch in stucco above awning. If stucco repair is required match decorative stucco features.
- Retain stucco clad awning with curved corners.

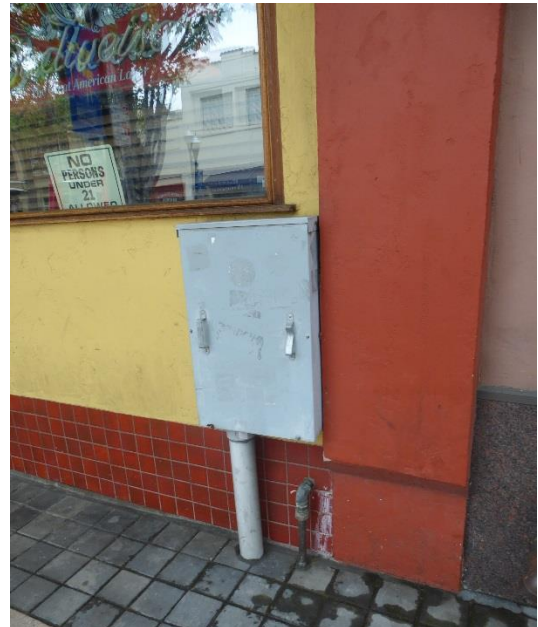
***Above: Electrical box and conduit that distract from the buildings architectural features.***

- Conduit and meters should be minimized at Murphy Avenue façade and priority given to relocating these (if possible).
- Consider enlarging (restoring) size, shape and configuration of storefront windows. Uncover door windows.
- Paint electrical panel on Murphy Avenue façade to match building.
- Remove ATM signs on the awning (not allowed).
- Replace entry doors with a door type that is more compatible with the building and the District.

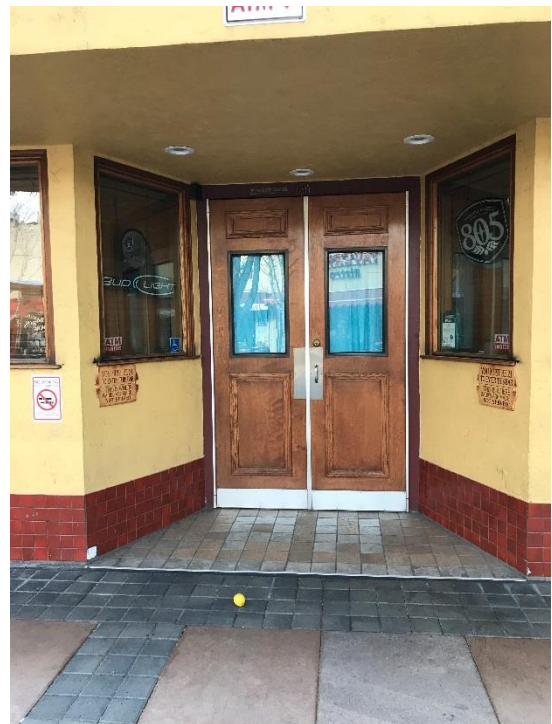
***Above: Current entry doors are not historic and could be replaced with doors that are more in keeping with commercial buildings of this era***

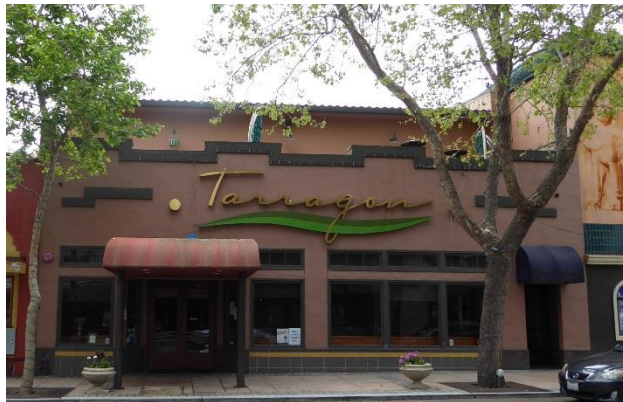
*Above: The Murphy Avenue façade is one-story with a second story set back from street.*

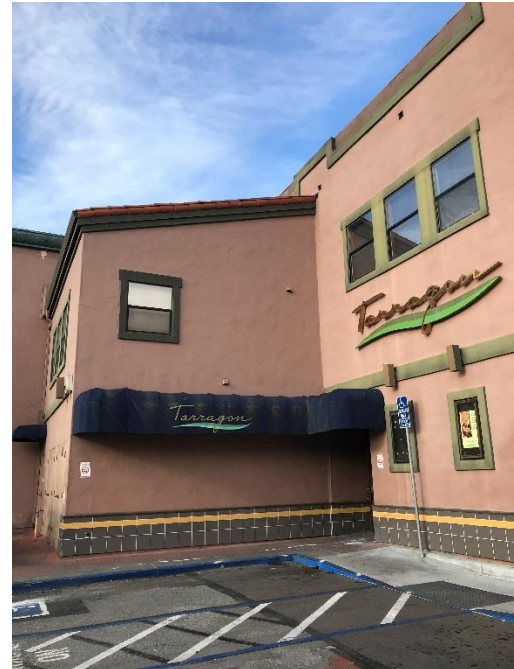
*Above: The rear façade has an awkwardly placed awning that should be reconfigured or removed.*

- Future modifications to the building should strive to contribute more to the character of the overall District
- Remove the current awning and replace with one that is more compatible with the building and the District (e.g. an awning that spans across the front façade).
- Remove/reconfigure rear awning.
- Consider a change in color scheme by lightening the main paint color and using a darker color for the accents and trim.
- Consider removal of the tile from the second level roof to make the building more compatible with adjacent structures, and contribute better to the District.
- Ensure consistent building trim colors on front and rear facades.
- Replace marble base with a tile base that is more compatible with the District.

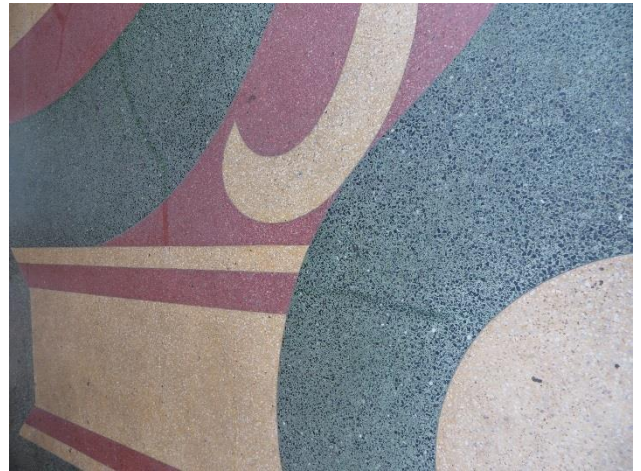
*Above: Detail of terrazzo flooring.*

- Two-story theater.
- Recessed entry with elaborate terrazzo flooring pattern that extends into the sidewalk.
- Ceramic tile base.
- Four arched metal-framed, signage or display windows, two each on either side of the entry doors.
- Location and configuration of double entry doors (not style).
- Two large, multi-paned, arched, wood windows centered above entry.
- Stucco-clad awning with metal trim and neon lights.

- Retain entry in original configuration.
- Retain terrazzo flooring.
- Avoid application of paint or coating over ceramic tile. Match broken or missing tiles in size and color. Match grout in color and composition.

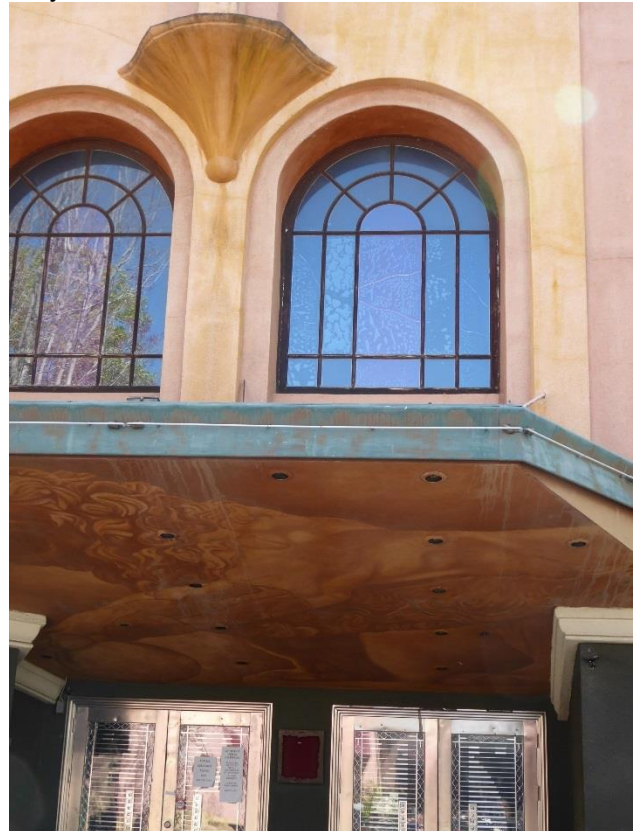
*Below: Detail of multi-paned, arched, wood windows above entry*

- Retain arched wood windows. Repair and repaint wood regularly.
- Restore original character-defining features described further in recommended priority improvements.

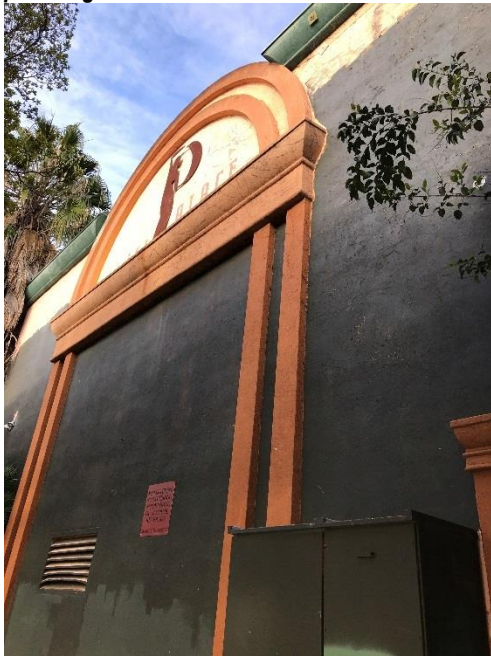
***Below: Rear façade showing various paint schemes and patching.***

- Expand tile base and replace with a tile color/style that is more compatible with the building/District.
- Repaint the entire building base the same color (all sides appear to be different colors) with priority given to the rear of the building where the paint line stops about three feet from roofline and is not a consistent color. Use color for trim or accent in limited locations.

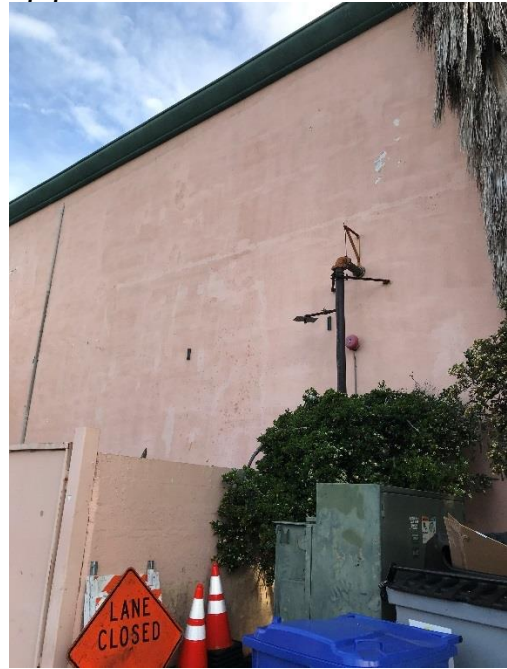
***Below: Side façade with storage and mechanical equipment.***

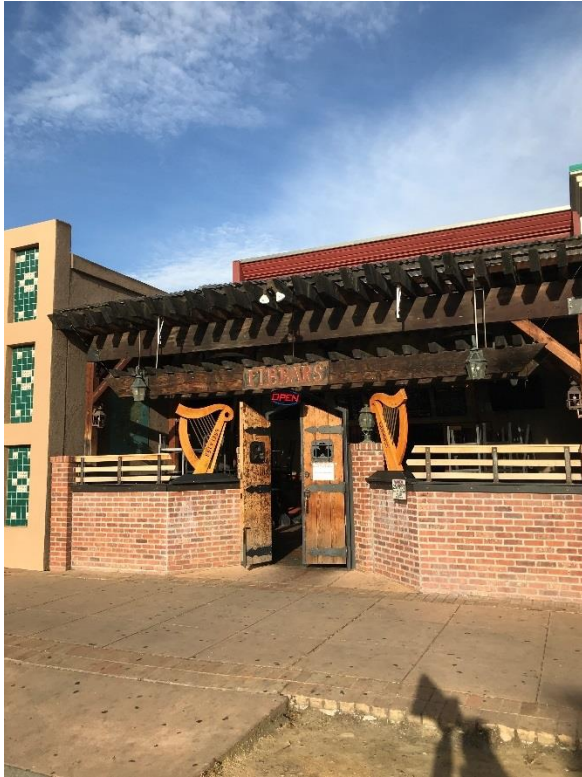
***Above: Rear elevation of the north storefront.***

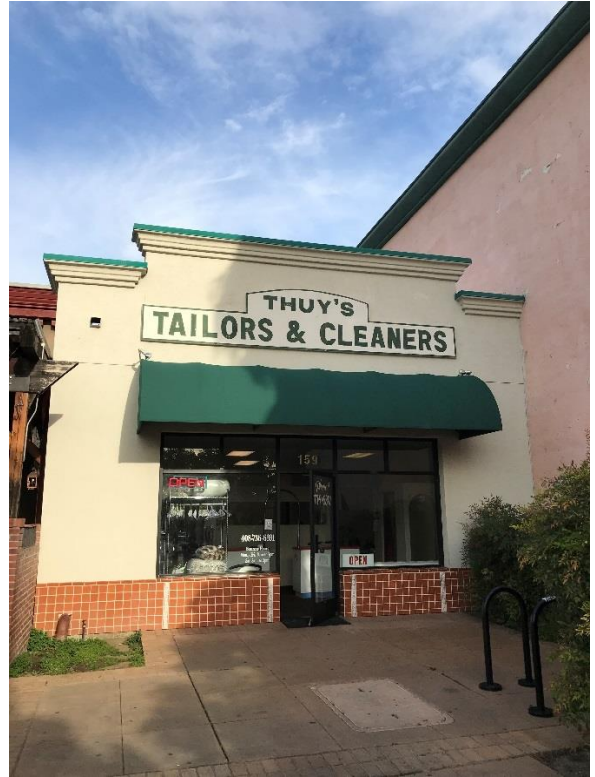
***Above: Rear elevation of the south storefront.***

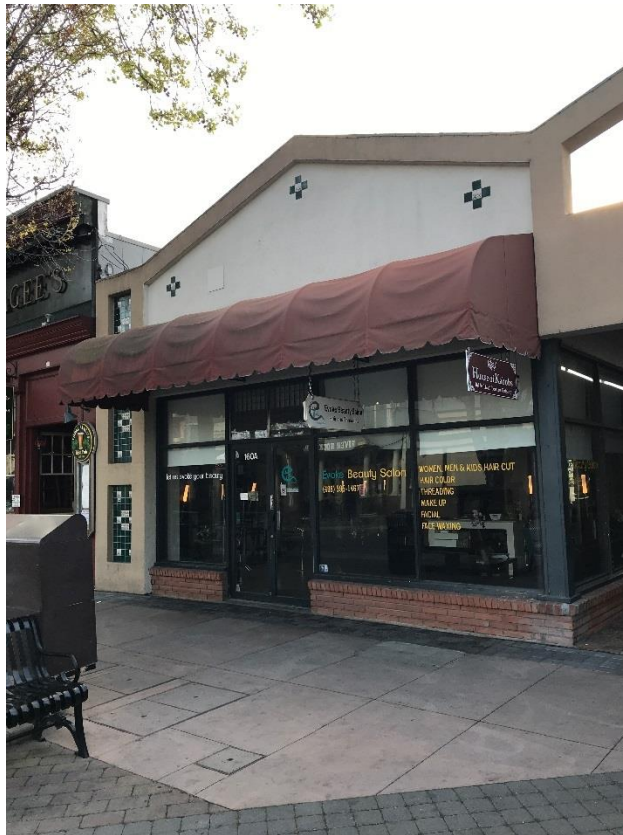
*Above: One-story commercial building with storefront*

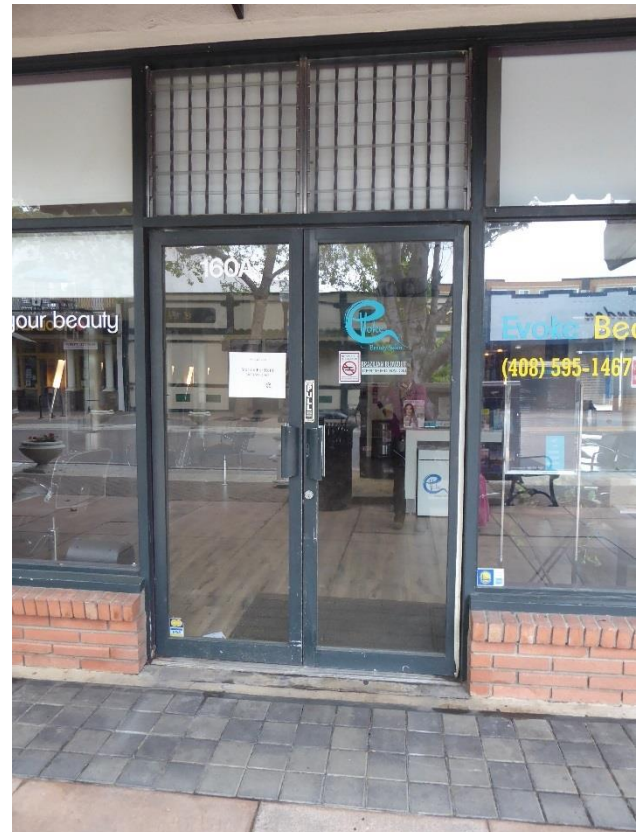
*Above: Brick base, wood storefront windows and location of entry doors.*

- This building represents Mid-Century infill onto Murphy Avenue and was then subsequently modified in the 1980s. The following building specific features are compatible with the character of the earlier commercial buildings represented in the District:
  - One-story commercial building with storefront.
  - Decorative base.
  - Wood-framed storefront windows.
  - Size, and shape of entry doors.

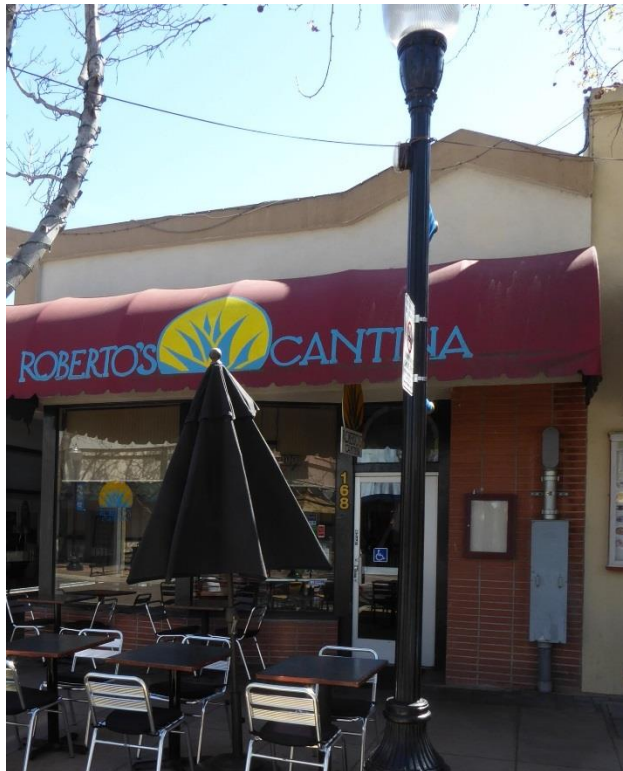
**Above: One-story commercial building with storefront facing Murphy Avenue.**

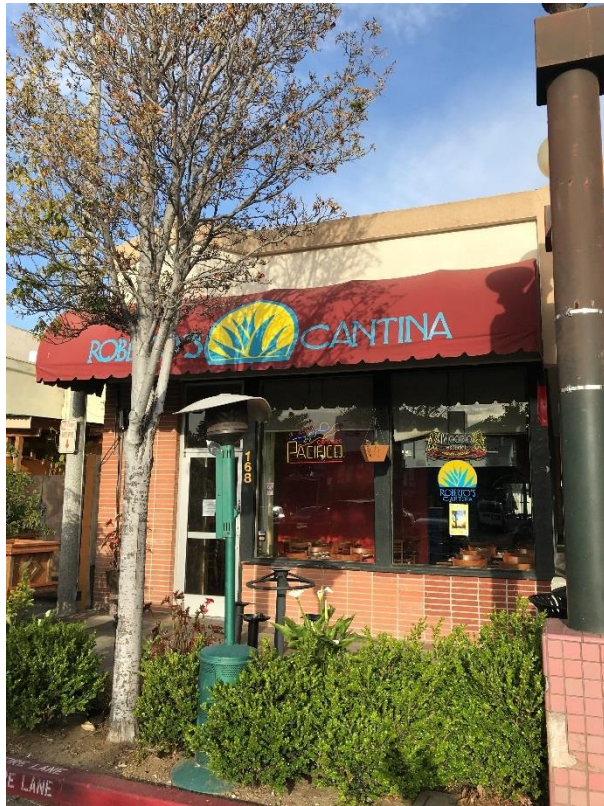
***Above: Detail of Roman brick at rear façade of storefront.***

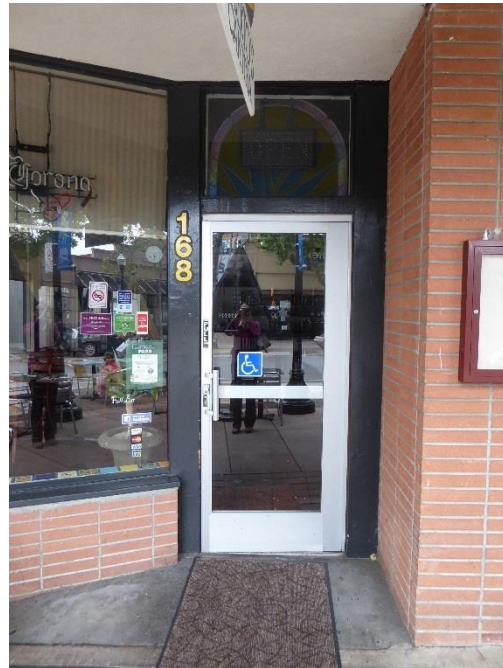
***Above: Detail of Roman brick at entry and side wall.***

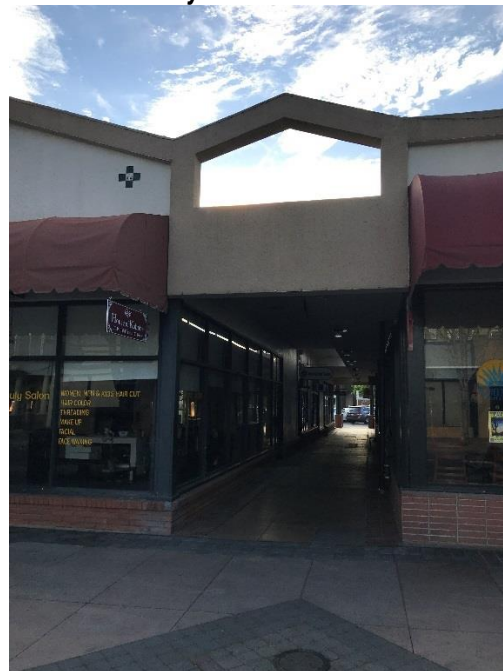
***Below: Breezeway between storefronts.***

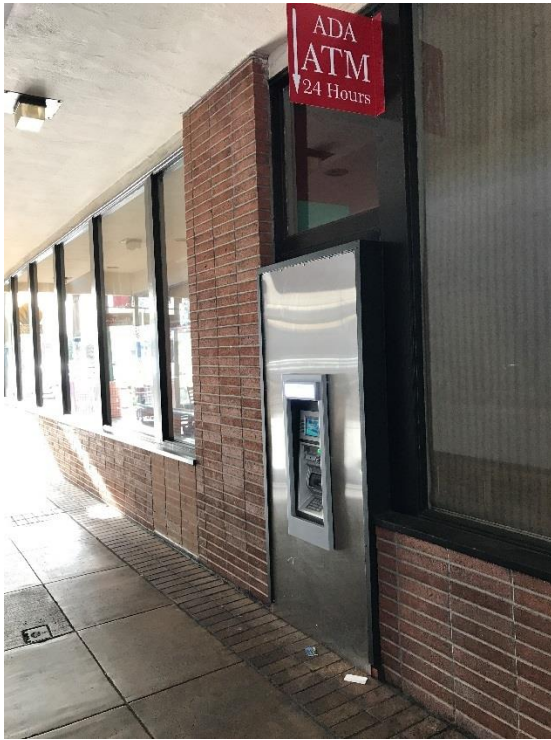
***Above: Detail of the Roman brick that carries through the breezeway.***

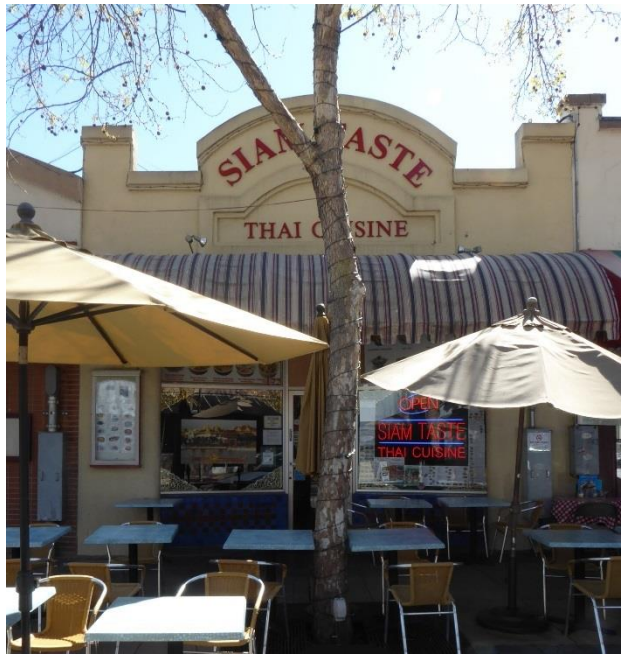
***Above: One-story commercial storefront with scalloped parapet and curved awning.***

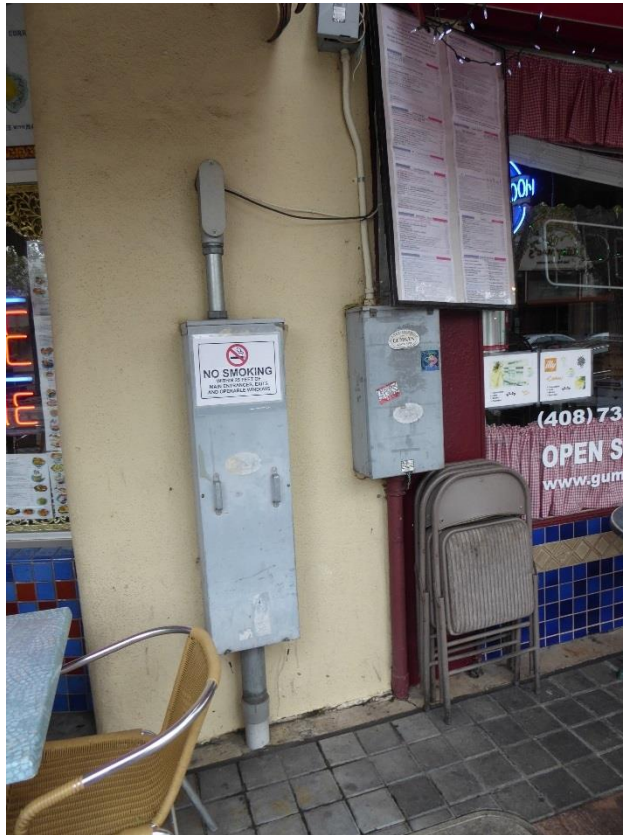
*Above: Detail showing meters and conduit applied to exterior of building.*

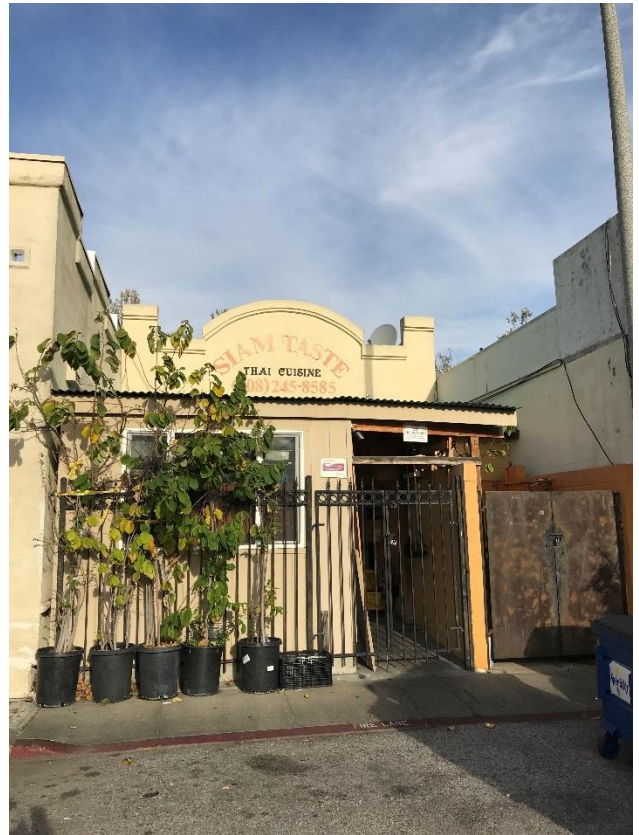
*Above: Rear façade of storefront.*

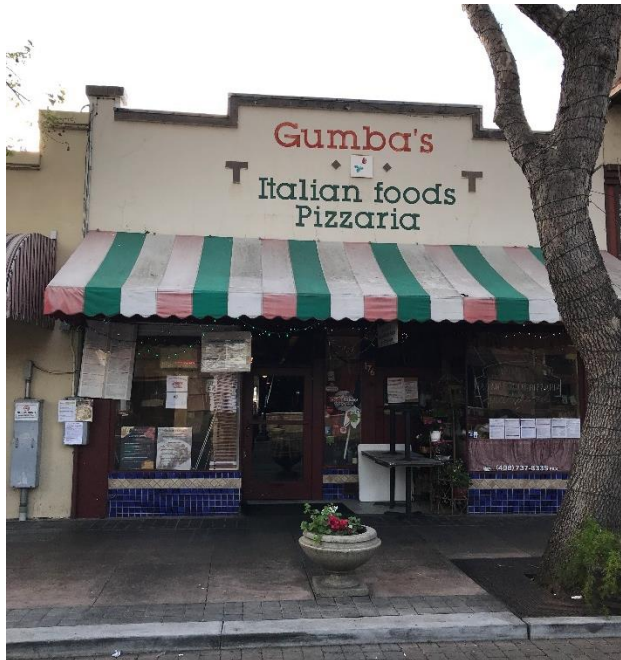
*Above: One-story commercial storefront with "Western" style stepped parapet.*

- One-story commercial building with storefront.
- Smooth stucco finish with light paint color.
- Recessed store entry with hexagonal tile entry flooring.
- Metal-frame storefront windows.
- Location, size, and shape of ceramic tile base.
- Single panel glazed wood entry doors.
- Stepped parapet.
