**Date: 4/29/2019**  
**To: All Interested Parties**  
**From: Amber Blizinski, Principal Planner, Community Development Dept.**  
**Subject: Public Draft of the Design Guidelines for the Murphy Station Heritage Landmark District**

*DRAFT*  
DESIGN GUIDELINES  
FOR  
MURPHY STATION  
HERITAGE LANDMARK  
DISTRICT  
April 2019 Version

# MURPHY STATION HERITAGE LANDMARK DISTRICT

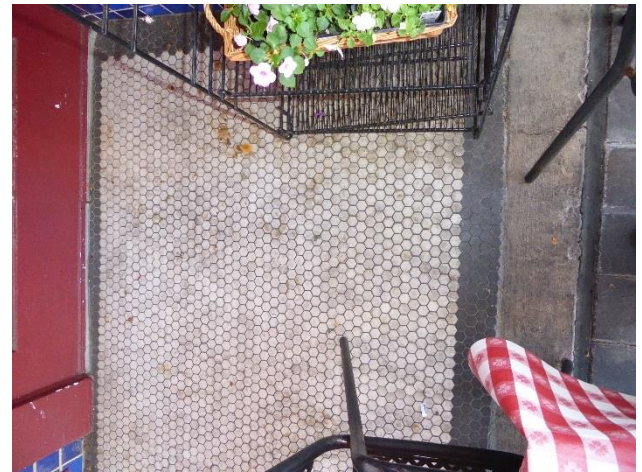
*Above: Detail of hexagonal tile entry flooring.*

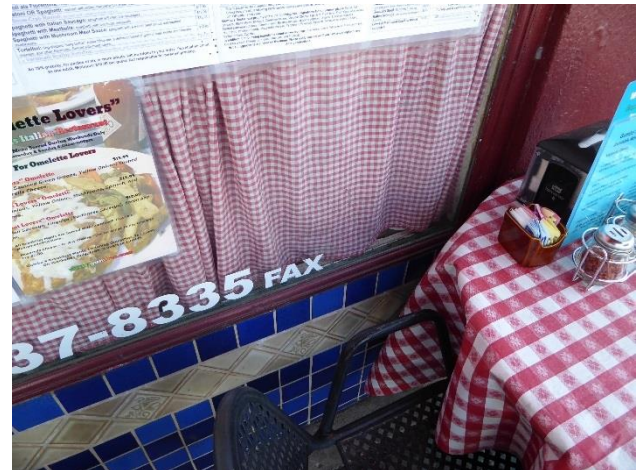
*Below: Detail of ceramic tile base and metal-frame storefront window.*

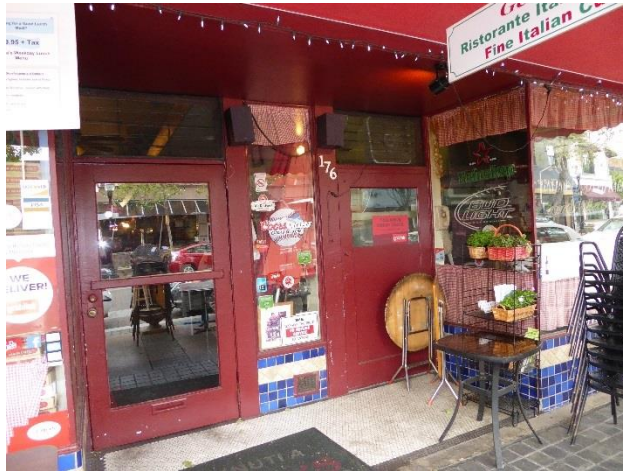
Above: Detail of entry doors.

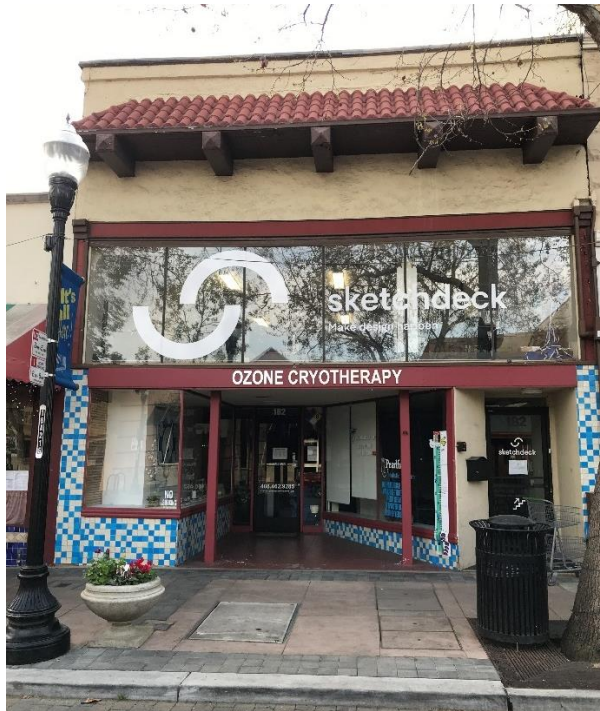
*Above: Two-story commercial building with storefront*

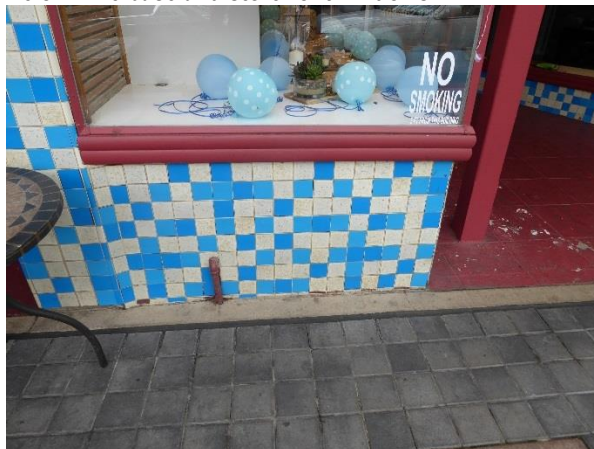
*Below: Tile base and storefront windows*

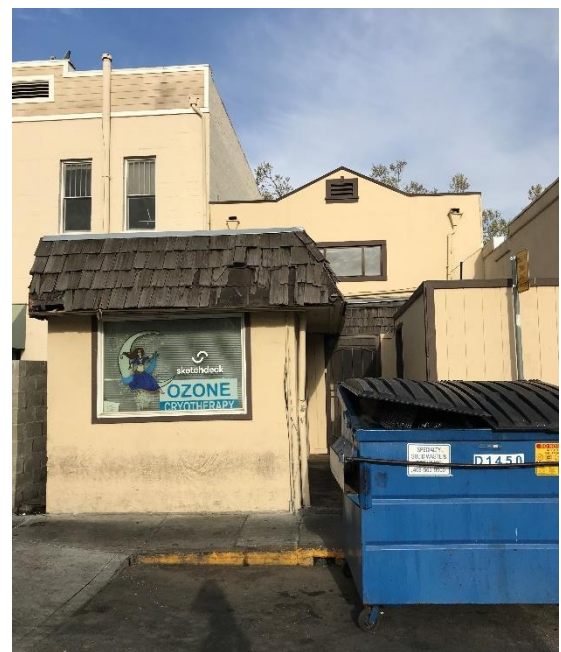
***Above: Rear of storefront showing outbuildings and garbage dumpster.***

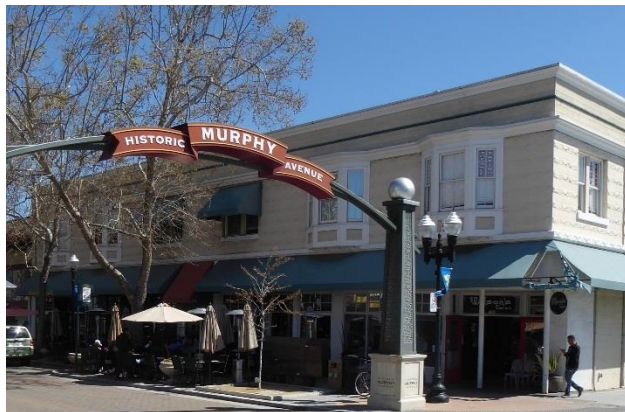
***Above: Murphy Avenue elevation***

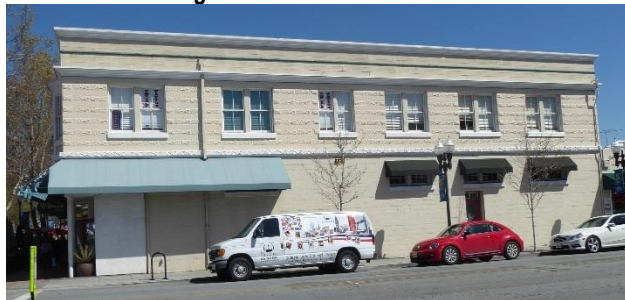
***Below: W. Washington Avenue elevation***

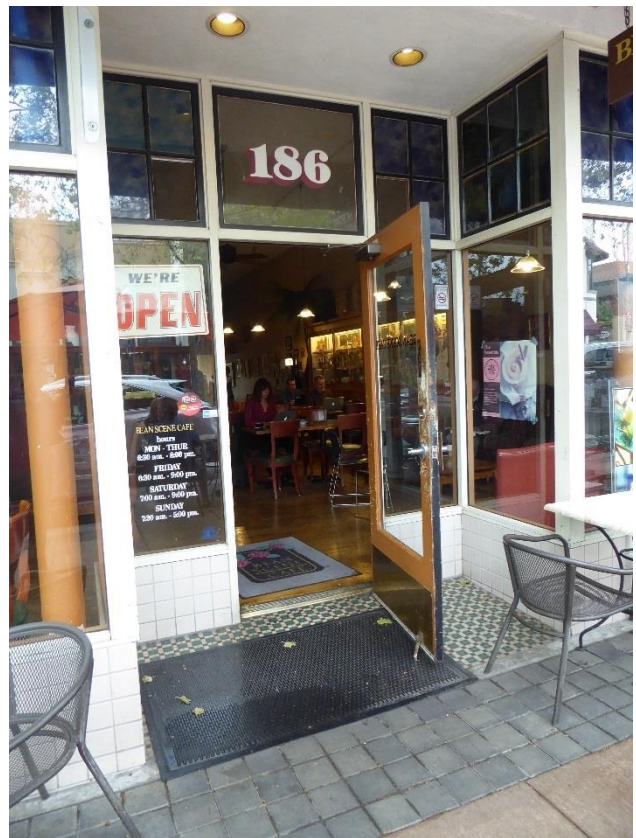
***Above: Detail of typical restored storefront***

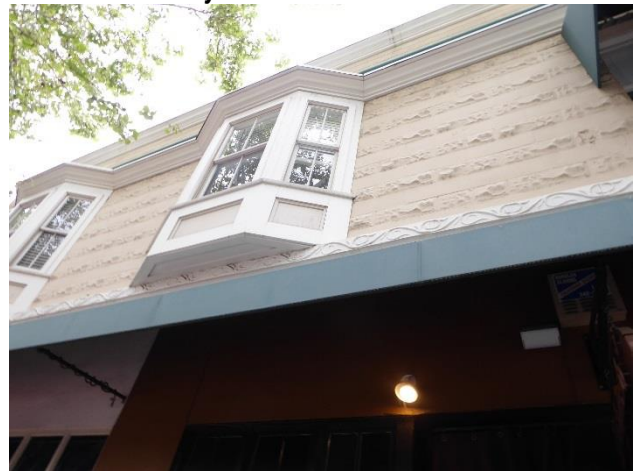
***Below: Detail of bay windows and exterior finish***

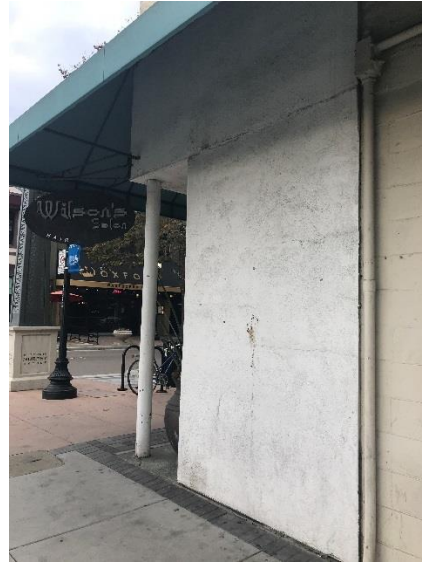
***Below: Detail showing corner alteration***

***Above: Detail showing corner alteration and incompatible materials and placement.***

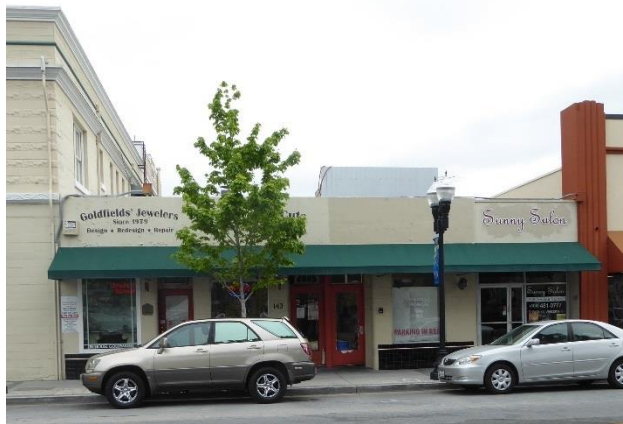
**Above: This is a one-story, Mid-Century Modern commercial building with continuous awning across several storefronts.**

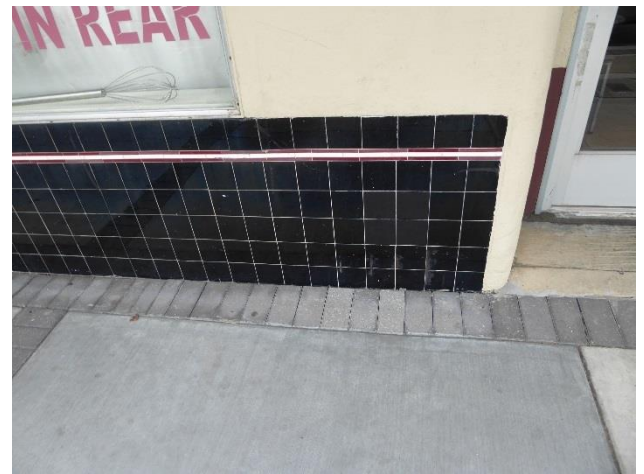
**Above: Detail of tile base at storefront.**

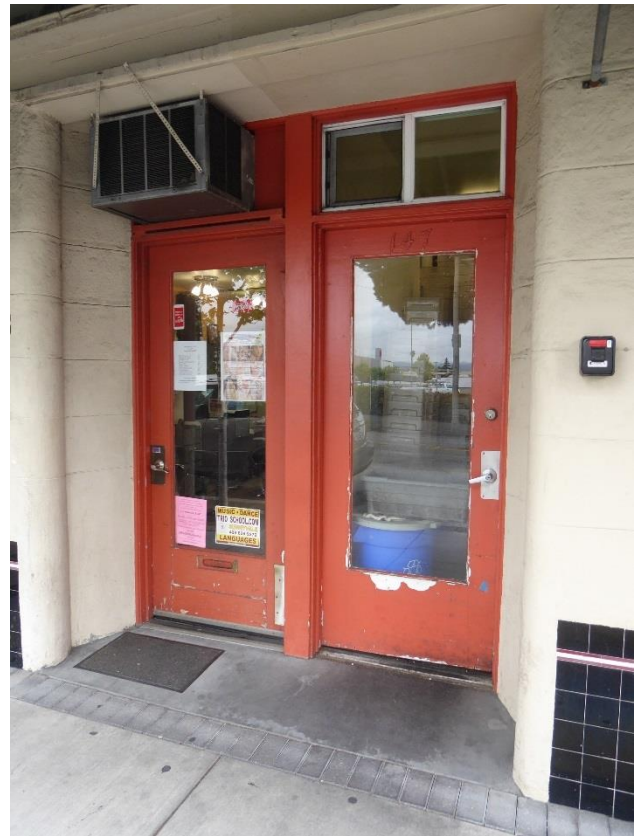
***Above: Recessed entry with single panel glazed wood doors into the storefronts.***

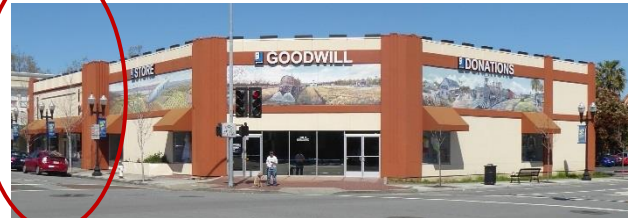
*Above: Overall building showing corner location; circle indicates 1940s element of the building.*

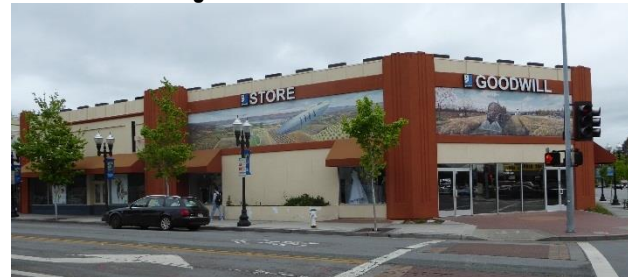
*Below: E. Washington elevation.*

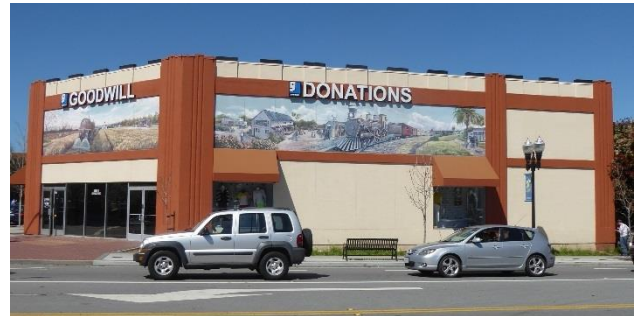
*Above: S. Sunnyvale elevation.*

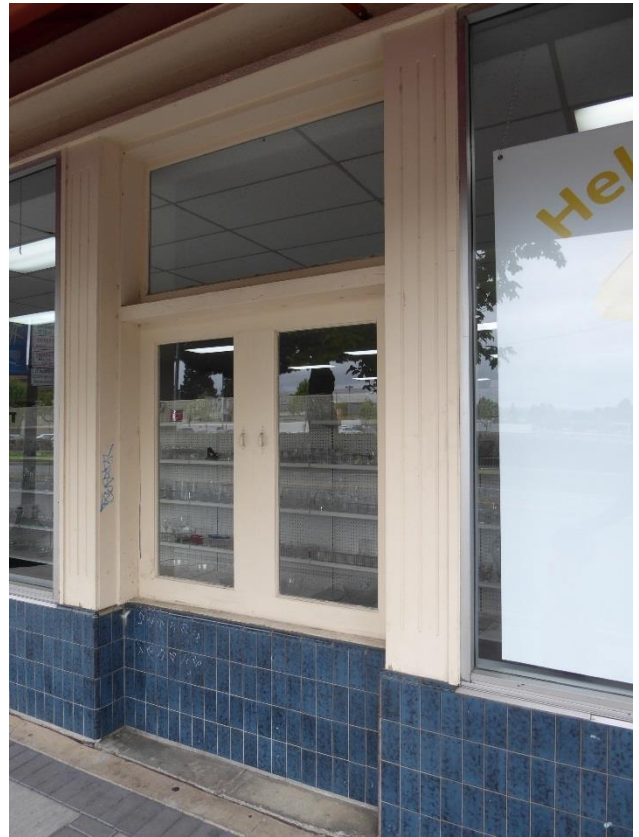
***Above: Detail of recessed area, tile base, and fluted wood columns.***

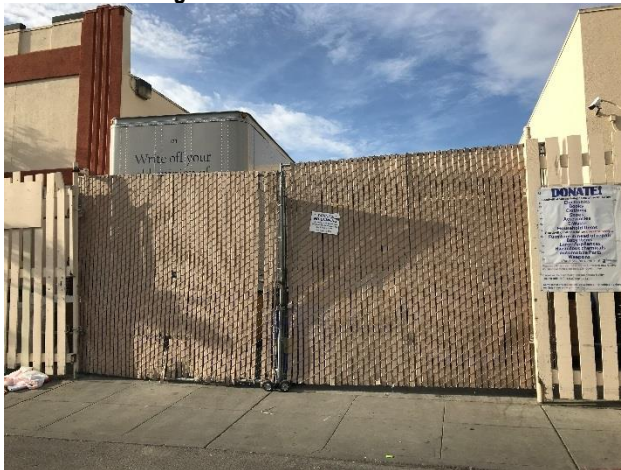
***Below: Detail of gates.***

- Landscape planters should be maintained or removed.
- Maintain planted area along S. Sunnyvale.
- Low wall along Washington Avenue is in need of repair.
- Update rear gate/fence with a style that is more compatible with the building and the District.
- Keep stored items within fenced area at rear of building.
- Exposed conduit and pipes should be minimized and priority given to relocating these (if possible).

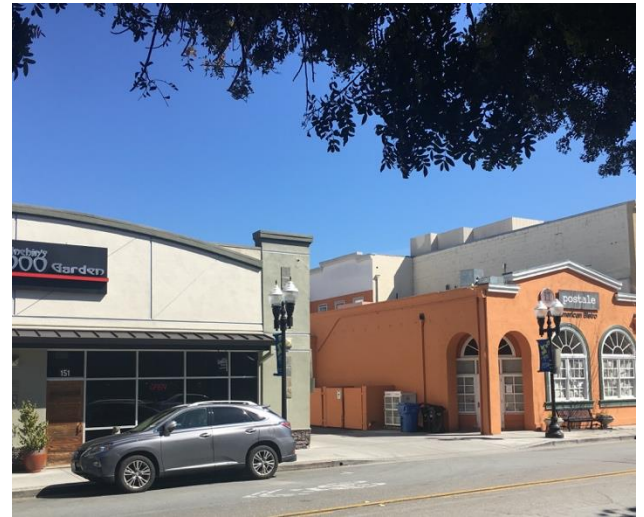
*Above: The east end of the E. Washington elevation showing its relationship to the building at 127 E. Washington and the alley to the parking area behind.*

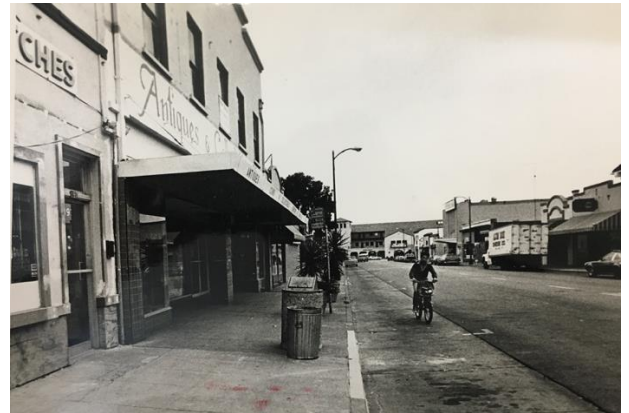
*Above: View from the 1980s of the projecting canopy at Murphy Avenue.*

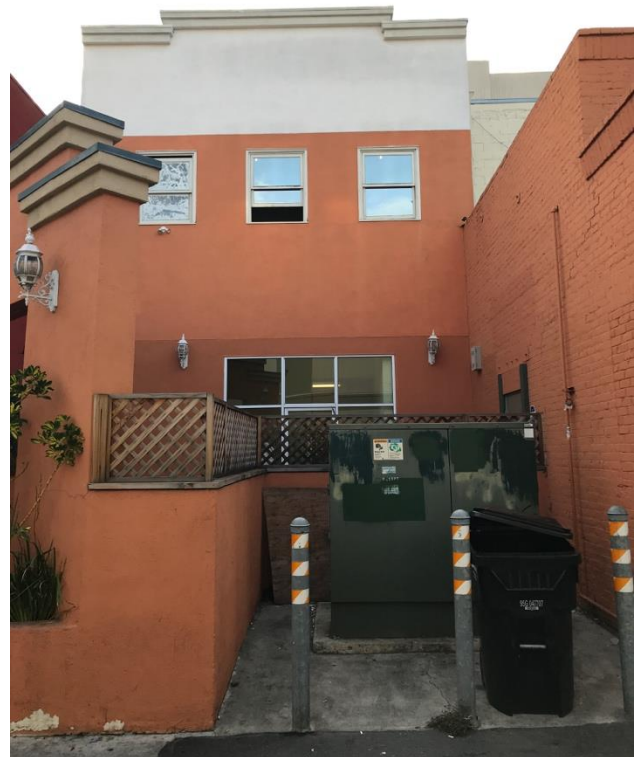
*Above: Rear façade of building from alley*

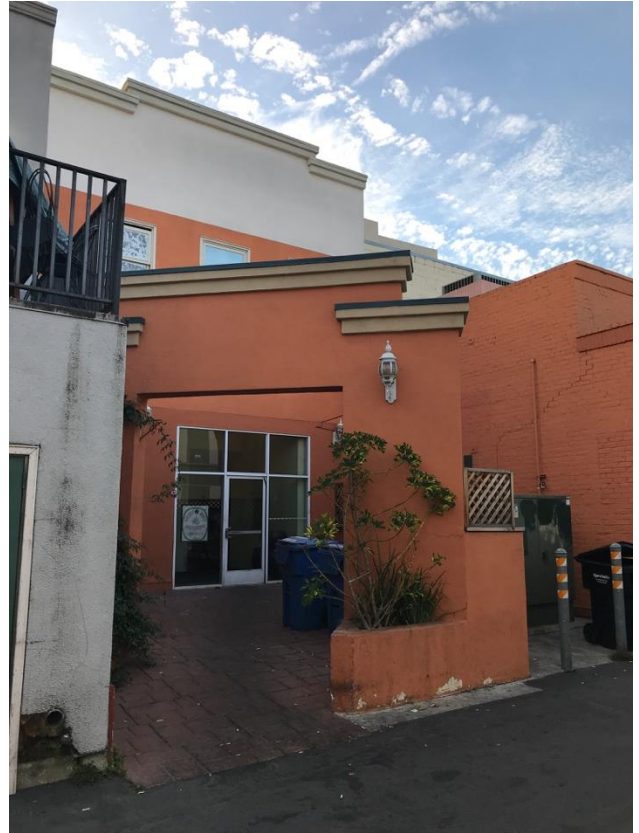
**Above:** Gateway to rear entrance.

- Maintain paint coatings at the upper story window surrounds and sills.
- Remove propane tank storage from alleyway off Washington Avenue.
- Replace windows on one-story Washington tenant space to a style that is more compatible with the District/building. The current windows are too contemporary.
- Remove gateway structure at rear of building.

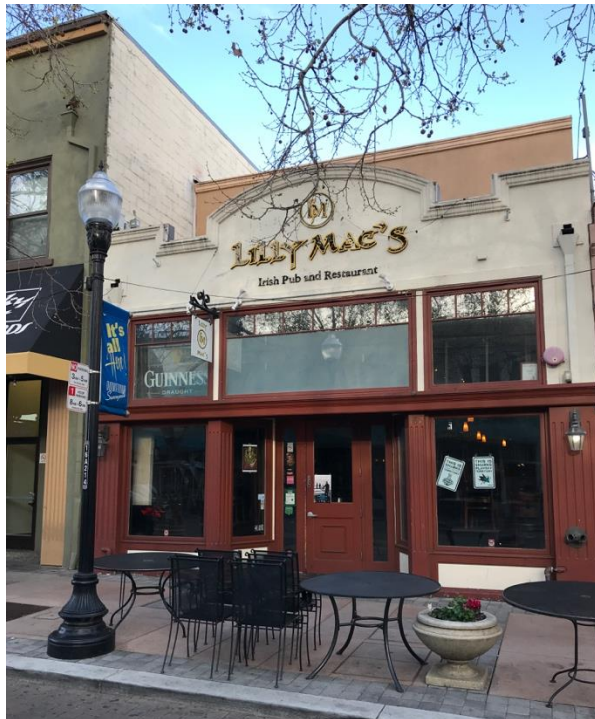
*Above: The front façade showing second story addition set back from the first story scalloped parapet.*

- Last exterior alteration permit
- Other alterations noted in field: Front facade was rebuilt similar to historic structure, new construction included a second story also.

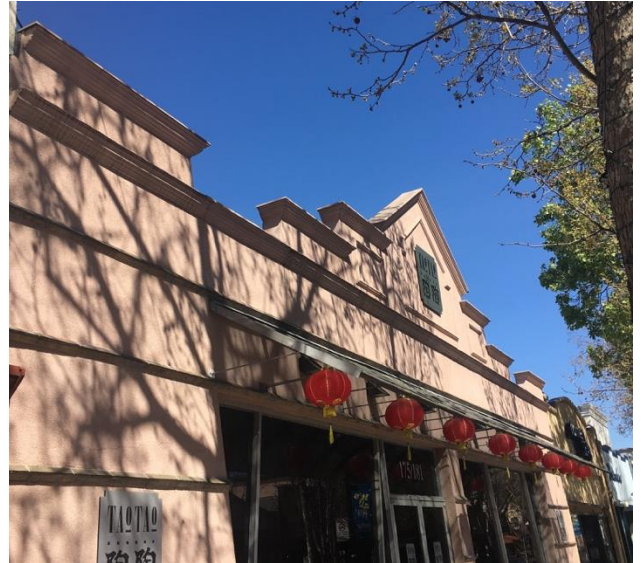
*Above: Detail of overhang and roofline*

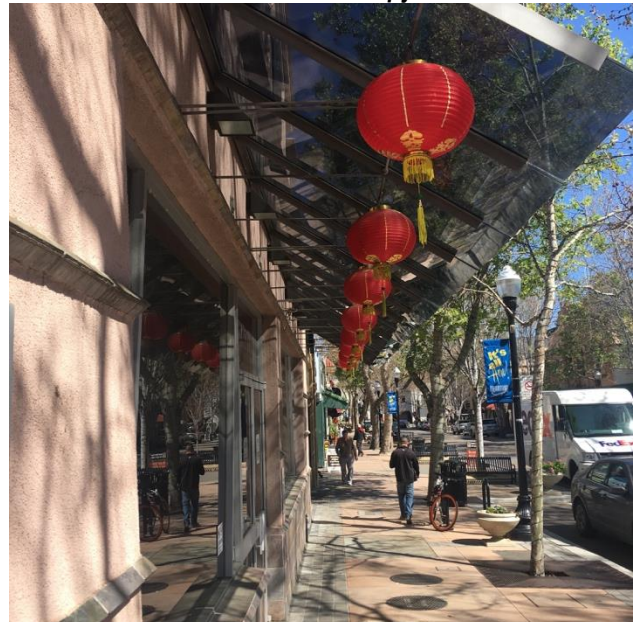
*Below: Detail of lanterns under canopy.*

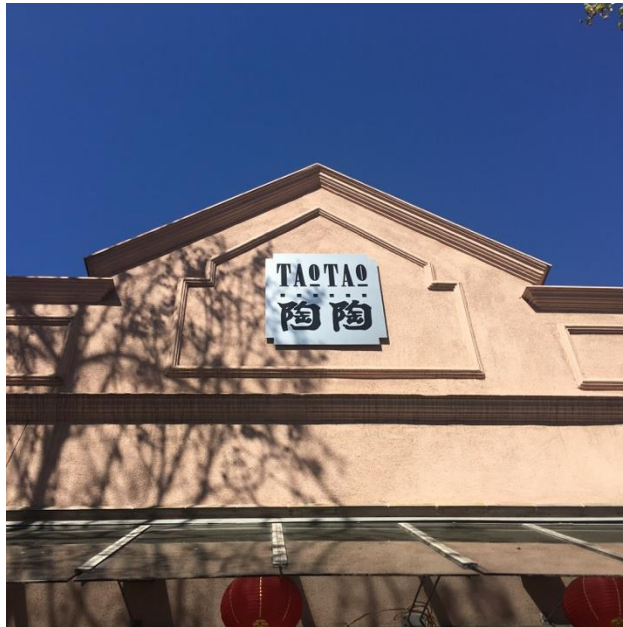
*Above: Detail of pedimented false parapet.*

- Year Built: 1957; originally long, low, one story building, heavily modified in 2000 (false parapet added to existing flat roof).
- Contribution Type: Secondary Contributor to District
- Parcel Number: 209-06-013
- Stories: 1
- 2018 Tenants: Tao Tao Restaurant
- Architectural Style: None

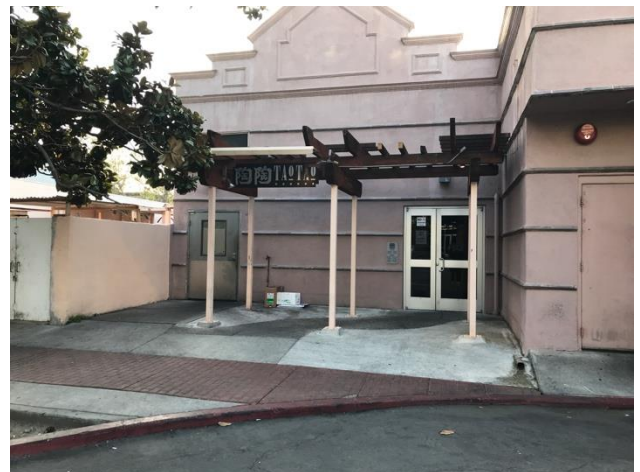
*Above: Detail of the rear trellis.*

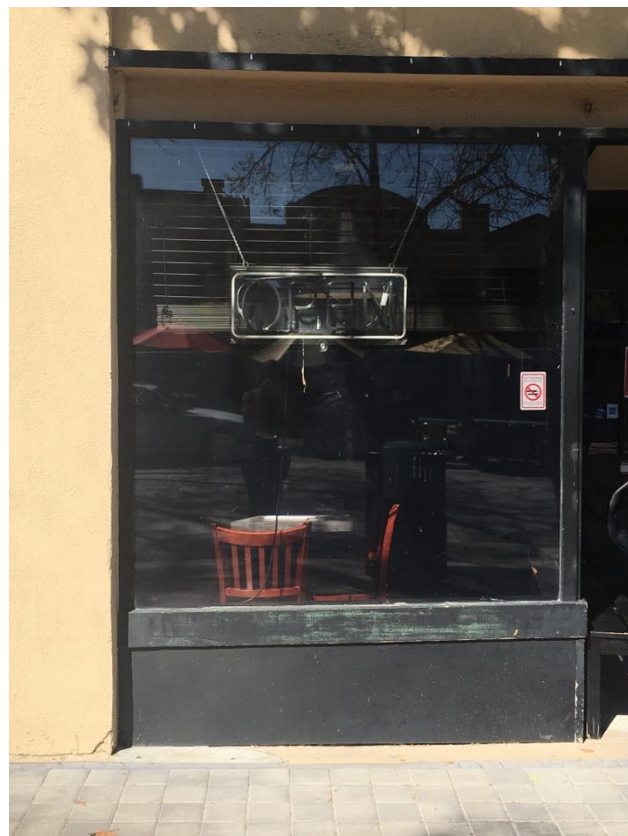
*Above: The storefront glazing; note that this building does not have a tile base.*

- Conduit and meters should be minimized at Murphy Avenue façade and priority given to relocating these (if possible).
- Install tile or brick on the base of the Murphy facade to further contribute to the District character.
- Consider exterior lighting (e.g. gooseneck lamp) on indented band above storefront windows.
- Make improvements to front façade above storefront windows; area appears unfinished with visible nails and fasteners apparent.
- Modify the trash enclosure “roof” to make it more compatible with the building.
- Replace rear cabinet sign with a sign style that is compatible with the District; ensure current signage is property permitted.
- Opportunities exist for use of rear patio area to enhance the rear façade and engage uses at this side of the building.

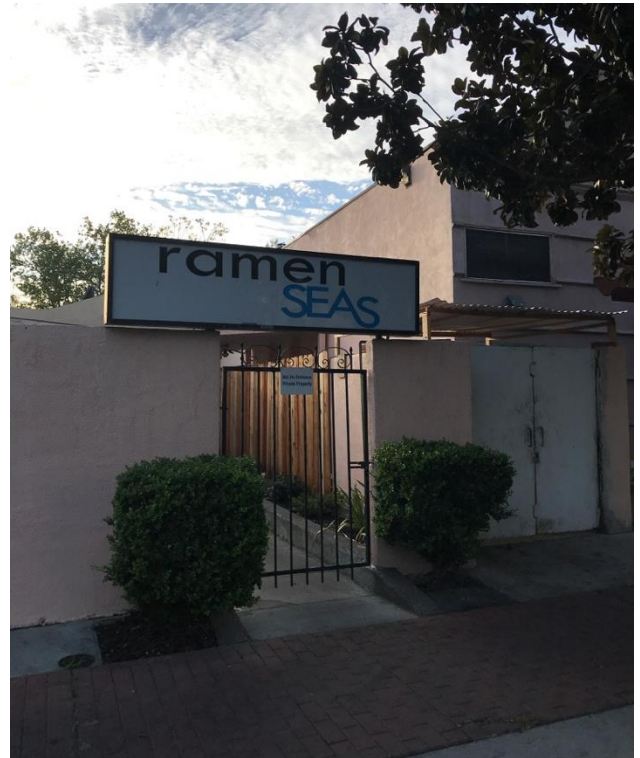
*Above: At the rear of this building there is area for an outdoor patio space; the trash enclosure needs to be improved.*

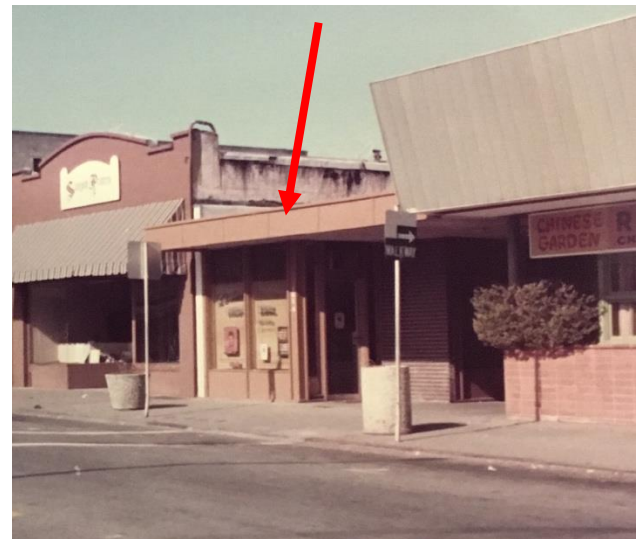
***Above: Front façade before alterations.***

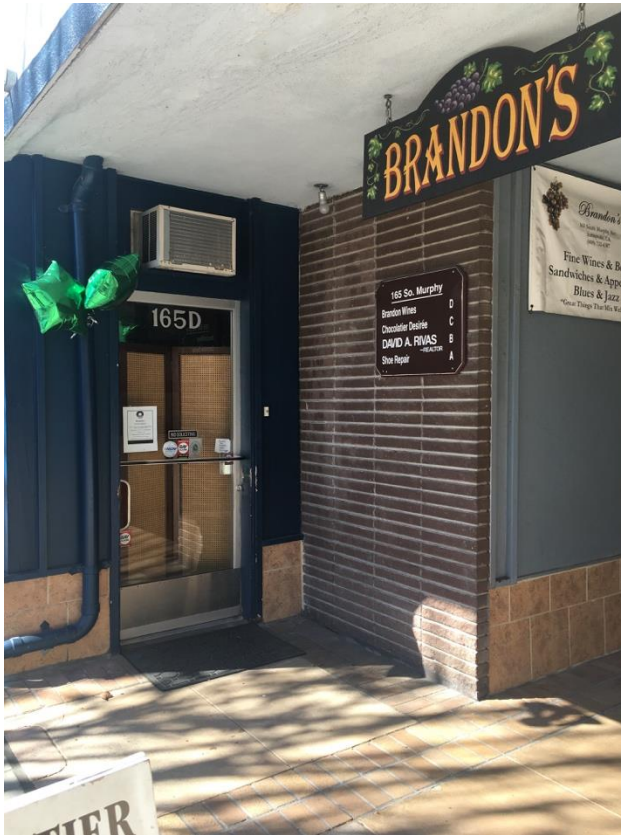
**Above: Front façade showing original roman brick at façade.**

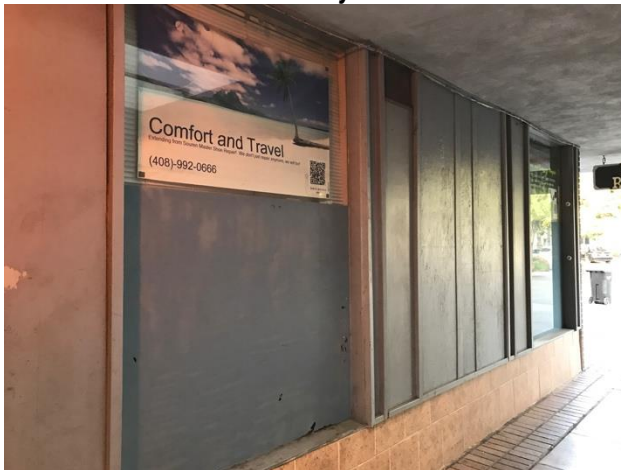
**Below: Wall within the breezeway.**

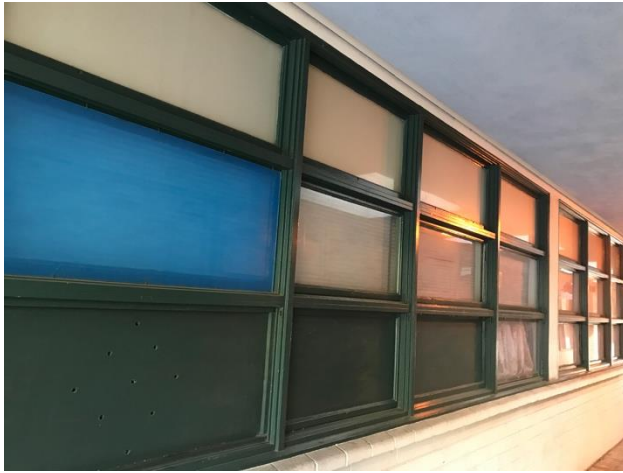
***Above: Breezeway windows to additional commercial spaces.***

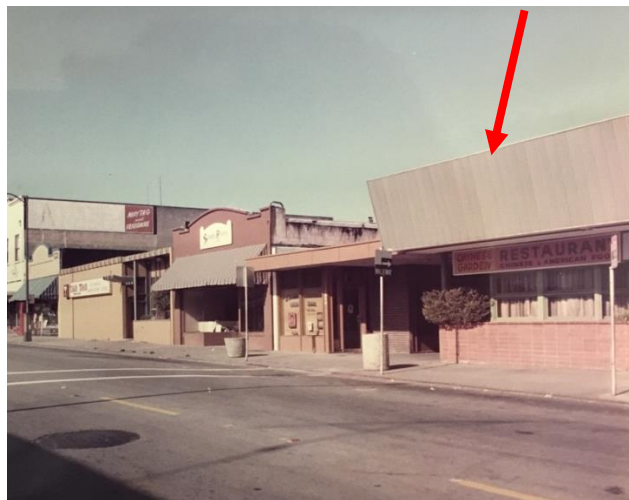
***Above: Historic photograph showing original configuration of the front façade.***

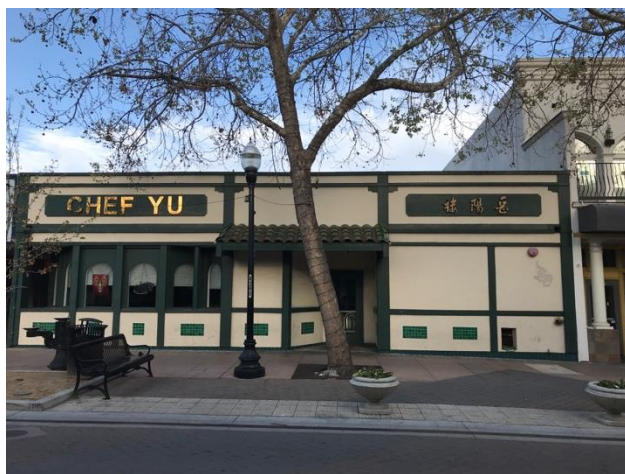
***Above: The one-story front façade along Murphy Avenue.***

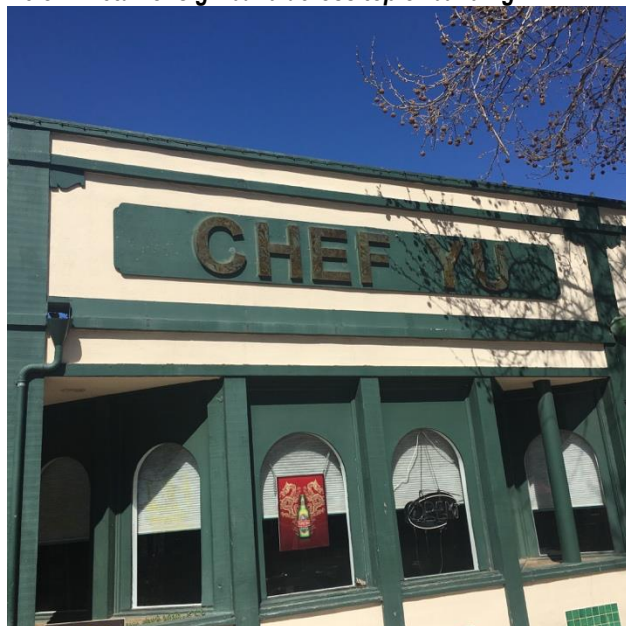
***Below: Detail of sign band across top of building.***

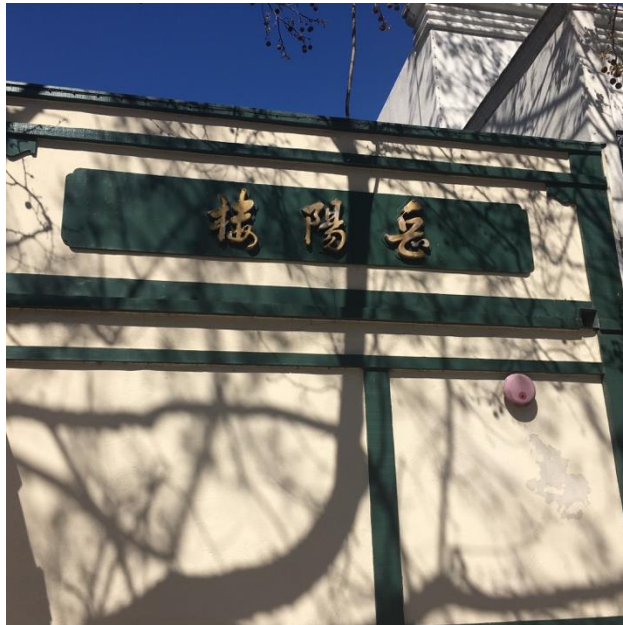
*Above: Detail of the north end of the front facade*

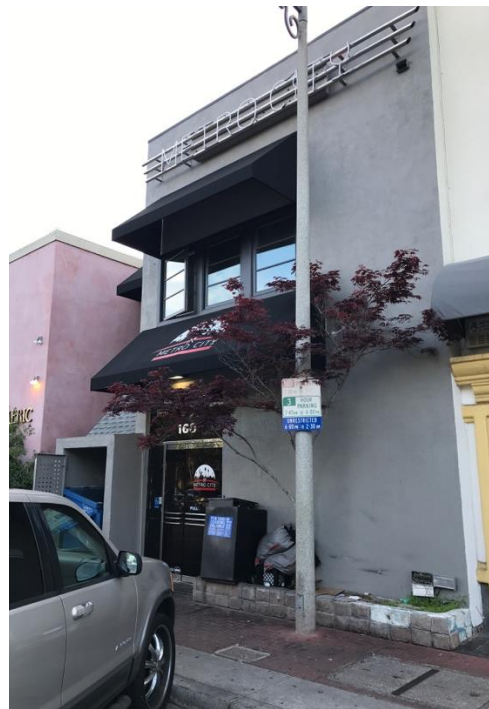
***Above: Rear façade showing two stories.***

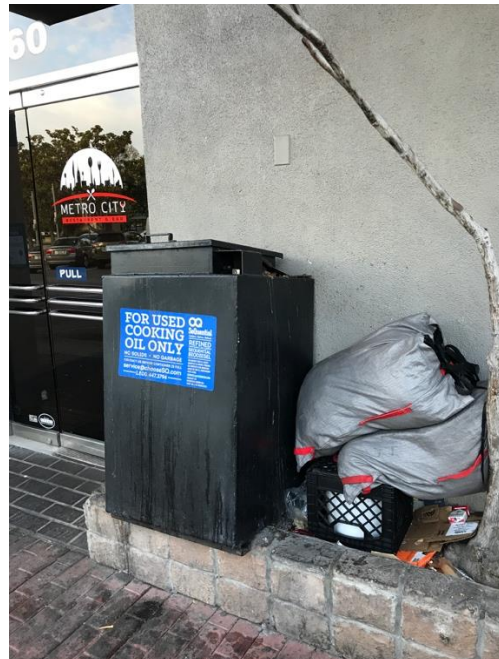
***Below: Rear area showing oil storage that should be enclosed.***

- Conduit and meters should be minimized at Murphy Avenue façade and priority given to relocating these (if possible).
- Consider variation in the form of the parapet, similar to other buildings in the District.
- Replace trash enclosure door (missing one door) in rear of building.
- No materials should be stored at outside area in rear of building. Storage of items related to restaurant use should be located inside the tenant space or within an existing screened storage area.

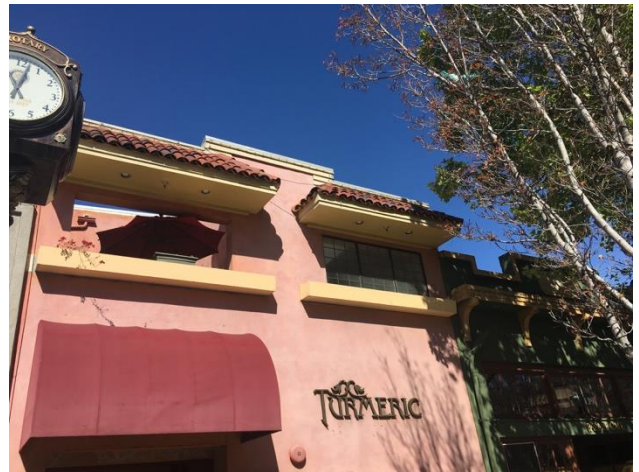
***Above: Detail of parapet and fixed and canvas awning.***

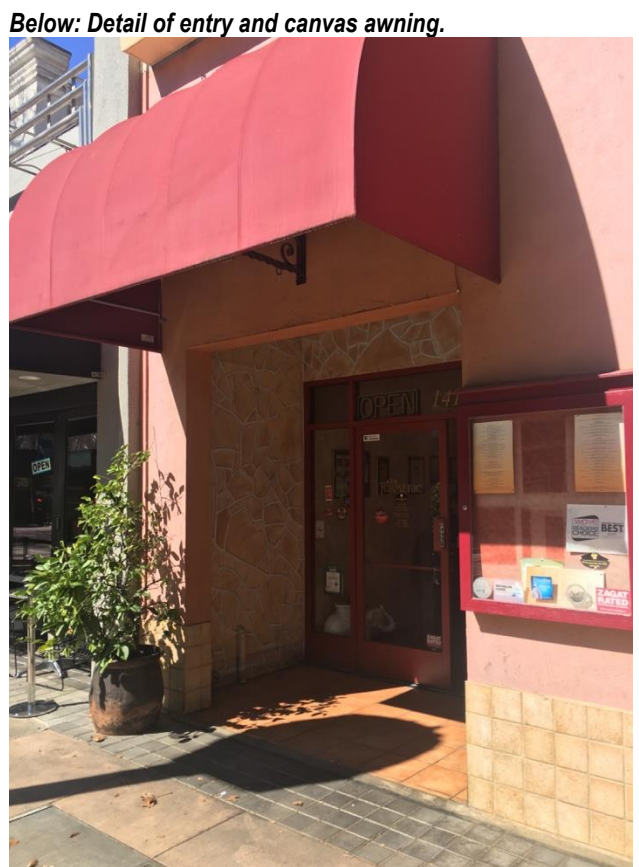
***Below: Detail of entry and canvas awning.***

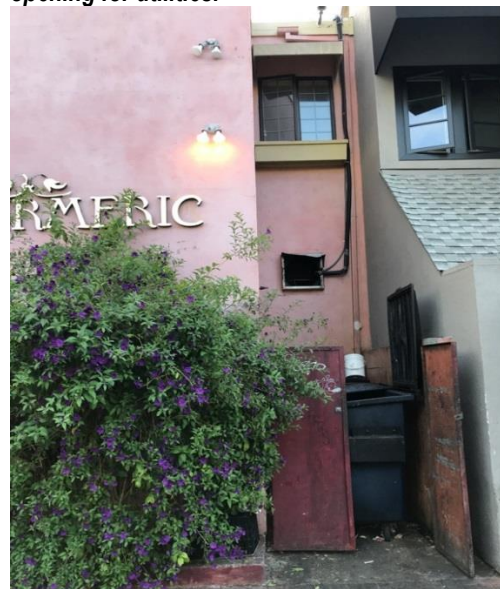
*Below: Detail of rear showing trash enclosure and opening for utilities.*

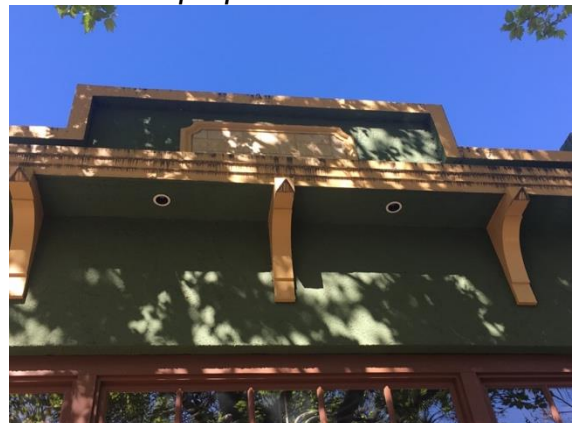
*Below: Detail of parapet.*

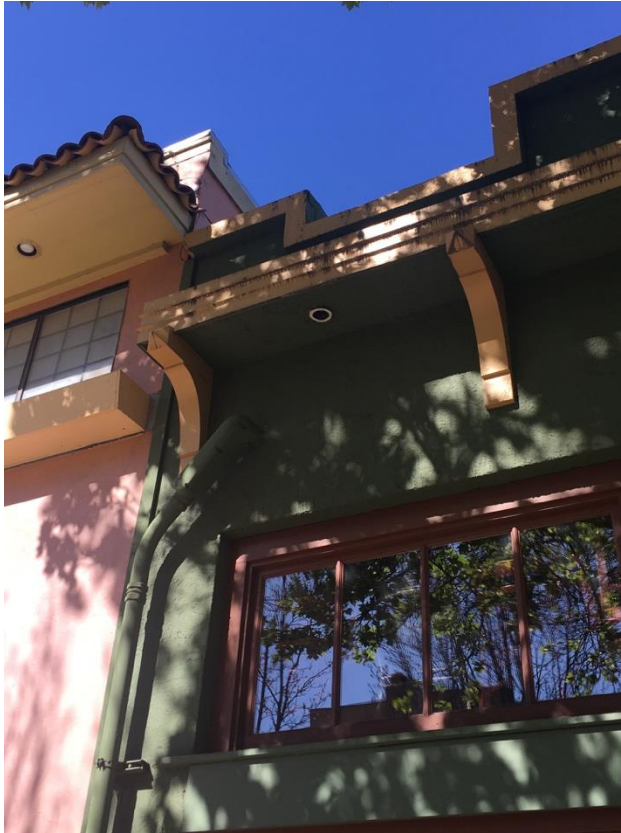
*Above: Front transom detail and conduit on façade.*

- Conduit and meters should be minimized at Murphy Avenue façade and priority given to relocating these, if possible.
- Retain tile base, but replace existing tiles with a tile/style that is more appropriate to the building design and District.
- Rear elevation is in good condition; however, future modifications should strive to make it more compatible with the District by employing fewer materials and providing consistent door openings.

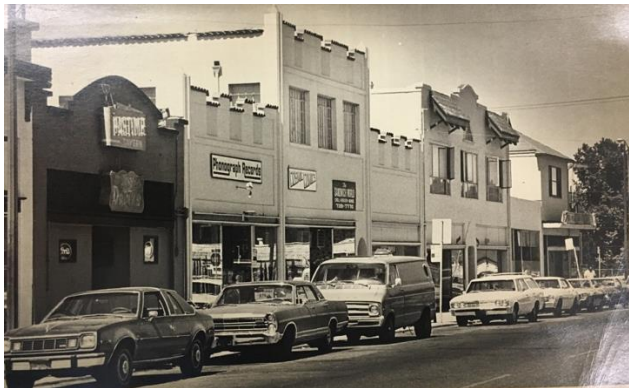
*Above: A photograph of the building, with the Pastime sign, and a much less glazed storefront dating to about 1981. The scalloped parapet is a similar configuration today.*

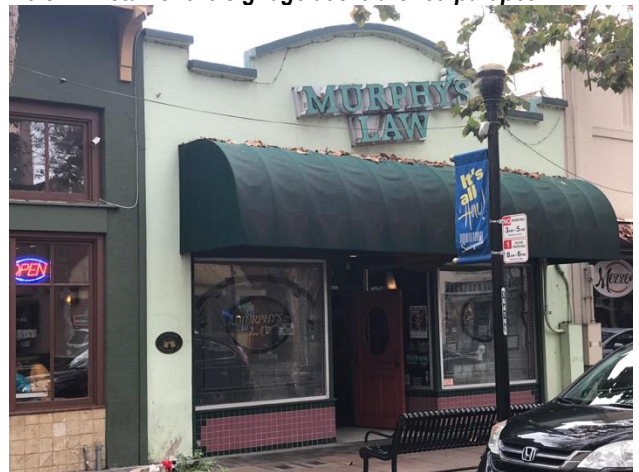
*Below: Detail of the signage at the arched parapet.*

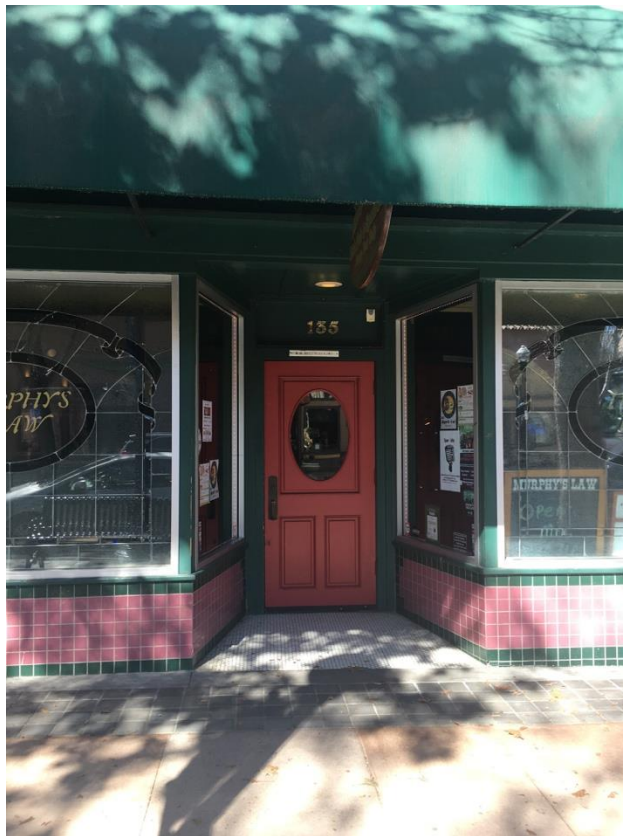
*Above: The angled, recessed entry to the building.*

- Single, centered, angled, recessed storefront entry.
- Smooth stucco finish.
- Ceramic tile base.
- Storefront configuration with windows above tile base and tiled entry floor
- Arched, Mission Revival-inspired parapet.
- Use of an awning.
- Simple color scheme.

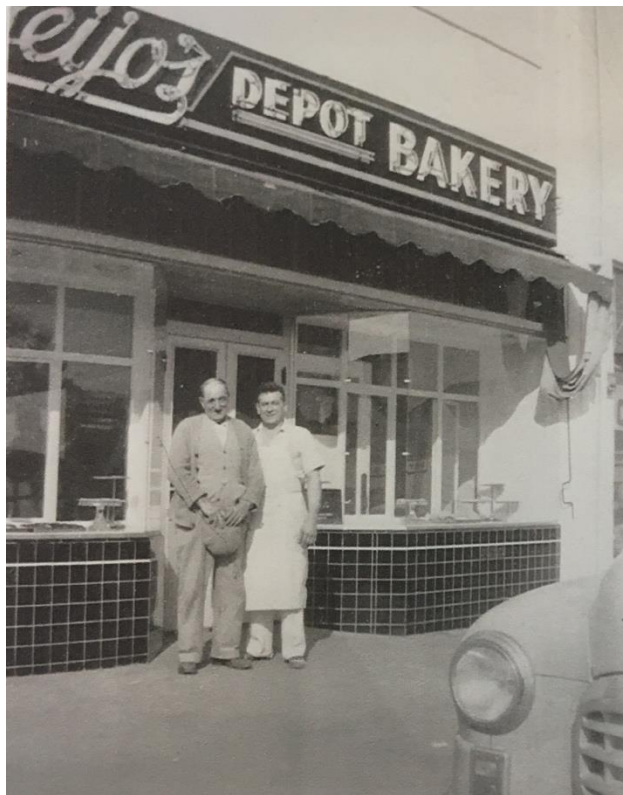
*Above: An historic photograph showing the tile work below the window boxes.*

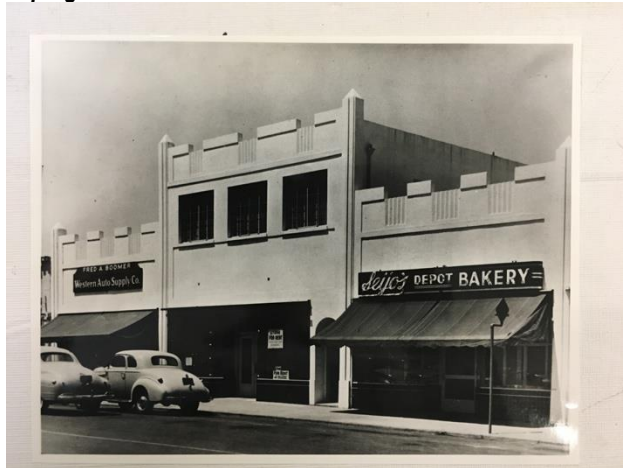
*Below: The building just after construction, note no red tile coping at roof line.*

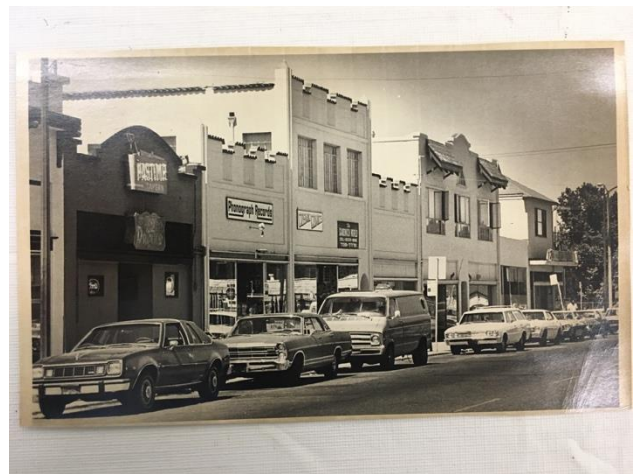
*Above: A photograph of the building dating to about 1981, showing the addition of the red tile coping at parapet.*

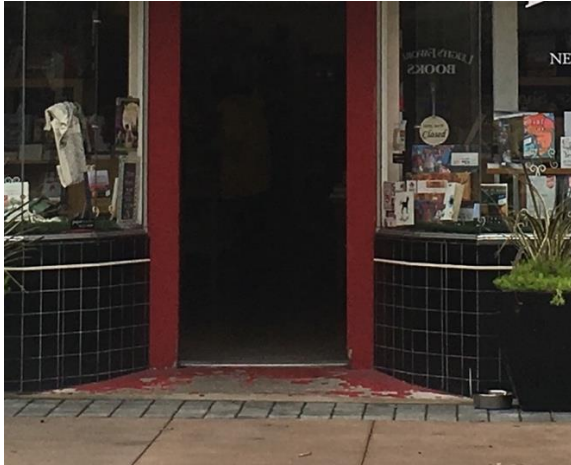
***Above: Detail of recessed entry and tile work.***

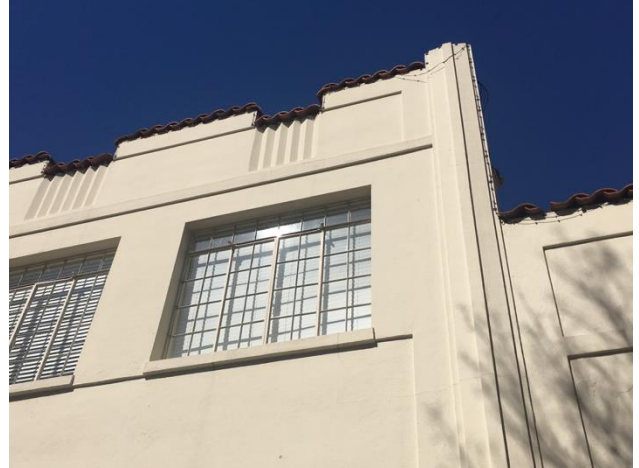
***Below: Detail of upper story window and decorative stucco at roofline.***

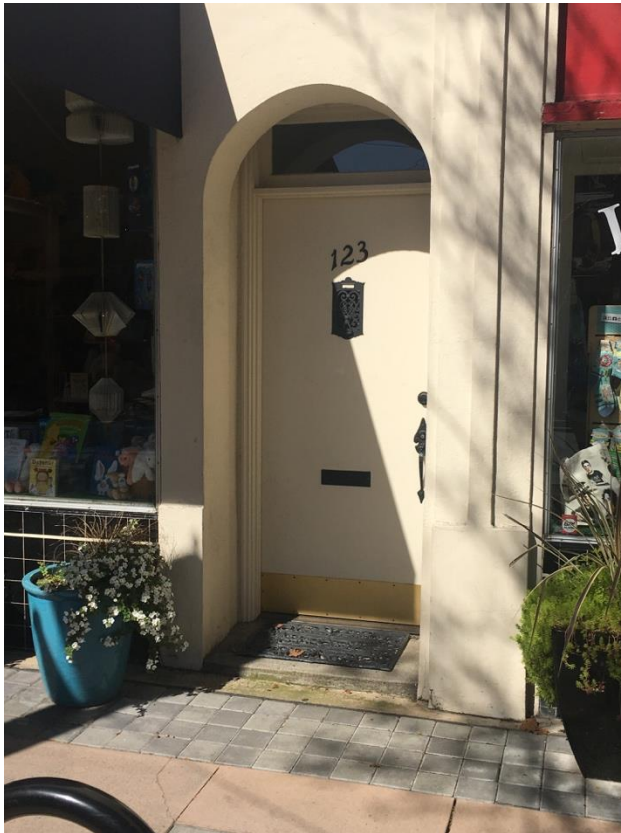
***Above: Arched entry to upper story office space.***

- Retain arched entry and wood door as access to upper story offices.
- Retain stepped parapet and signage panels. If stucco repair is required match decorative stucco features.

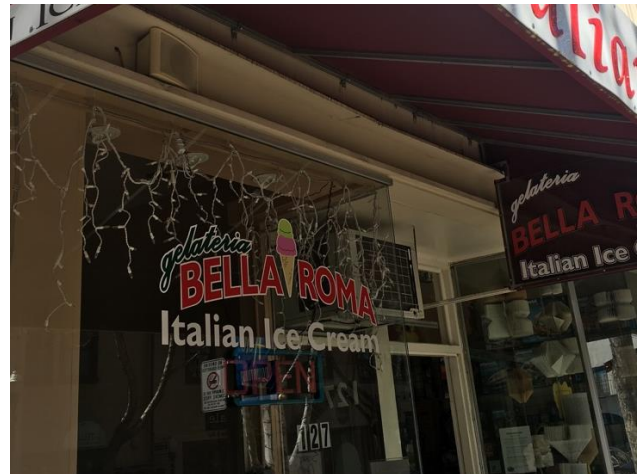
**Below: This storefront has a window air conditioning unit in the transom above the door.**

- Retain recessed store entries in historic configuration.
- Retain storefront doors and over door transom windows. Eliminate air conditioning units above storefront doors and find other solutions to cooling interior spaces.

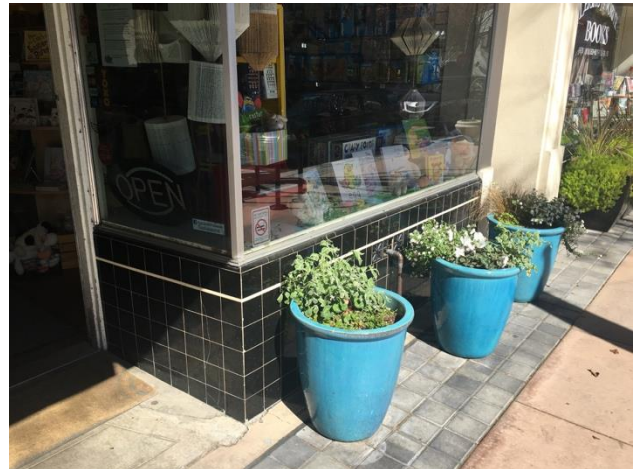
**Below: These planters distract from the historic tile at the base of the storefront.**

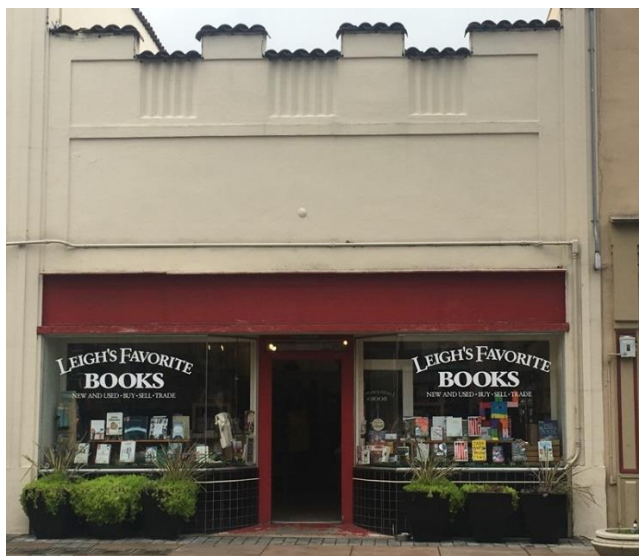
**Above: The light color stucco makes the colored details like the black tile, awnings, and red tile capping stand out.**

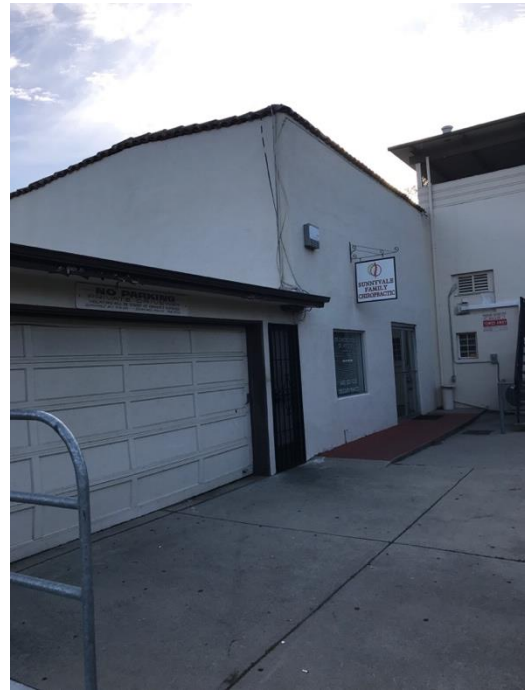
**Above: The rear wing and garage are in need of repair, paint and on-going maintenance.**

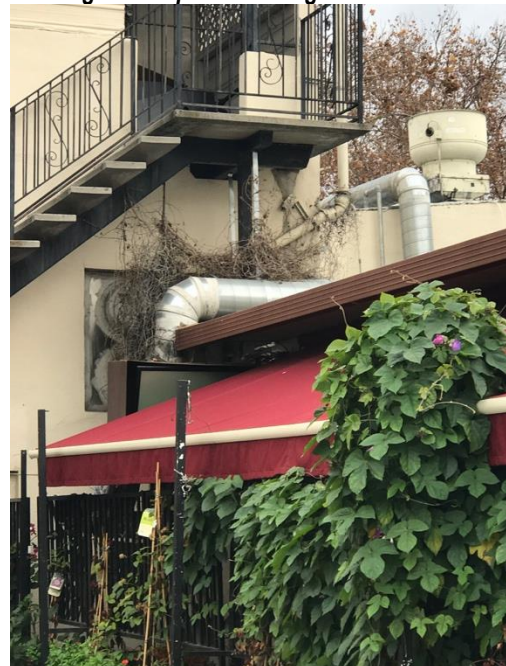
**Below: The large, unsightly air ducts and venting at the building rear requires redesign.**

- Replace the air duct at rear with a smaller duct and paint the new duct to match the existing building color, or relocate to an area that is out of the public view.
