**Date: 4/29/2019**  
**To: All Interested Parties**  
**From: Amber Blizinski, Principal Planner, Community Development Dept.**  
**Subject: Public Draft of the Design Guidelines for the Murphy Station Heritage Landmark District**

*DRAFT*  
DESIGN GUIDELINES  
FOR  
MURPHY STATION  
HERITAGE LANDMARK  
DISTRICT  
April 2019 Version

# MURPHY STATION HERITAGE LANDMARK DISTRICT

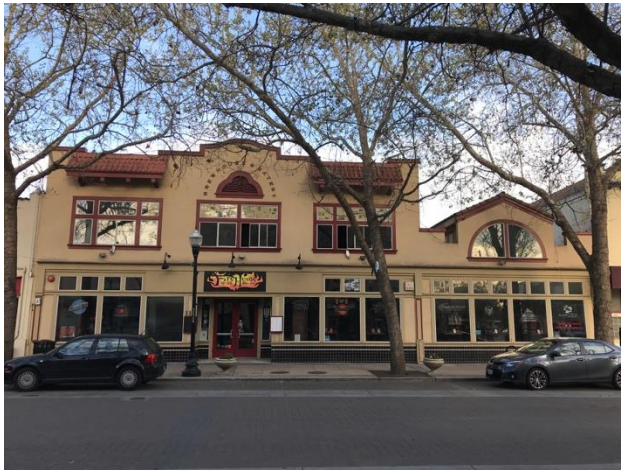
*Above: View of the two-part façade, one and two story elements.*

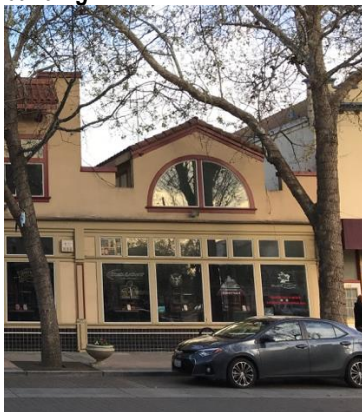
*Below: Detail of the northern one-story element of the building.*

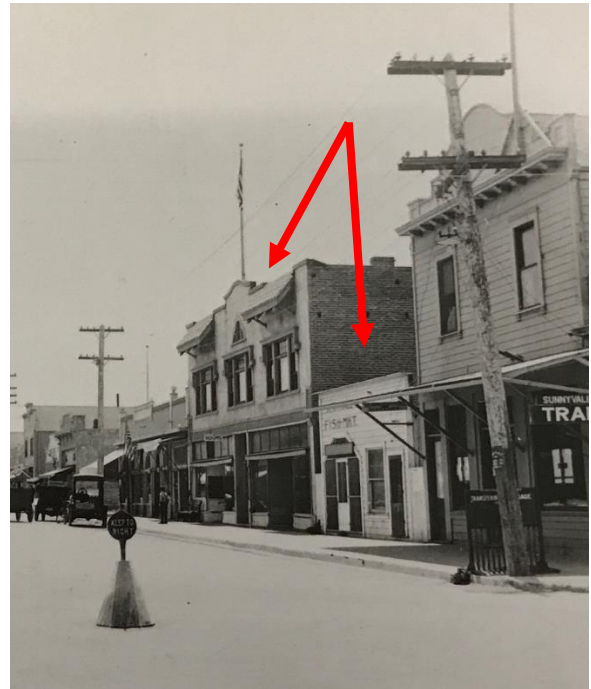
*Above: An historic image of the building showing the one-story building adjacent.*

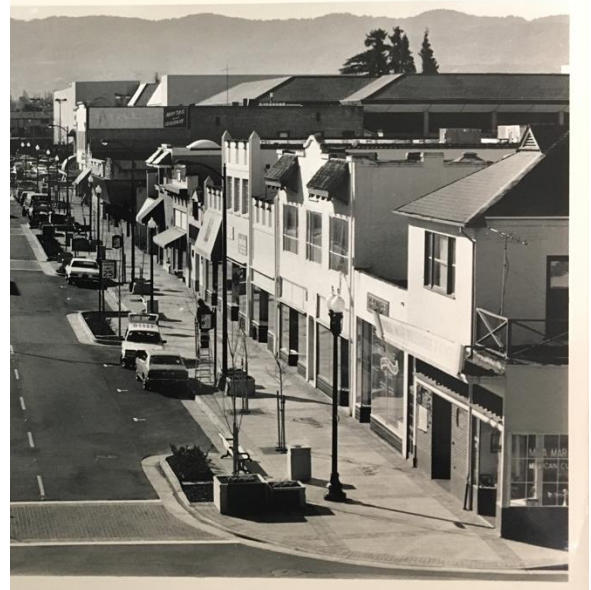
*Below: A view of the building around 1980-85; note the one-story portion had a flat roof at that time.*

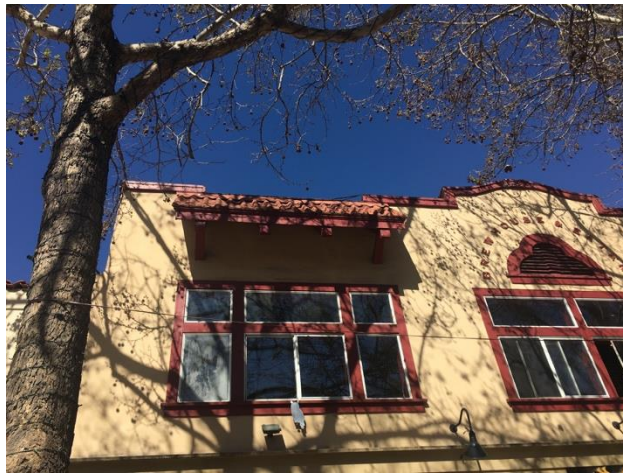
*Above: Detail of windows, awning and decorative vent.*

- One and two-story elements.
- Smooth stucco finish with light-colored base paint.
- Upper story windows with fixed awnings.
- Stepped parapet with wood trim.
- Decorative vent centered above the middle window and below the stepped parapet.
- Recessed storefront entry at S. Murphy Ave.
- Dark-colored tile base along S. Murphy.
- Transom windows at S. Murphy elevation.

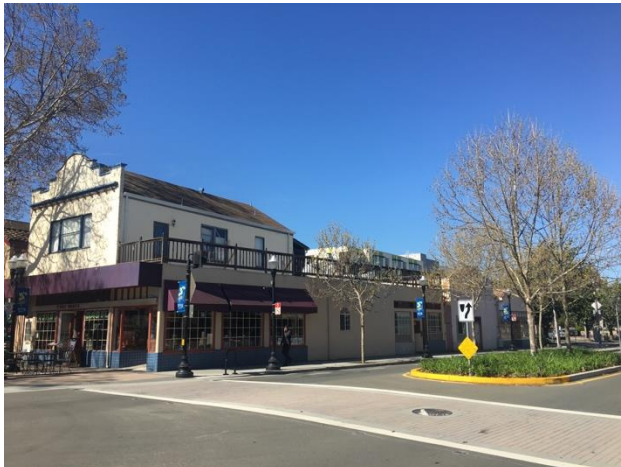
*Above: View of corner building looking southwest showing the two-story and one-story elements.*

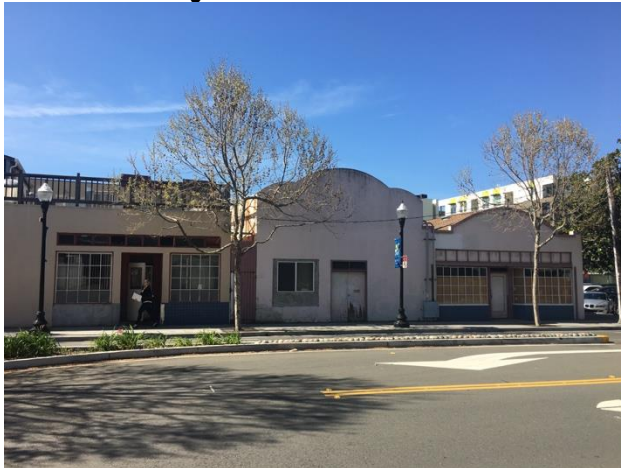
*Below: The W. Evelyn elevation of the building looking south and showing the two additions to the site.*

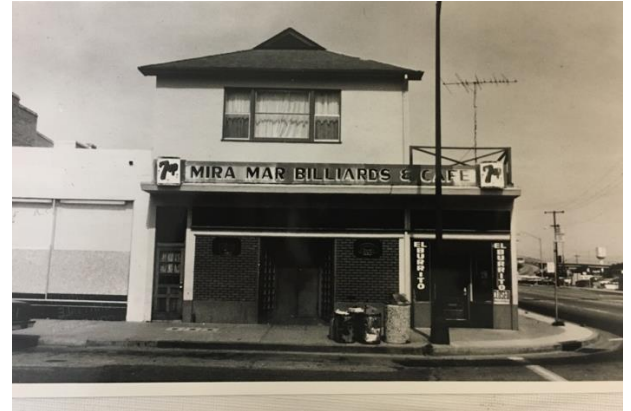
*Above: The building at 101 – 105 S. Murphy circa 1950s; note that the earlier Mission Revival roofline was altered.*

Other alterations noted in field: 1950s photograph shows building had been altered from its early appearance; building front has been restored to Mission Revival appearance.

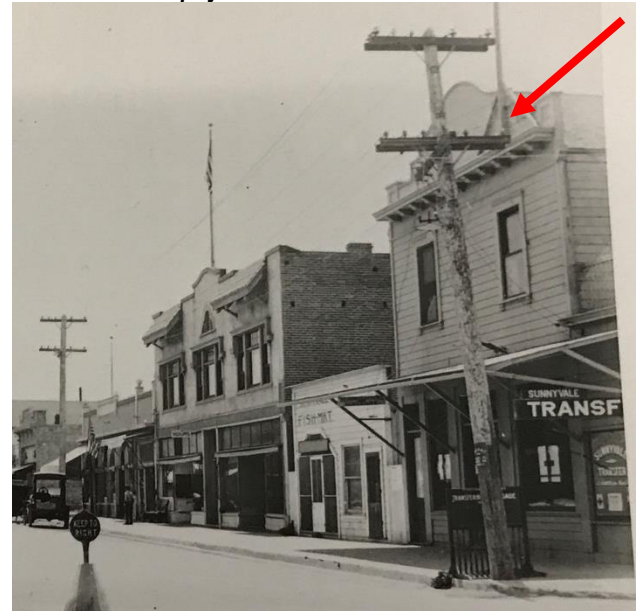
*Below: An early view of this structure circa 1910 looking south down Murphy Avenue.*

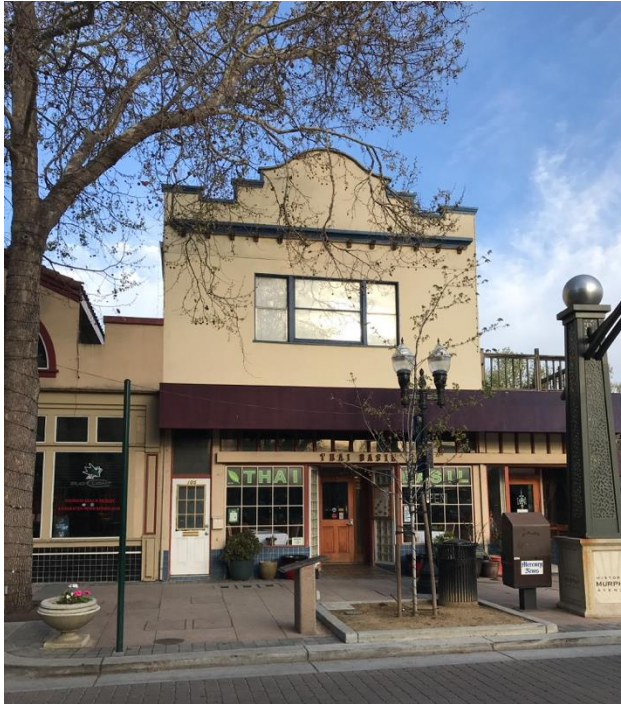
*Above: View of this corner building looking west.*

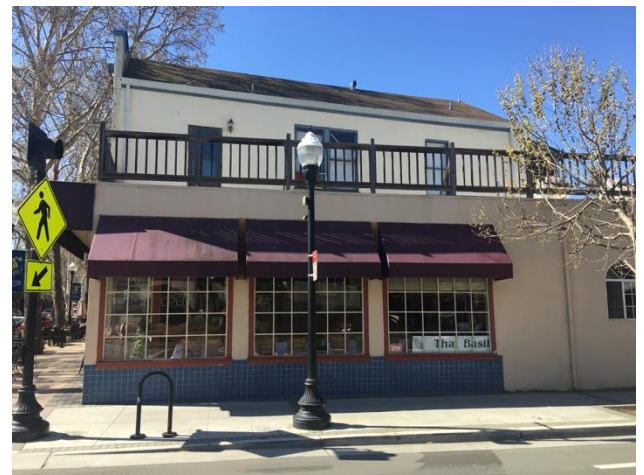
*Above: The building at the north (side) elevation.*

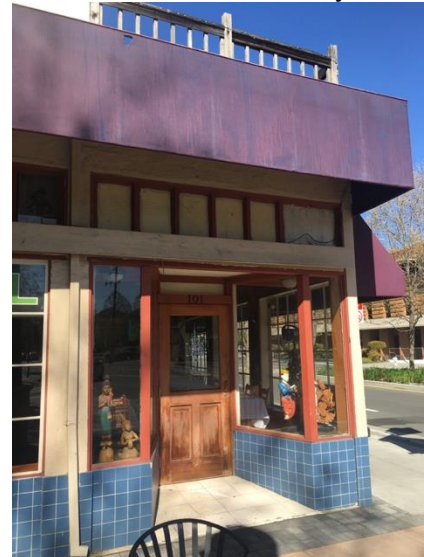
### *Below: Detail of the corner entry and tile.*

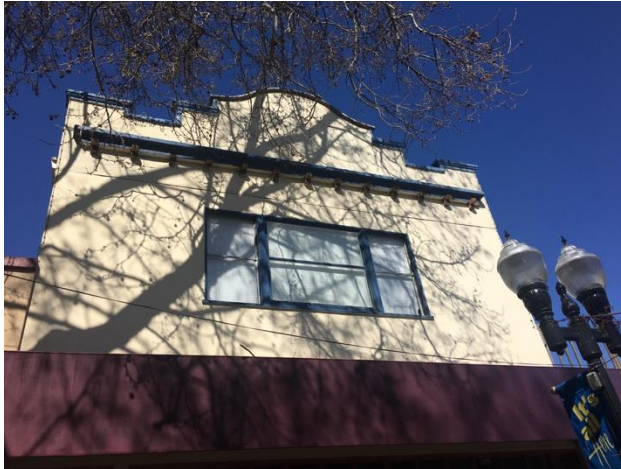
**Above: Detail of the scalloped parapet at the Murphy Avenue elevation.**

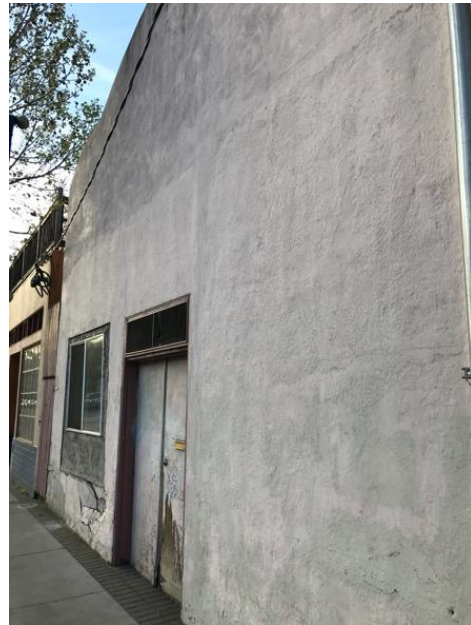
***Above: View of required repairs to stucco, windows and doors at the Evelyn Avenue façade.***

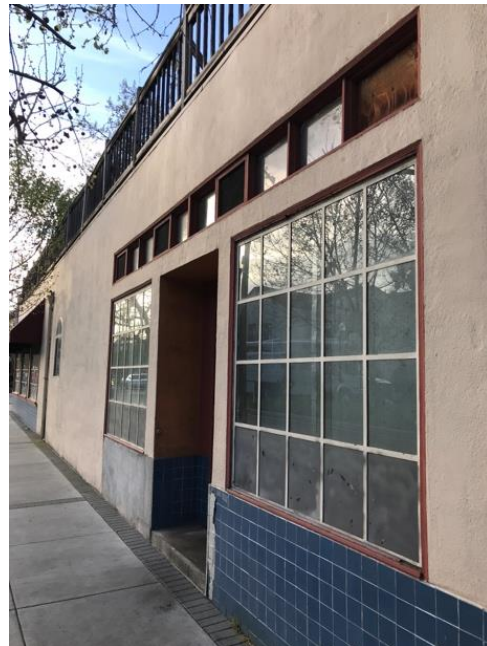
***Below: Evelyn Avenue showing missing tile and need for transom window restoration.***

- Restore transom windows to transparent glazing on the Murphy elevation, and fix broken windows.
- Remove glazed window features from entryway.
- If major renovations occur, consider restoring the siding and making major changes to the Evelyn Avenue façade to enhance the style of the building.

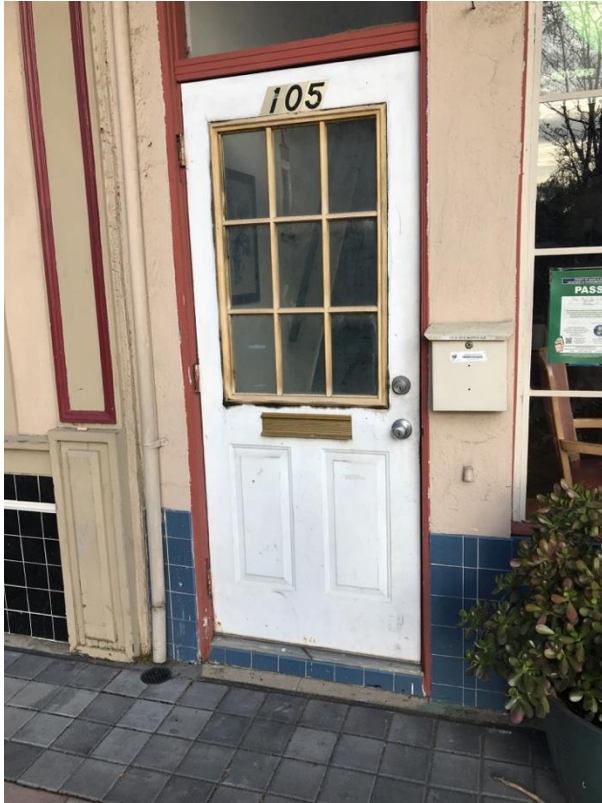
***Above: The door that accesses the second story.***

- Replace awnings with a style that is compatible with the building architecture.
- Open up windows along Evelyn Avenue façade (currently boarded up)
- Replace door to second level on Murphy Avenue with a door that is more compatible with the building architecture.

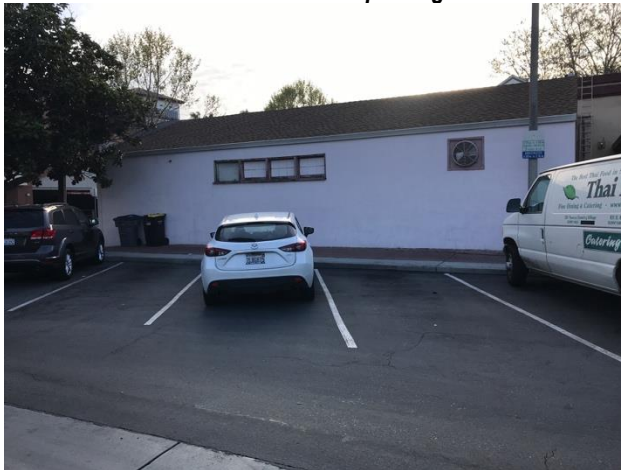
***Below: The rear elevation near the parking area.***

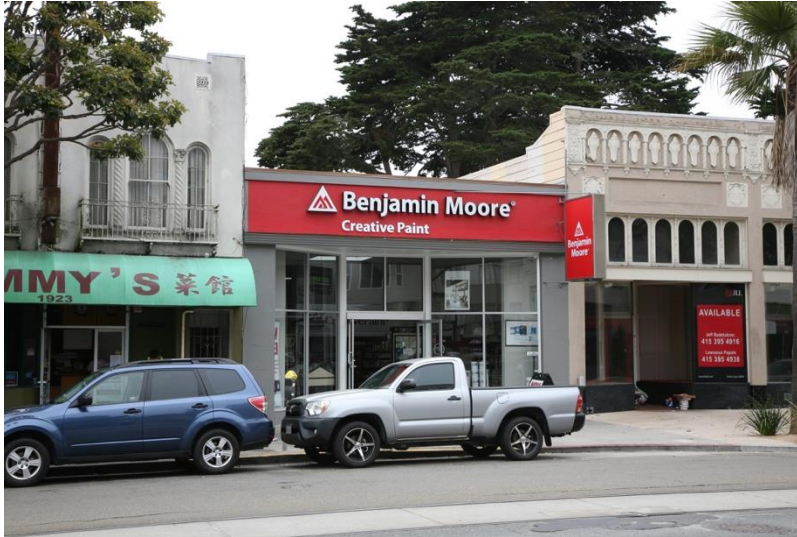
***This new building wedged between two much older structures could have done a better job of aligning with the roof heights along the street. While the building meets the street wall, had the roofline been more compatible, it would blend more with the adjacent structures even employing a modern aesthetic.***

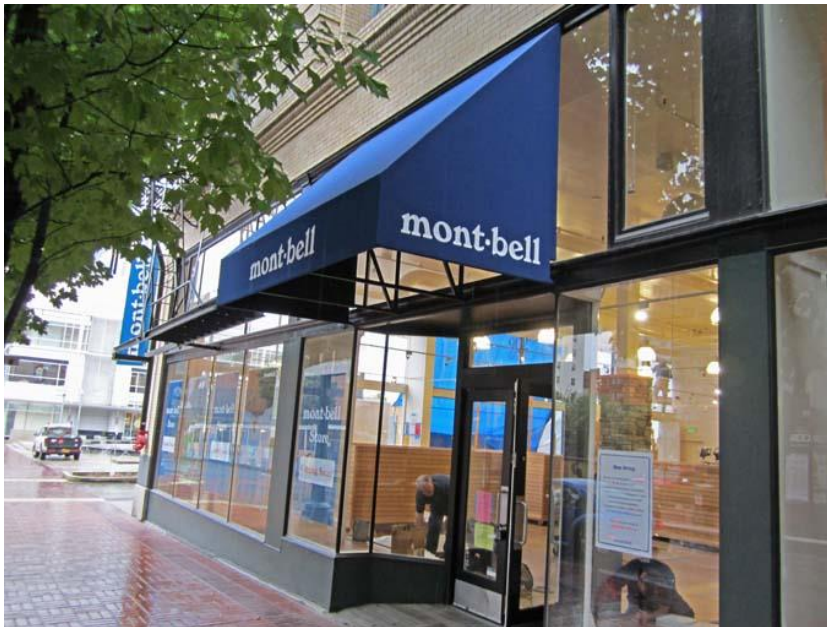
***Above: This storefront is clearly modern but by employing a solid base, clear glass, well-placed and designed awnings and a blade sign at the corner, it will blend well with its historic neighbors.***

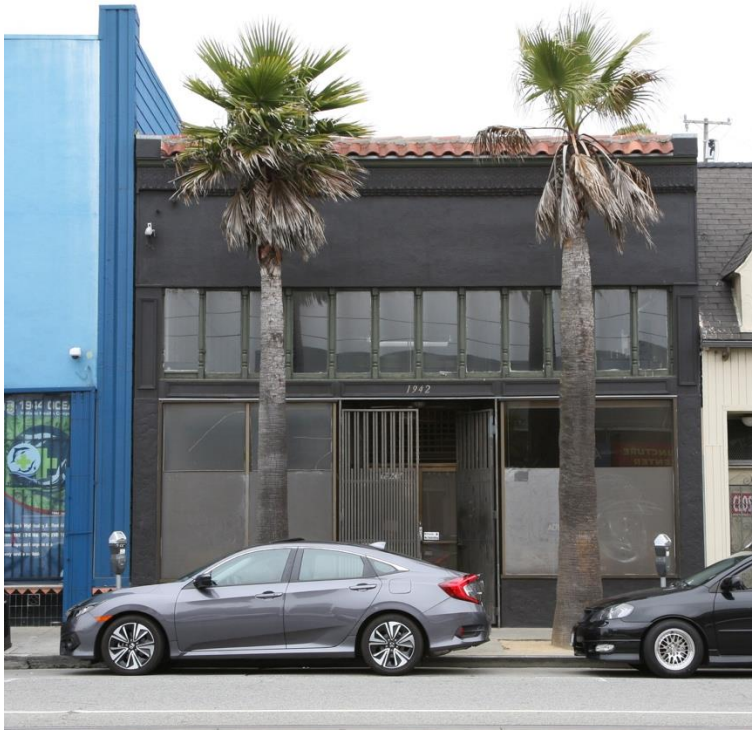
***Above: This storefront was intact at the upper level but had been badly remodeled at the lower portion of the storefront. Recently, it was remodeled again with large panes of glass, a recessed entry with nicely designed gate, and a simple, but solid base. It blends well with the other historic storefronts on the street.***
