CITY OF SUNNYVALE FIRE STATION MASTER PLAN

09.21.21

PREPARED BY KITCHELL AND SHAH KAWASAKI ARCHITECTS

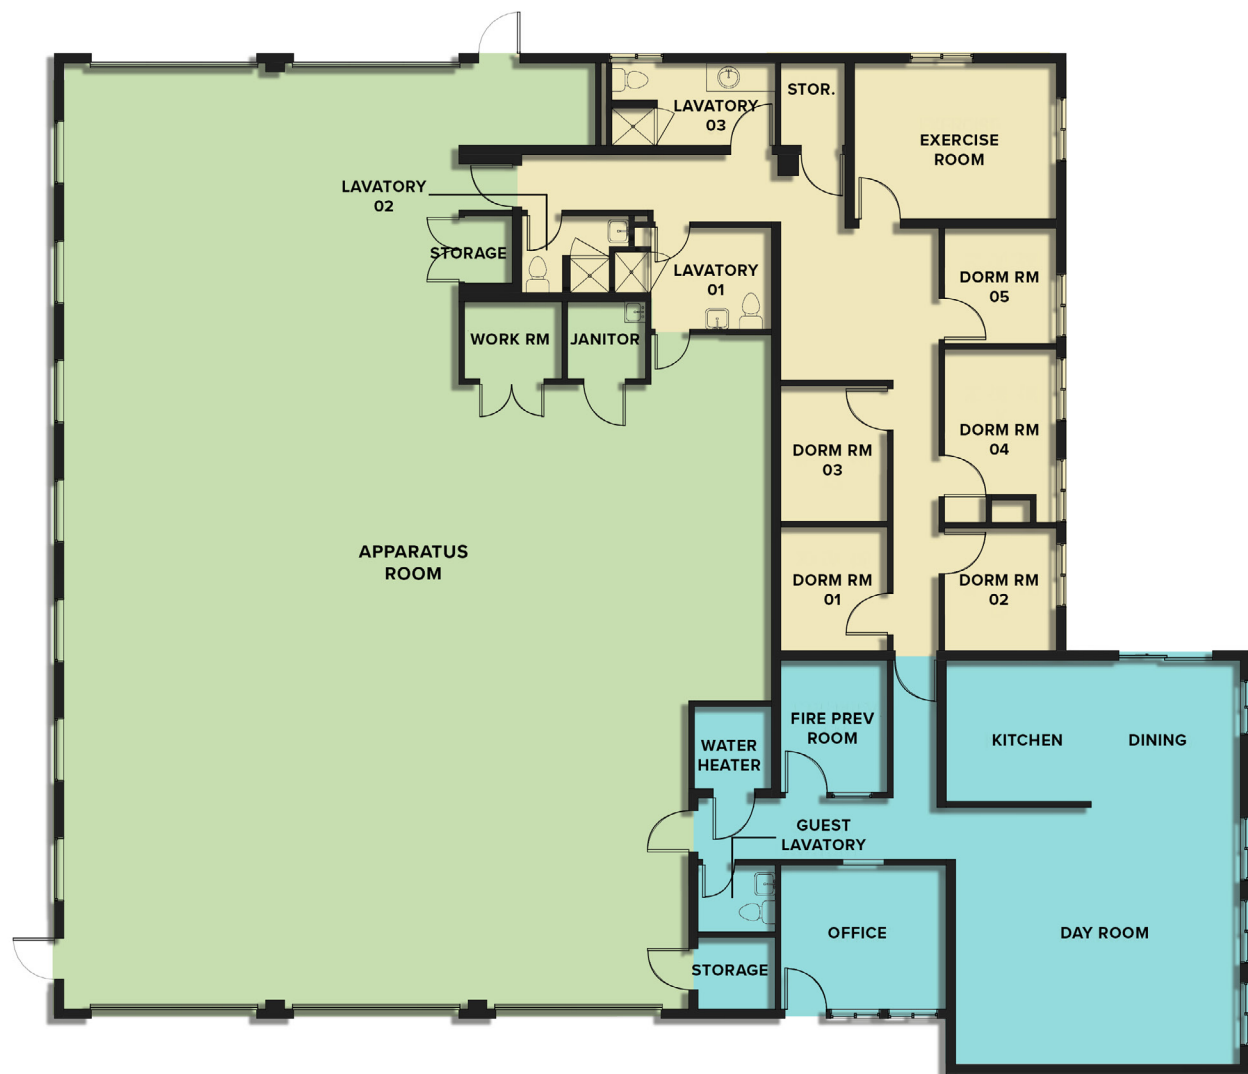
EXISTING FLOOR PLAN

FIRE STATION NO. 1

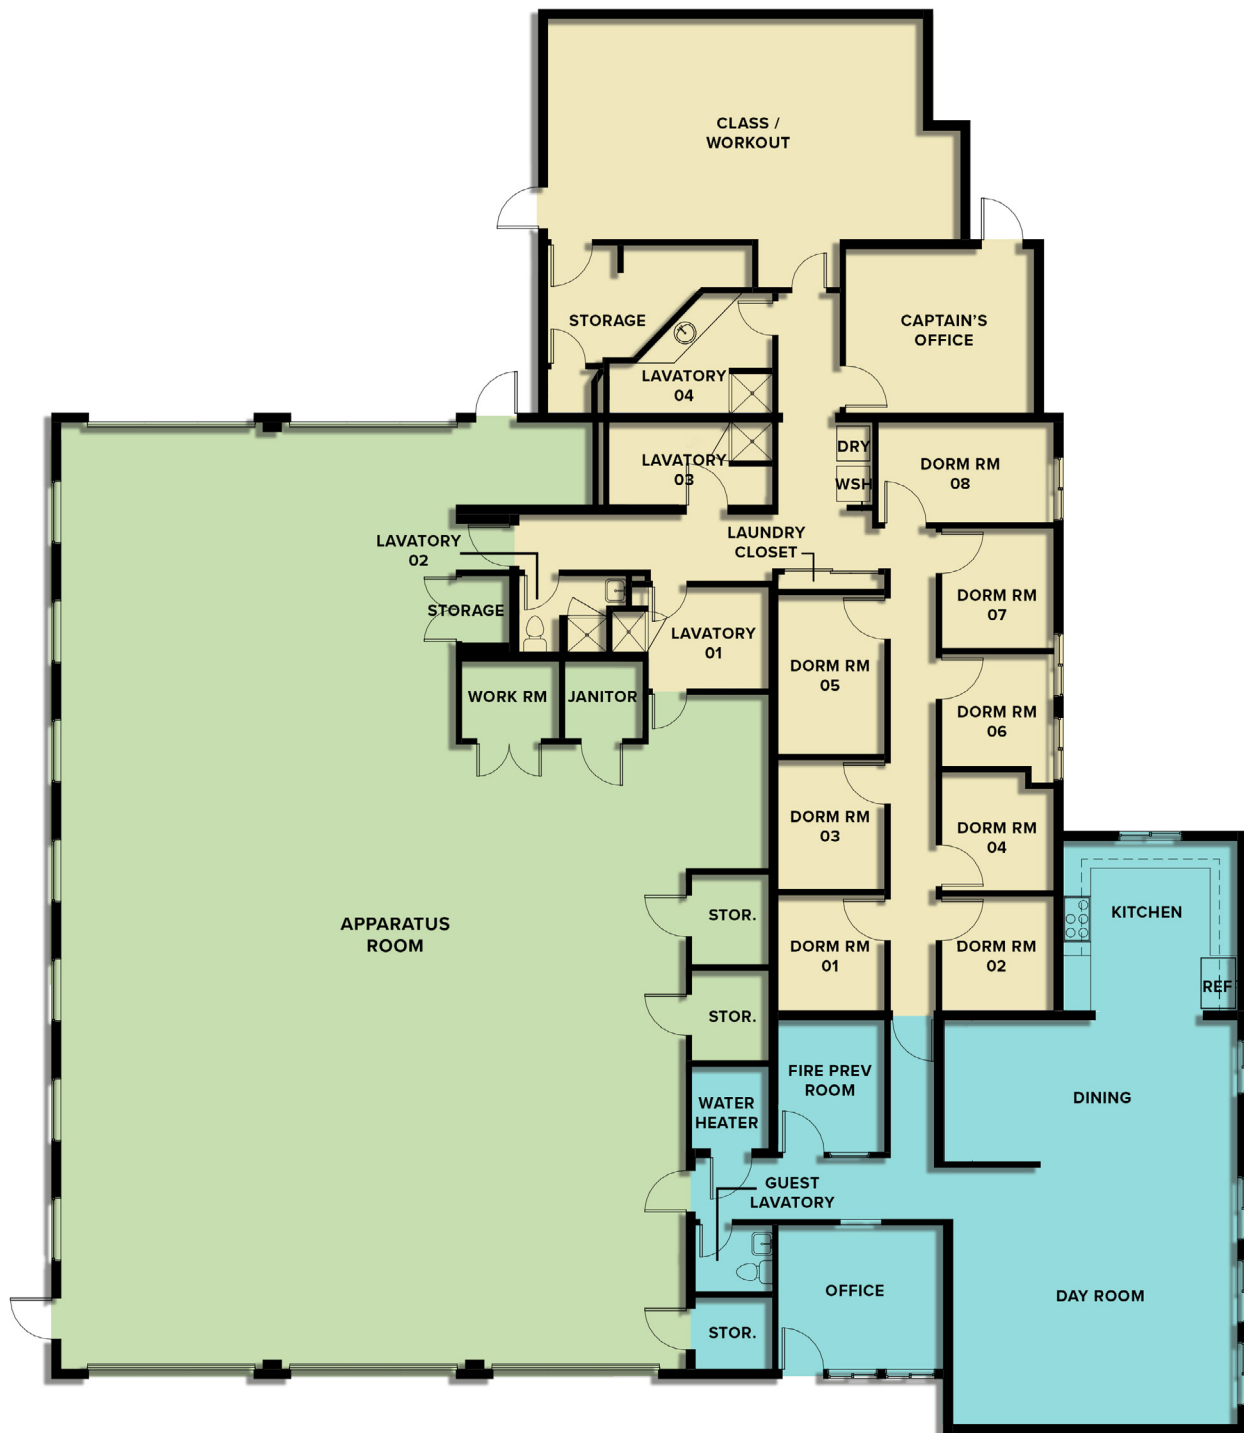
EXISTING FLOOR PLAN

FIRE STATION NO. 2

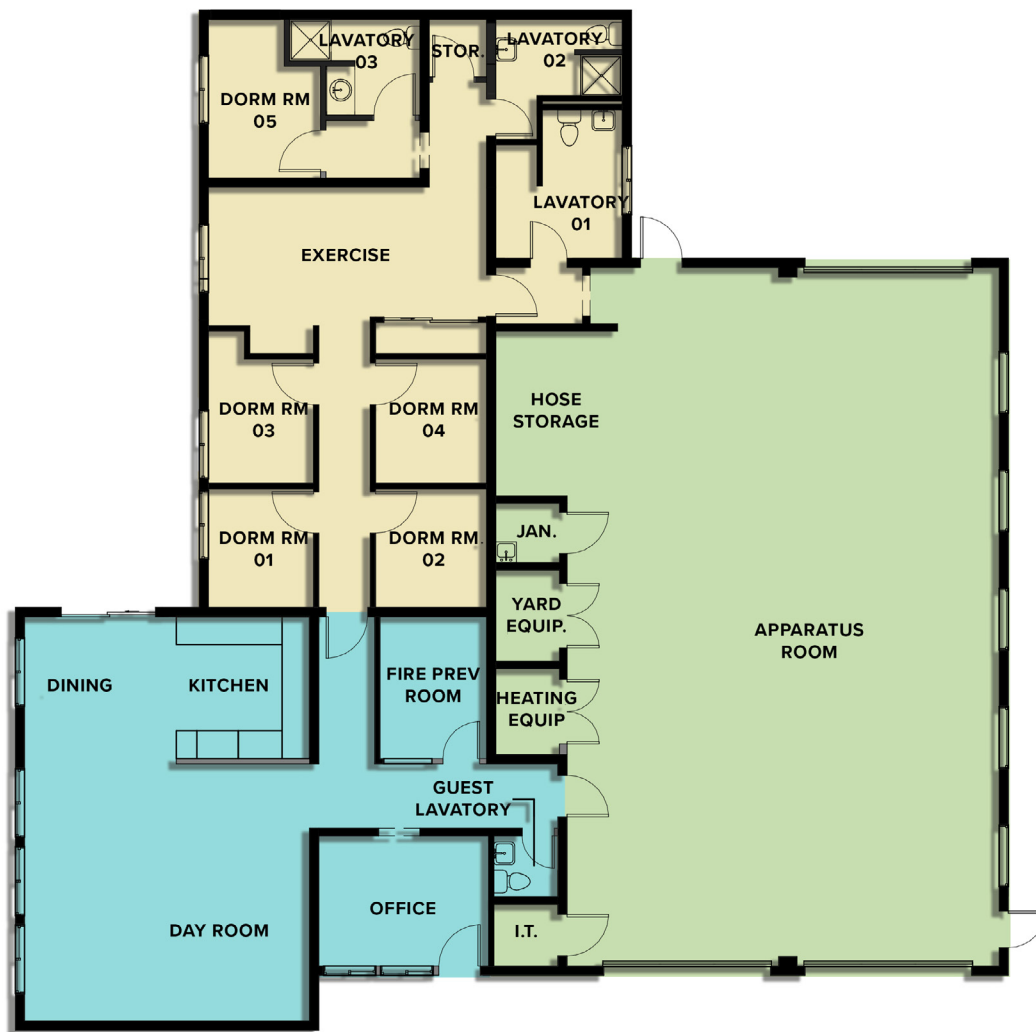
EXISTING FLOOR PLAN

FIRE STATION NO. 3, 4 & 6

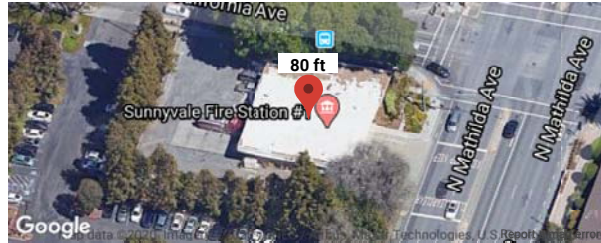
Address: 171 N Mathilda Ave, Sunnyvale, CA 94086, USA
Coordinates: 37.3820009, -122.033268
Elevation: 80 ft
Timestamp: 2020-02-11T02:22:07.299Z
Hazard Type: Seismic
Reference Document: ASCE7-16
Risk Category: IV
Site Class: D-default

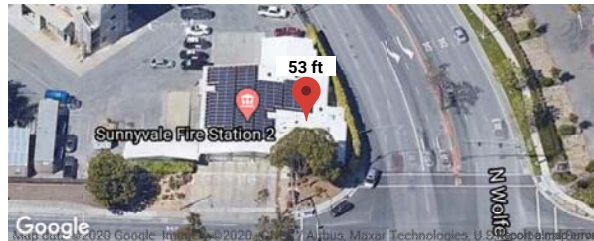
Address: 795 E Arques Ave, Sunnyvale, CA 94085
Coordinates: 37.3812954, -122.0122848
Elevation: 53 ft
Timestamp: 2020-02-11T02:24:26.074Z
Hazard Type: Seismic
Reference Document: ASCE7-16
Risk Category: IV
Site Class: D-default

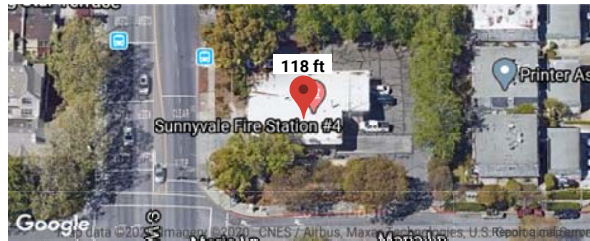
Address: 996 S Wolfe Rd, Sunnyvale, CA 94086
Coordinates: 37.3564904, -122.013817
Elevation: 118 ft
Timestamp: 2020-02-11T03:20:19.219Z
Hazard Type: Seismic
Reference Document: ASCE7-16
Risk Category: IV
Site Class: D-default

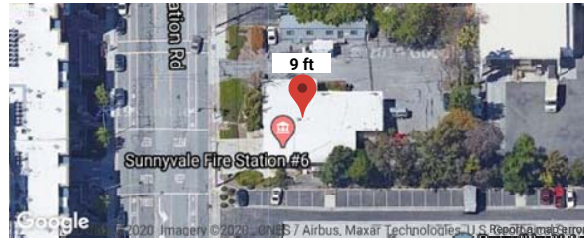
Address: 1282 Lawrence Station Rd, Sunnyvale, CA 94089
Coordinates: 37.4076084, -121.9955466
Elevation: 9 ft
Timestamp: 2020-02-11T03:26:25.504Z
Hazard Type: Seismic
Reference Document: ASCE7-16
Risk Category: IV
Site Class: D-default

Name	Value	Description
S_S	1.5	MCE_R ground motion (period=0.2s)
S_1	0.6	MCE_R ground motion (period=1.0s)
S_{MS}	1.8	Site-modified spectral acceleration value
S_{M1}	* null	Site-modified spectral acceleration value
S_{DS}	1.2	Numeric seismic design value at 0.2s SA
S_{D1}	* null	Numeric seismic design value at 1.0s SA
