ARBORIST REPORT-

Tree Resource Analysis, Construction Impacts & Protection Plan for:

1019 Edmonds Court/ APN: 320-12-008 Sunnyvale, CA November 10, 2018

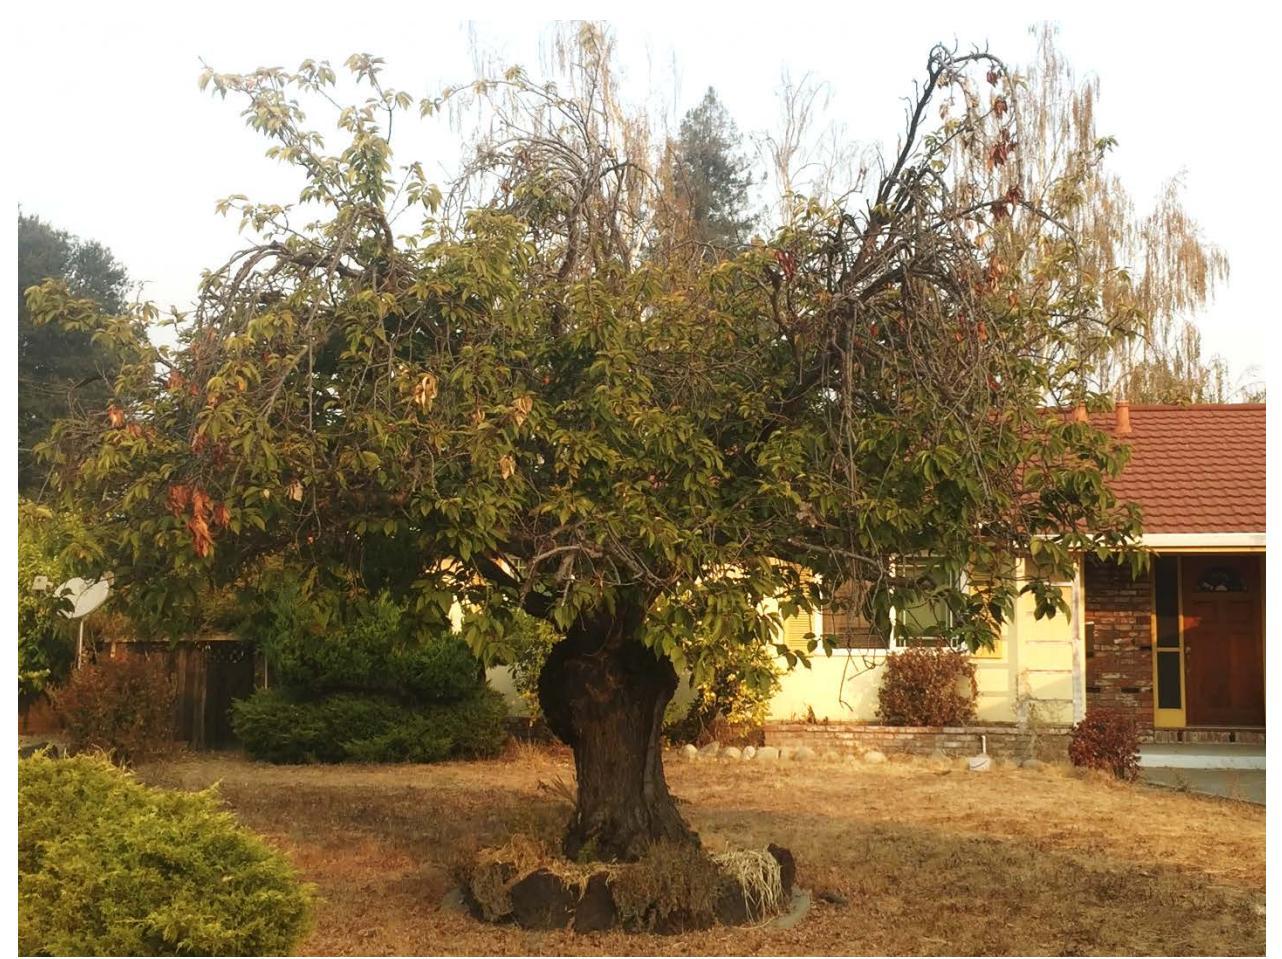
Image #1 – Tree T1 – flowering cherry, the only "protected" tree on the property.

"Protected" tree T1, a flowering cherry is within the footprint of the new driveway. No reasonable alteration of the proposed driveway footprint would allow for its retention.
