City of Sunnyvale

Notice and Agenda - Final Heritage Preservation Commission

Updates to the Design Guidelines for the Murphy Station Heritage Landmark District: Forward a Recommendation to the City Council to Adopt a Resolution Updating the Design Guidelines for the Murphy Station Heritage Landmark District, and Find that the Action is Exempt from CEQA Pursuant to CEQA Guideline Sections 15308 and 15061(b)(3). (Study Issue)

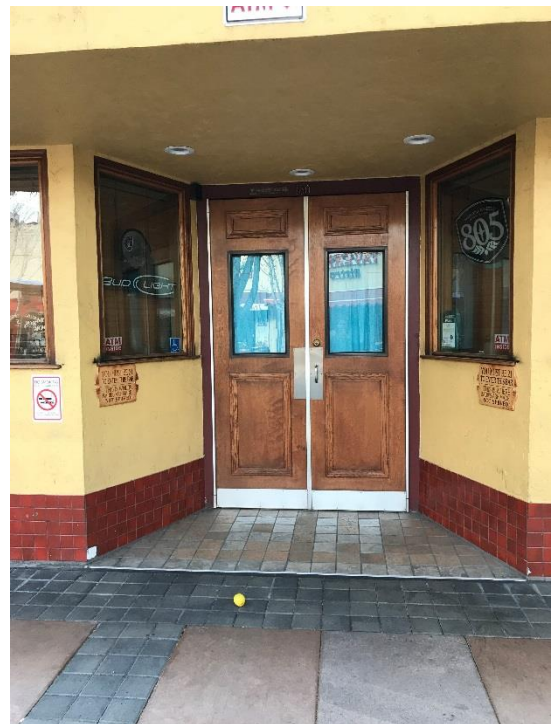
Above: Current entry doors are not historic and could be replaced with doors that are more in keeping with commercial buildings of this era

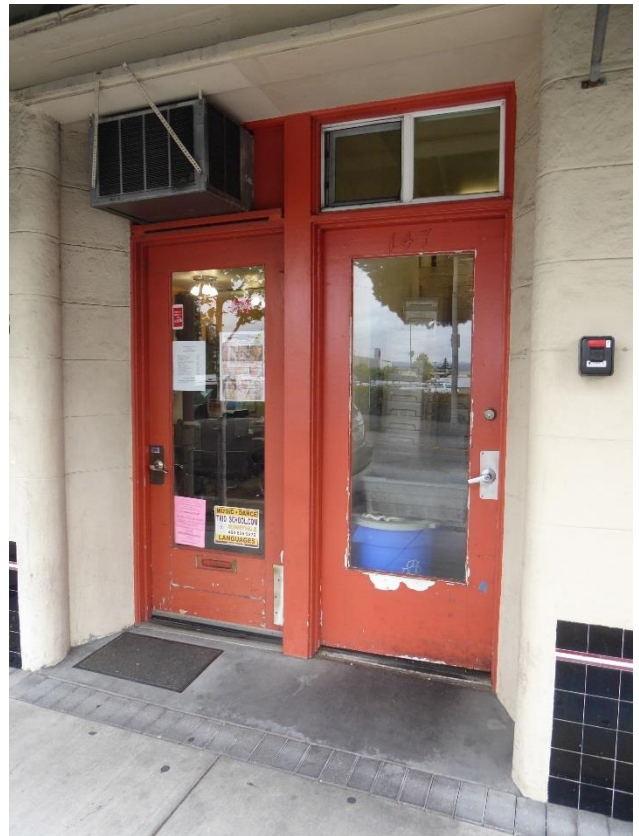
Above: Recessed entry with single panel glazed wood doors into the storefronts.

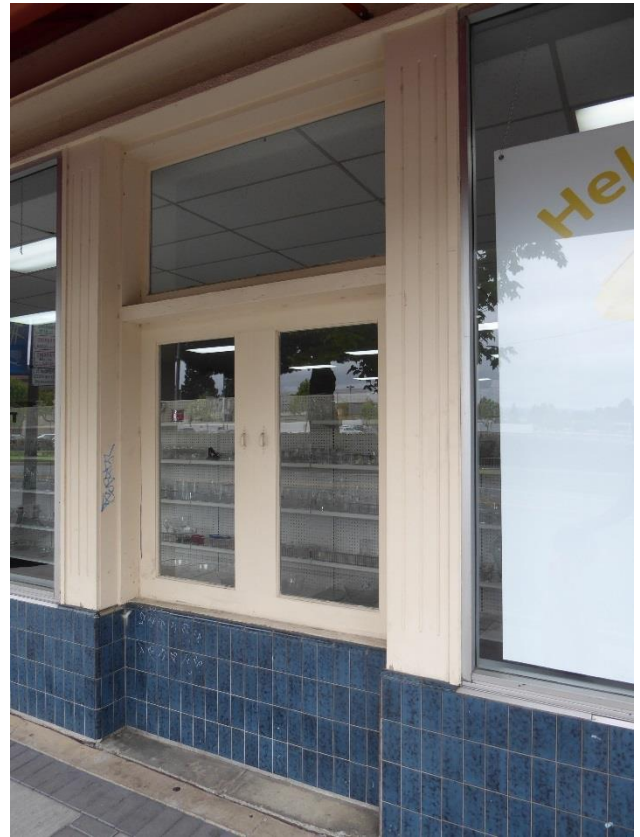
Above: Detail of recessed area, tile base, and fluted wood columns.

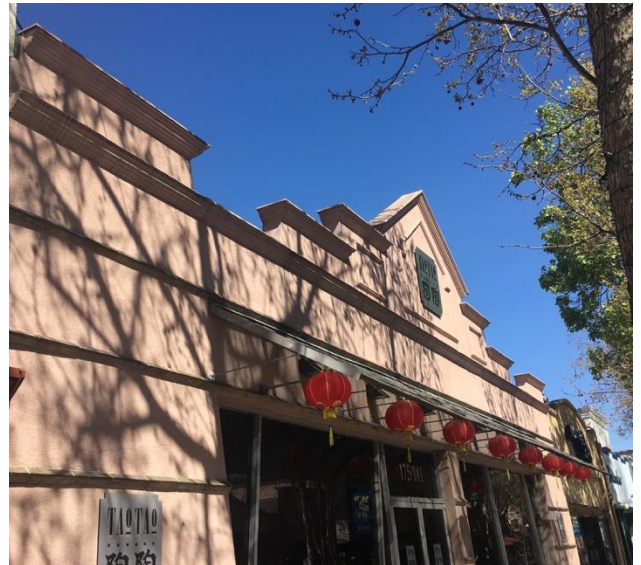
Above: Detail of overhang and roofline

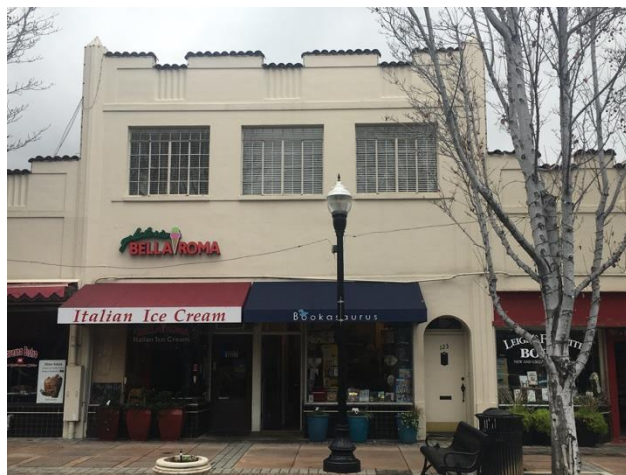
Above: The awnings on each storefront are different colors, sizes and materials. Uniformity of the awnings in shape, size and material could be considered.

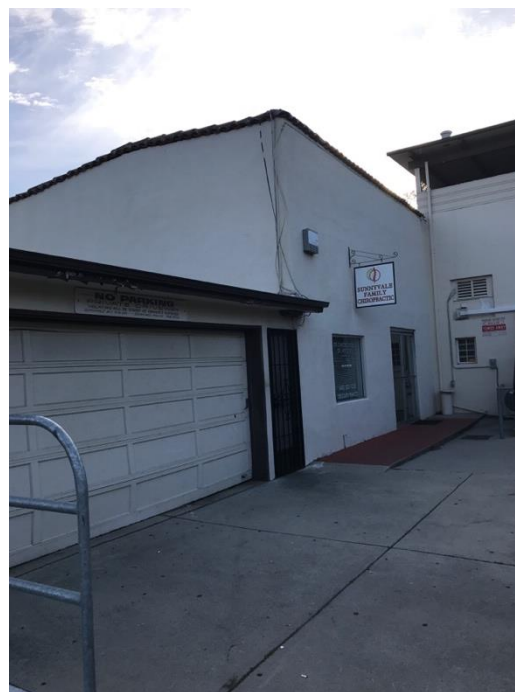
Above: The rear wing and garage are in need of repair, paint and on-going maintenance.
